Pipeline Investigation Report: NTSB/PIR-22/02

# Enbridge Inc. Natural Gas Transmission Pipeline Rupture and Fire

Danville, Kentucky  
August 1, 2019

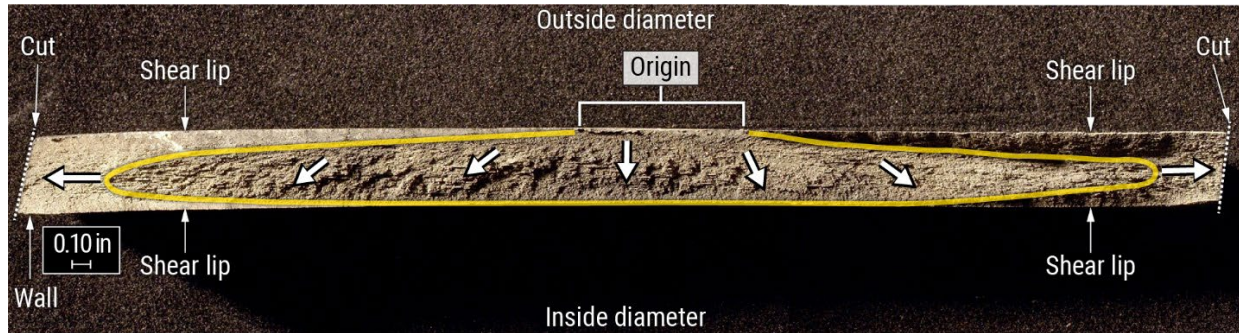
The NTSB Materials Laboratory examination of the fracture faces from the ejected pipe revealed that the fracture originated at the outer surface, as indicated in figure 6. The origin of the fracture and an area extending below it contained a flat region with a rough texture, shown enclosed by a yellow line. Fracture propagation was in the general direction indicated by the arrows.<sup>10</sup> The origin of the fracture showed no evidence of a gouge or dent and did not originate from a weld. The length of the origin at the outer surface measured about 0.8 inches, and shear lips extended from both ends.<sup>11</sup> The fracture face at the inner surface (opposite the

fracture origin) contained a minor shear lip, indicating the fracture did not start at the inner surface of the pipe. The fracture areas located outside of the north and south ends of the flat region were on a slant plane and contained a chevron pattern, consistent with overstress separation.

**Figure 6.** East face of the fracture origin.

A detailed scanning electron microscope examination of the fracture face revealed that the origin exhibited intergranular fracture features, which came from localized embrittlement caused by exposure to hydrogen.<sup>12</sup> The amount of intergranular fracture features decreased toward the inner surface of the pipe.

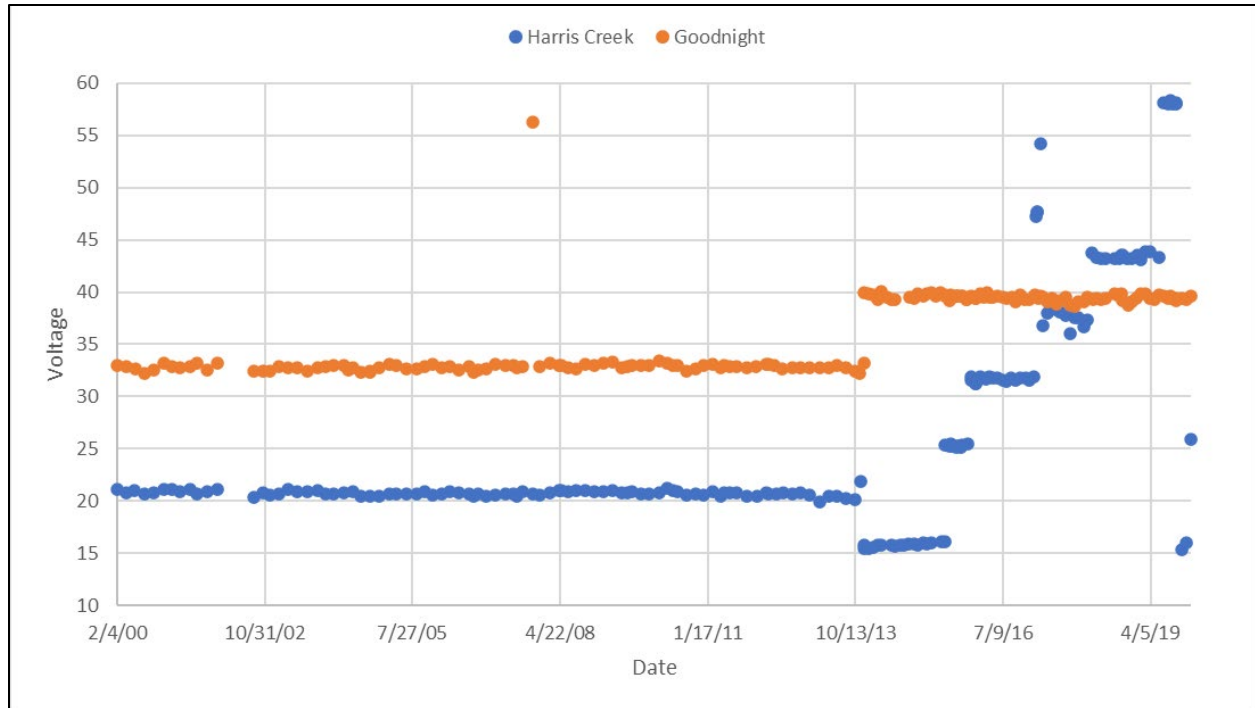
Investigators examined 10 years of maintenance activities related to cathodic protection at Goodnight and Harris Creek. In 2017 and 2019, the output from the Harris Creek rectifier was increased to address dropping potential readings.<sup>28</sup> These dropping potentials began in early 2014 after the flow reversal project was completed. Before the flow reversal, cathodic protection voltages were regular and consistent; after the flow reversal, technicians were unable to stabilize readings; at Harris Creek, voltages were increased by 18 percent, and the voltages at Goodnight increased by 58 percent. (See figure 9.) The plot in figure 9 shows the steady potentials up to 2013; after that, they became unstable. In 2018, a new anode was installed at Harris Creek, but it did not successfully raise potentials.

**Figure 9.** Voltage outputs at Goodnight and Harris Creek rectifiers.
