## TransCanada Keystone Pipeline, LP

# Root Cause Failure Analysis of Pipeline Rupture at Ludden +17

April 18, 2018

**Final Report**

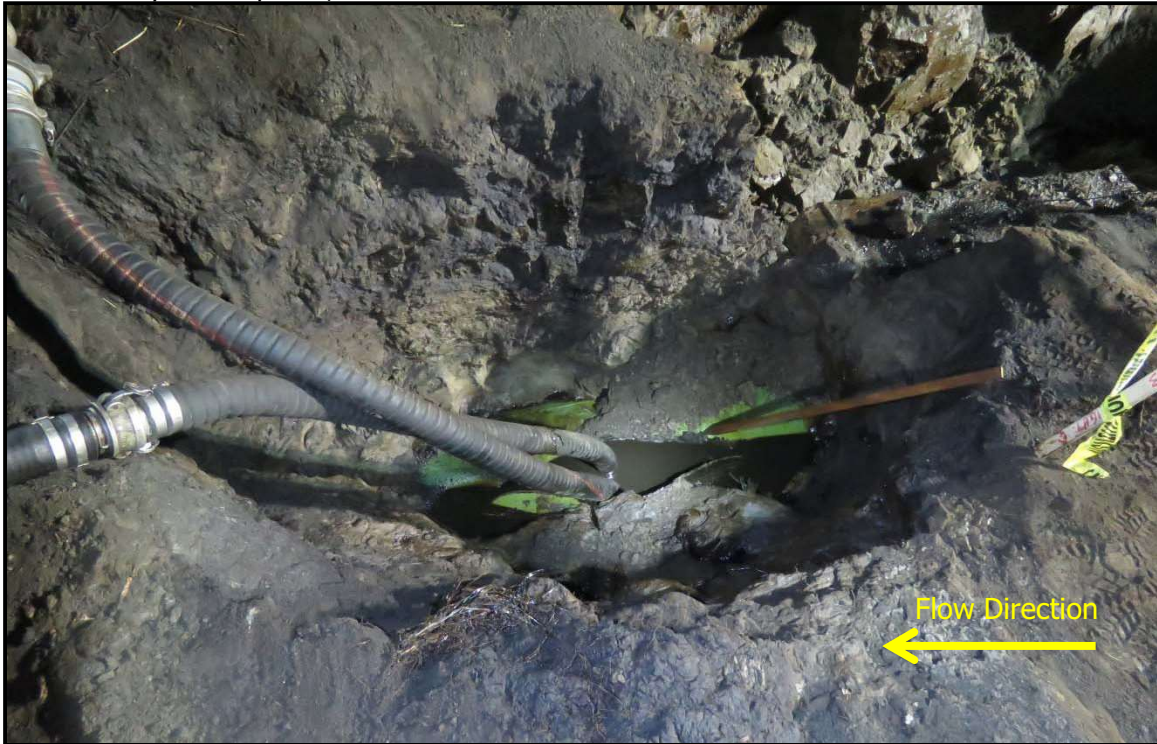
During the field investigation, the Incident Management Team (IMT) discovered that the pipeline had ruptured at a feature indicative of mechanical damage (see Figure 4). The rupture initiated downstream of mill weld [REDACTED] in pipe joint number [REDACTED]<sup>3</sup> (part of heat number [REDACTED]) but the running fracture crossed into the upstream joint before arresting (see Figure 5). A set-on concrete weight used for buoyancy control was located approximately three feet away from the initiation point. Upon confirmation of the release location, two stopple fittings were installed to isolate the damaged pipe for removal and replacement.

**Figure 4. Rupture Feature as Found In-the-Ditch. The set-on concrete weight is located on the right hand side of the photo.**

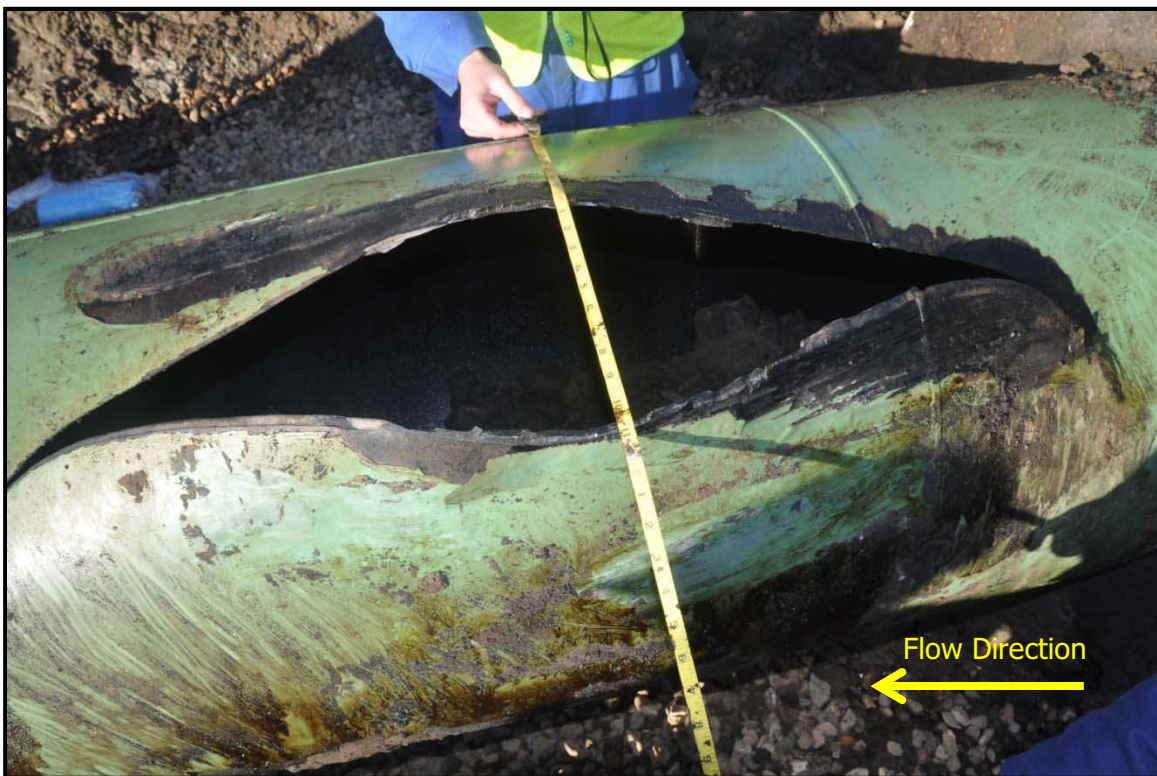
**Figure 5. Extent of the Failure Feature**

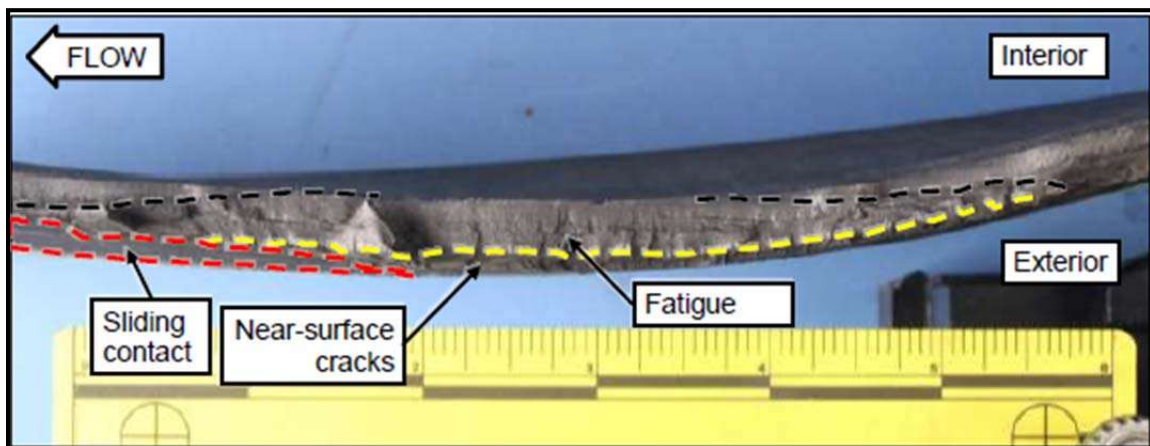
**Figure 7. Extent of Failure Feature**

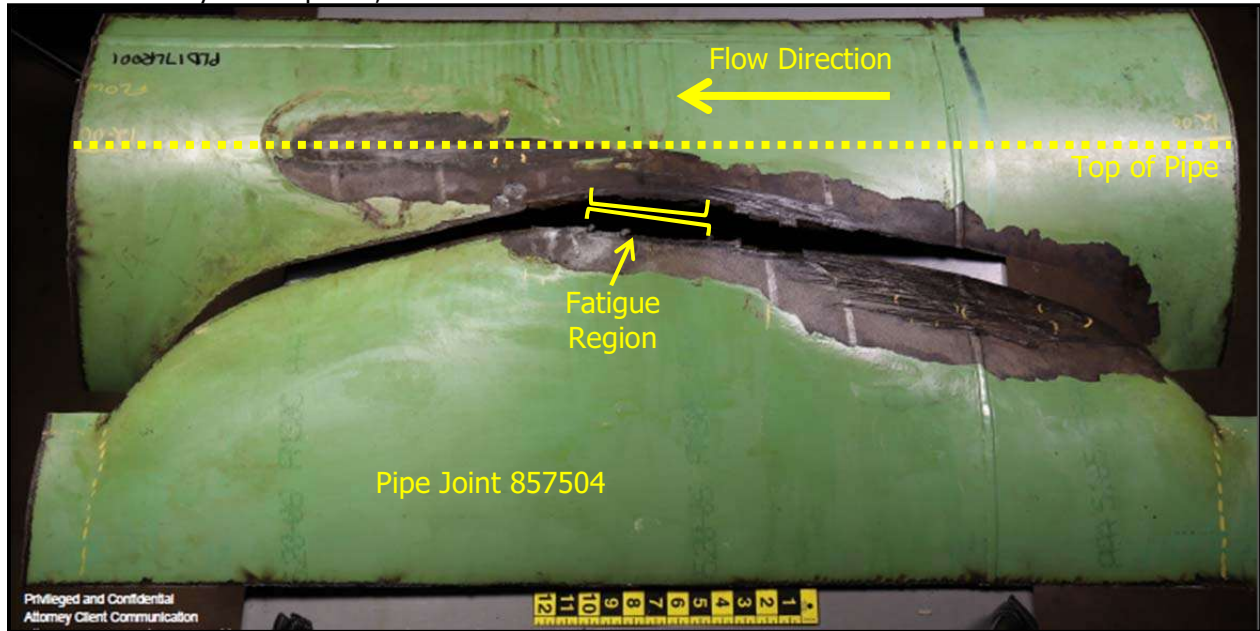
Figure 8 shows the overall extent of the mechanical damage feature which extends on both sides of the fracture. The sliding contact marks were mostly aligned parallel to the longitudinal axis of the pipe and extended nine inches upstream and 21.5 inches downstream of the girth weld. The width of the sliding contact area measured up to 3.5 inches wide counterclockwise of the fracture location. As shown in Figure 8 and Figure 9, linear abrasions on the surface of intact coating were observed at the downstream end of the sliding contact marks. Coating material was present intermixed with the sliding contact marks and many edges of the remaining coating adjacent to individual contact marks were curled and rounded consistent with sliding contact deformation.

**Figure 8. Mechanical Damage Feature between 11:00 and 12:00 Clock Position. The bracketed area indicates the fatigue crack region.**

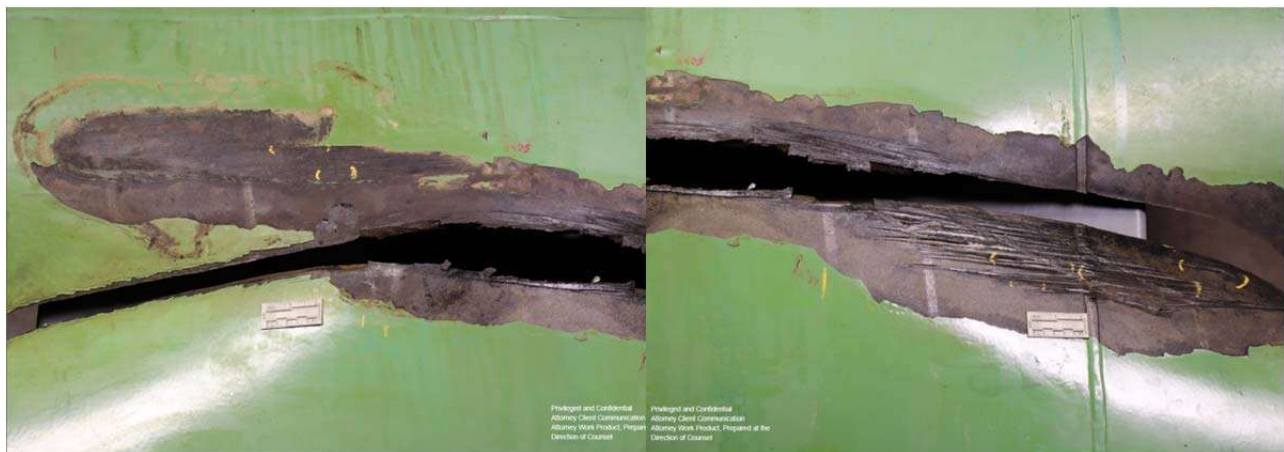
**Figure 9. Close Up of Mechanical Damage Feature**

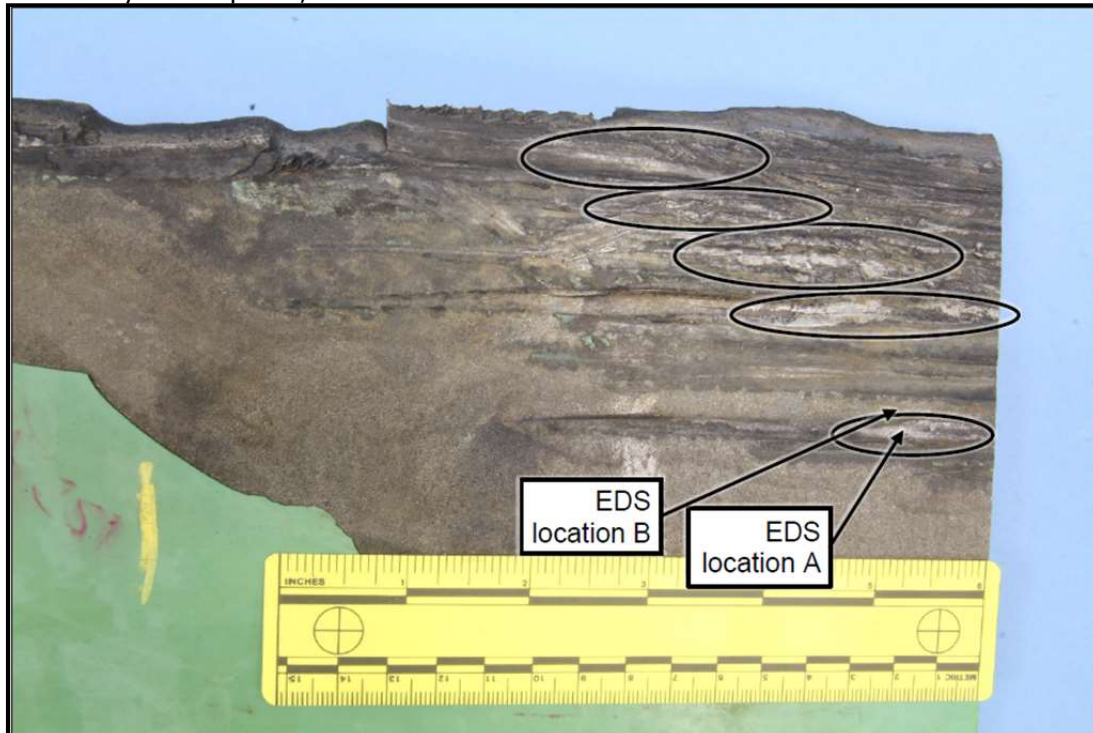
**Figure 19. Locations for EDS Analysis (within a sliding contact mark and undisturbed metal)**

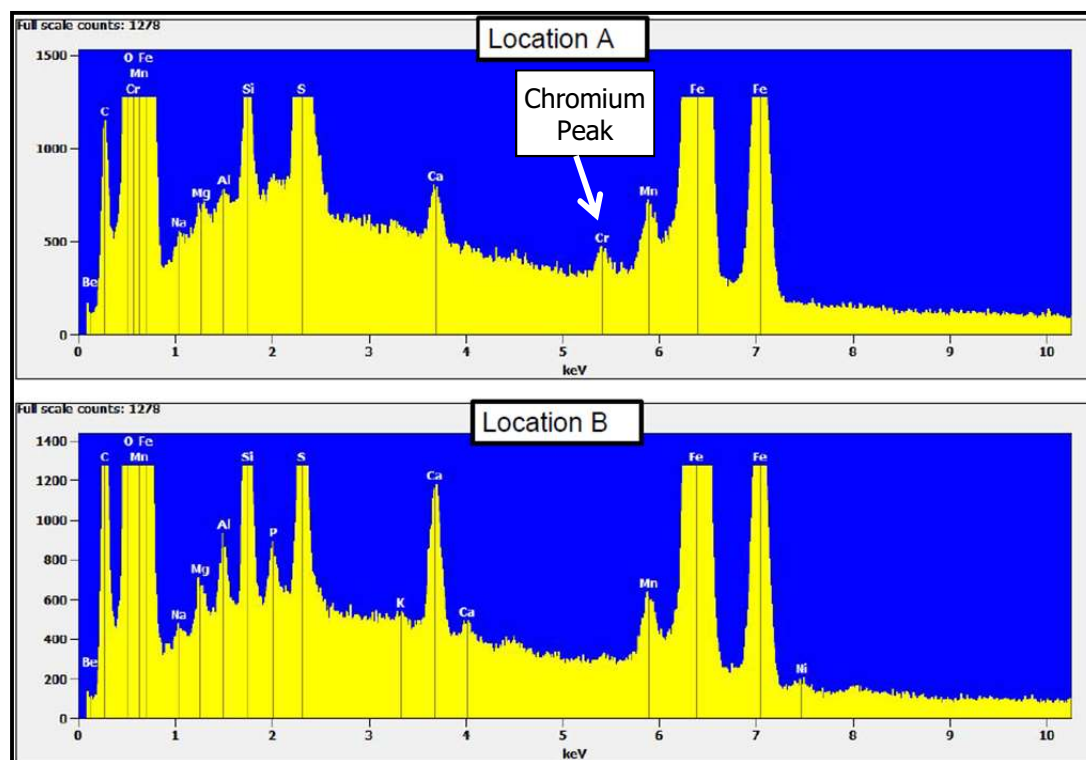
**Figure 20. EDS Spectra Indicated in Figure 19. Chromium was consistently present in the sliding contact marks but was mostly absent in undamaged areas.**

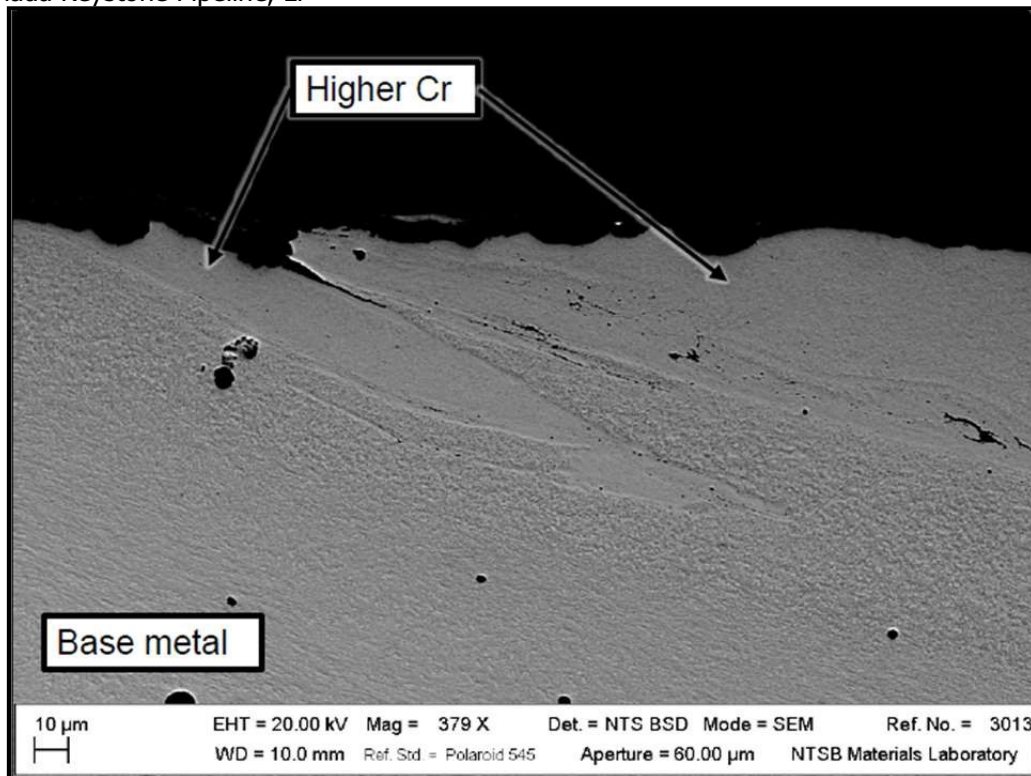
**Figure 21. Backscattered Image of Surface Mount Showing Surface Deposits with Higher Chromium Relative to the Base Metal**

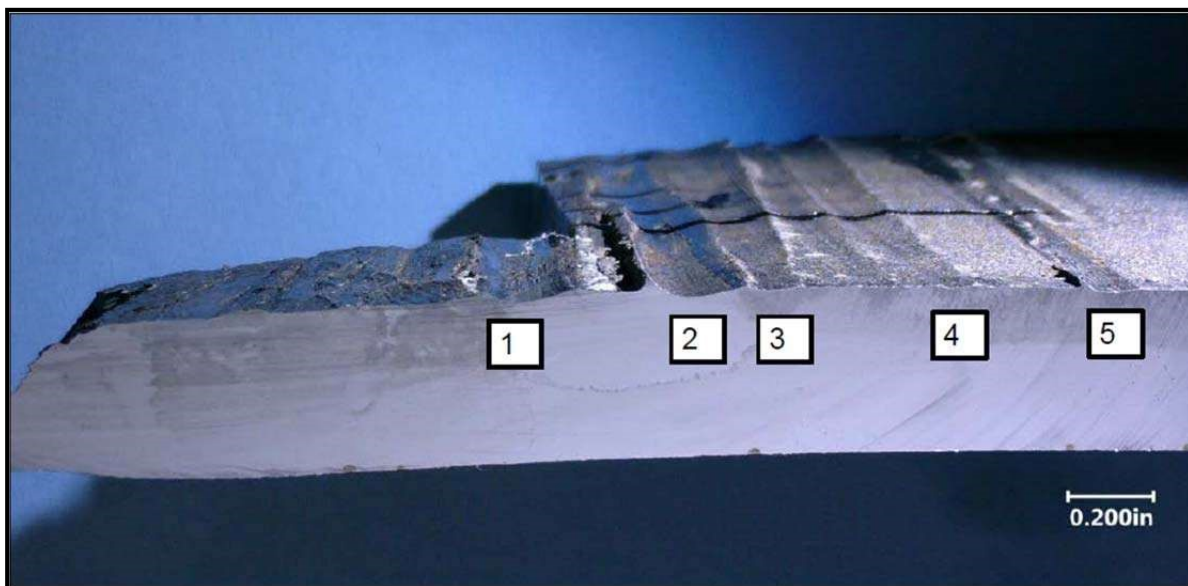
Although it could not be conclusively determined that cleats from tracked equipment caused the mechanical damage on pipe joint 857504, it is the most plausible conclusion based on the evidence uncovered during this investigation and based on expert opinions.

**Figure 24. Profile View of the Multiple, Axial Sliding Contact Marks**

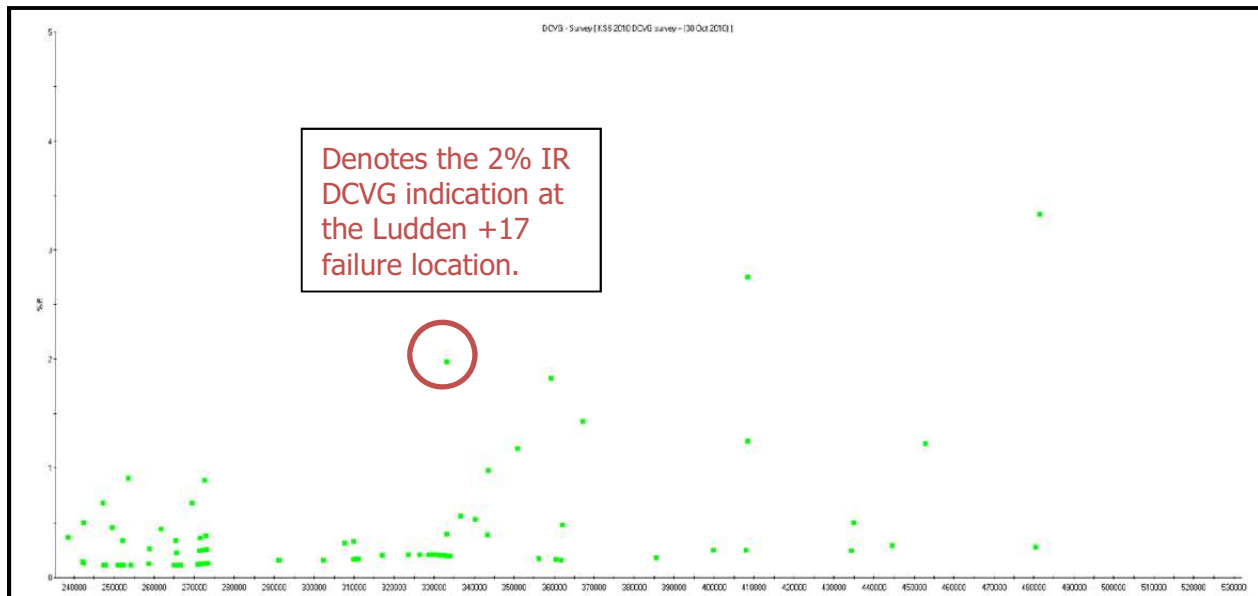
At the location of the failure, the DCVG survey noted a 2% IR indication (see Figure 37). The size of this indication was not actionable according to either criterion, even if denting was reported by the caliper survey, which it was not.

**Figure 37. October 30, 2010 DCVG Survey Findings. The location of the failure is at virtual pipeline model distance from start 332,979.7 ft.**

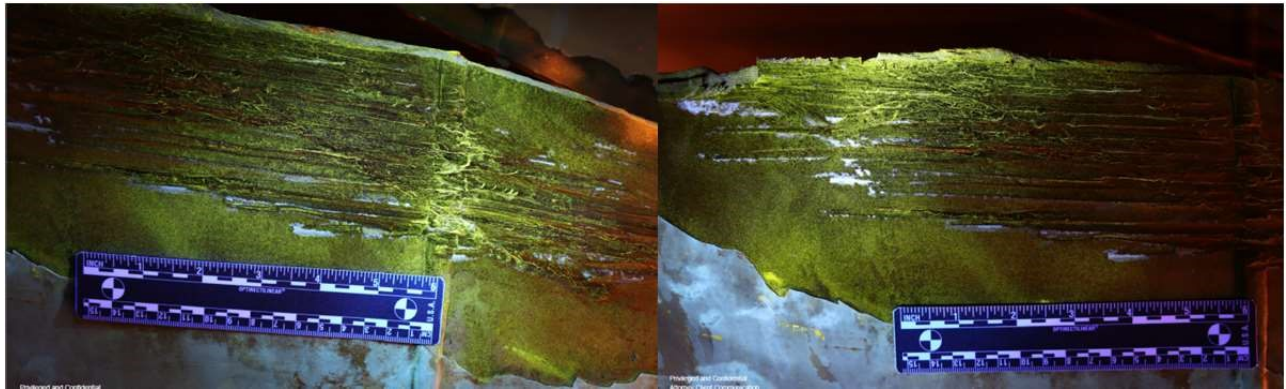
Fatigue is a process of incremental subcritical crack growth that occurs due to repeated cycles of applied load or stress. Fatigue crack growth is typically apparent on a fracture surface by the presence of “beach marks” of parallel semi-elliptical markings emanating from one or more points of origin. These mark the progression and direction of incremental crack growth. The fracture surface may also exhibit “ratchet marks” which are small ridges oriented in the direction of crack growth, which represent the convergence of portions of the fatigue crack that are not perfectly aligned in the same plane at the point(s) of origin. Prominent beach marks and ratchet marks are visible unaided in Figure 41 and Figure 42. The fatigue crack growth is seen to have originated in a tear or crack at the base of a sliding contact mark.

**Figure 40. MPI of Sliding Contact Areas**

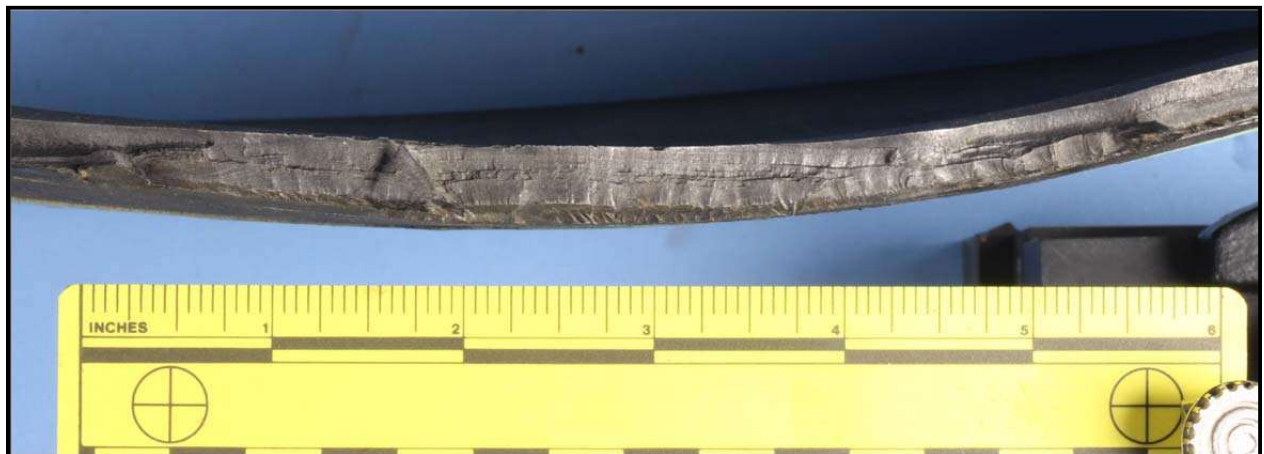
**Figure 41. Initiating Feature**

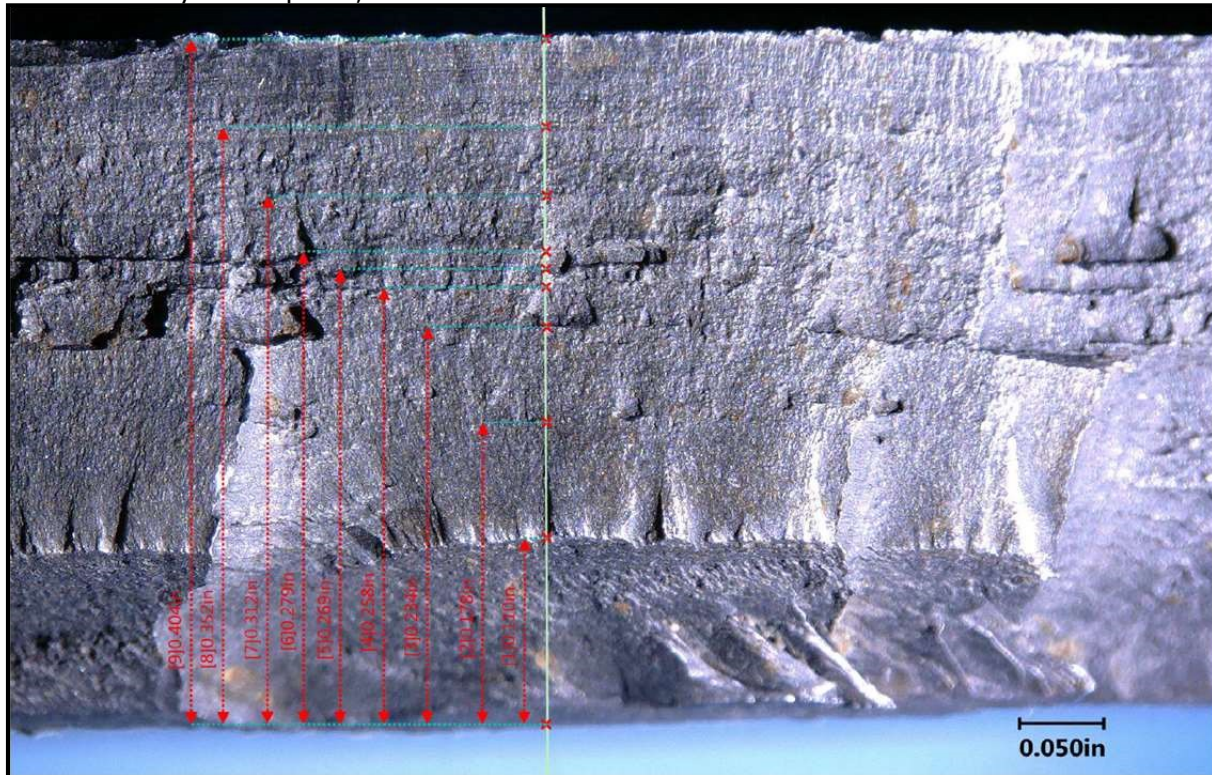
**Figure 42. Arrest Line Measurements Indicating Fatigue Crack Growth**
