PRELIMINARY REPORT

Over-pressure of a Columbia Gas of Massachusetts Low-pressure Natural Gas Distribution System

Merrimack Valley, Massachusetts

PLD18MR003

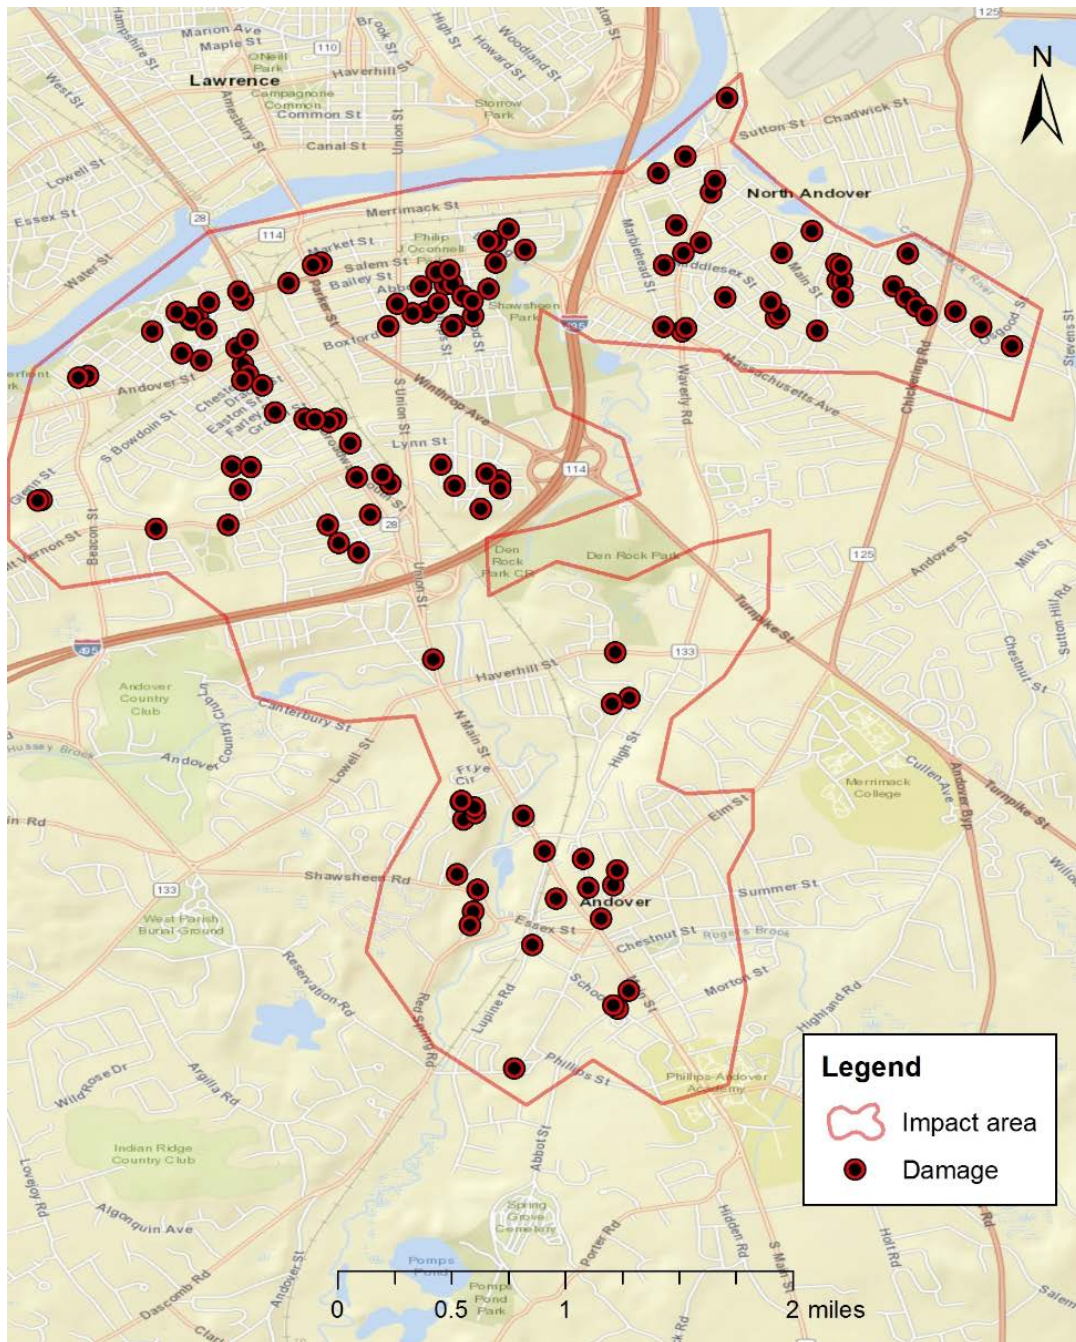
Figure 1. Area impacted by accident depicting structures that were damaged.

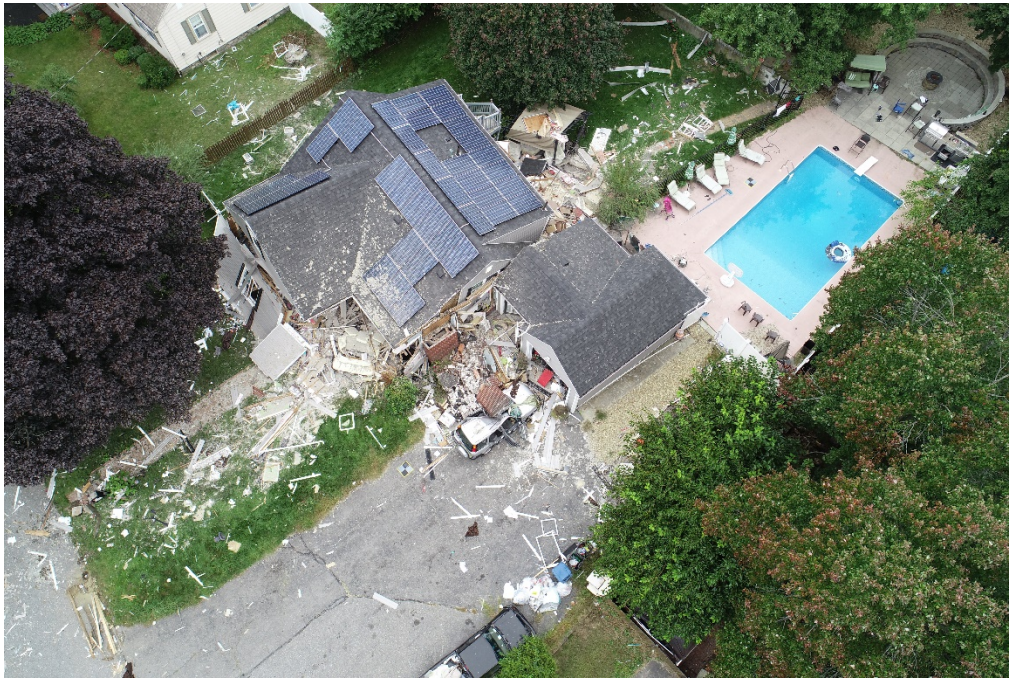
Figure 2. Aerial view of damaged home where a fatality occurred after the chimney collapsed on vehicle in the driveway.

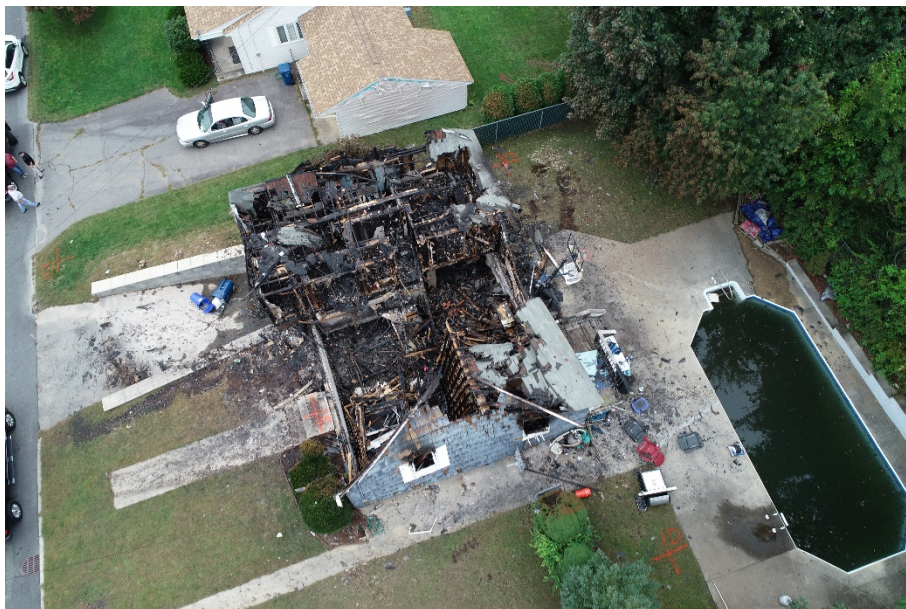
Figure 3. Aerial view of burned-out home impacted by the event.
