Statement explaining additional imagery:

The Motor Tanker (M/T) Kokuka Courageous sustained damage from a limpet mine attack while operating in the Gulf of Oman, on June 13th. Limpet mines are attached to a vessel via magnets and/or nails and detonated by a timer. Following the attack, sailors from the Kokuka Courageous discovered a second, unexploded, limpet mine on their vessel and abandoned ship. The Dutch tug Coastal Ace rescued the crew of 21 sailors. The USS Bainbridge (DDG 96) then transferred and transported the Sailors to safety. Later that day, an Islamic Revolutionary Guard Corps (IRGC) Gashti Class patrol boat approached Kokuka Courageous and was observed and recorded by a U.S. Navy MH-60R helicopter removing the unexploded limpet mine from Kokuka Courageous. Iran is responsible for the attack based on video evidence and the resources and proficiency needed to quickly remove the unexploded limpet mine. The hull penetration measures 1.1m at the widest point by 1.5m 4'2" x 3'8" (H x W) at the tallest point. The penetration begins approximately 1m above the water line.

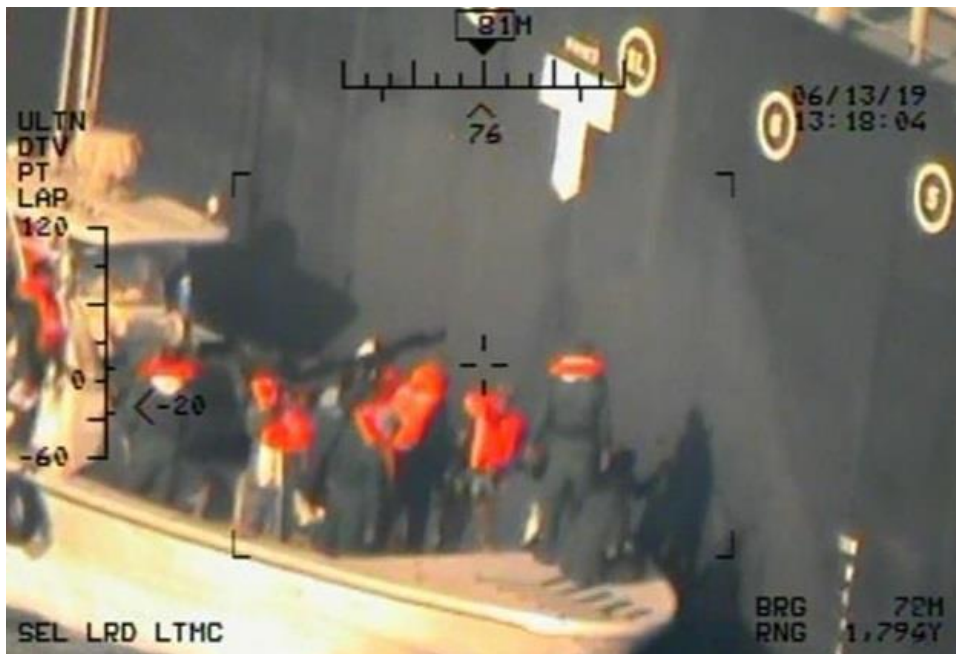
Imagery taken from a U.S. Navy MH-60R helicopter of the Islamic Revolutionary Guard Corps Navy removing an unexploded limpet mine from the M/T Kokuka Courageous.

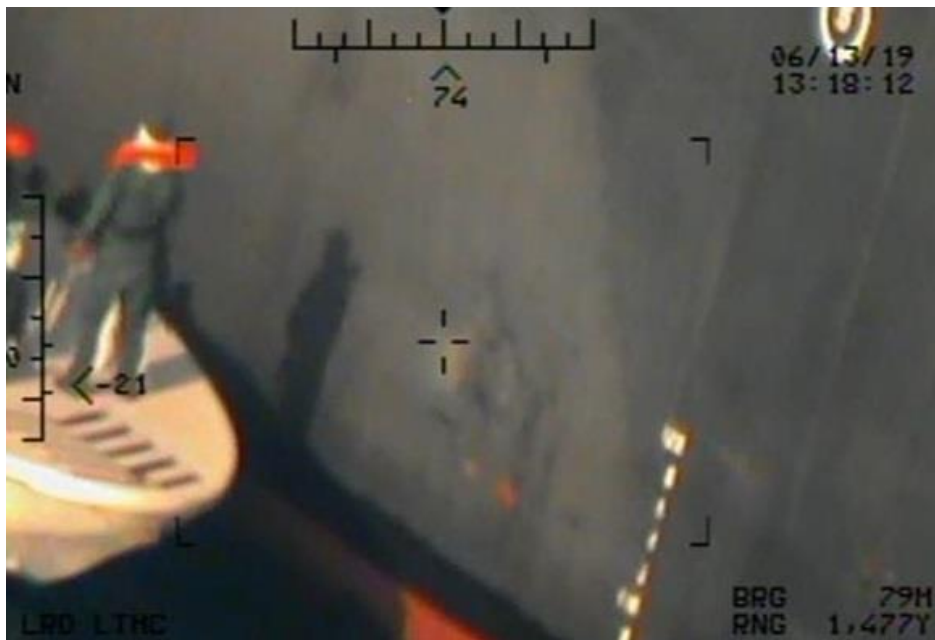
Imagery taken from a U.S. Navy MH-60R helicopter of the Islamic Revolutionary Guard Corps Navy after removing an unexploded limpet mine from the M/T Kokuka Courageous.

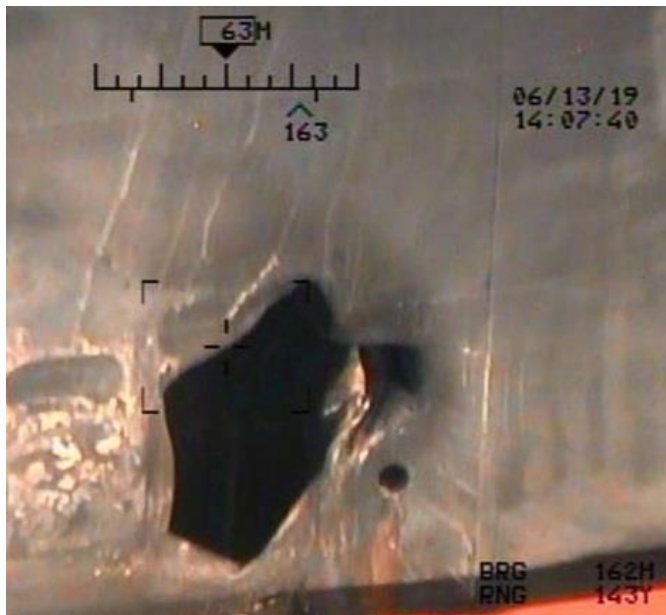
Imagery taken from a U.S. Navy MH-60R helicopter of blast damage to M/T Kokuka Courageous. M/V Kokuka Courageous received damage consistent with a limpet mine attack in the Gulf of Oman, June 13.

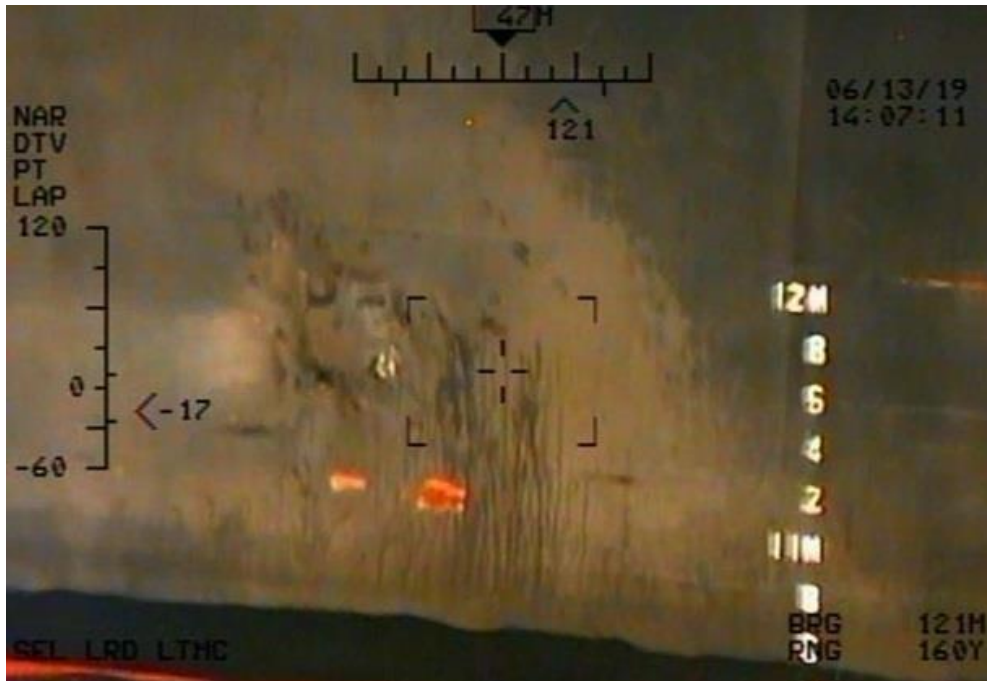
Imagery taken from a U.S. Navy MH-60R helicopter of the Islamic Revolutionary Guard Corps Navy of the remnants of the magnetic attachment device of unexploded limpet mine from the M/T Kokuka Courageous.

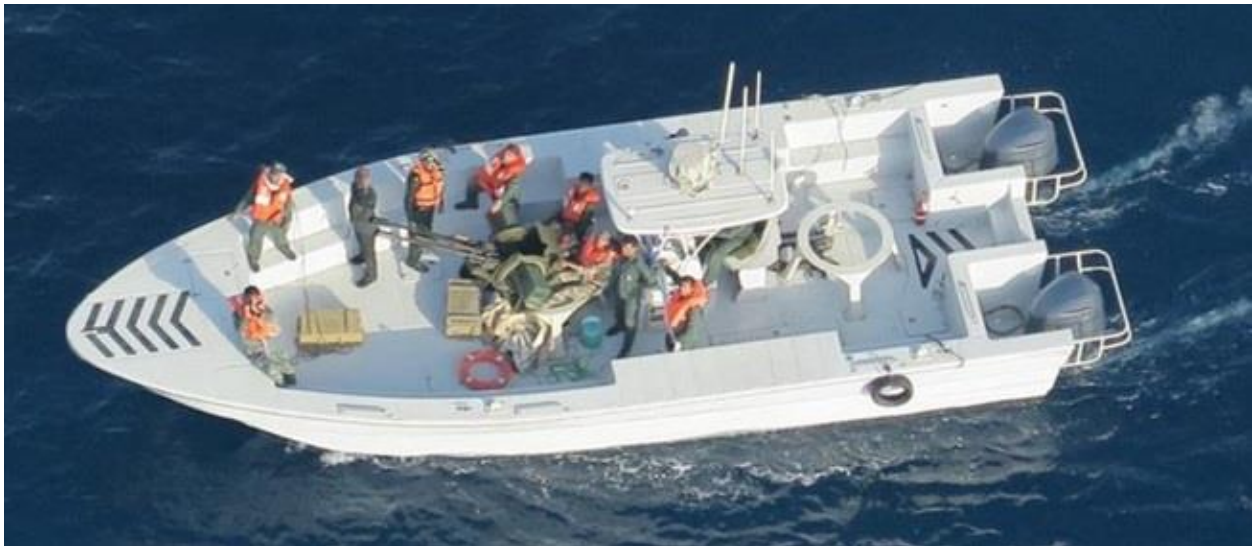
Imagery taken from a U.S. Navy MH-60R helicopter of the Islamic Revolutionary Guard Corps Navy after removing an unexploded limpet mine from the M/T Kokuka Courageous.

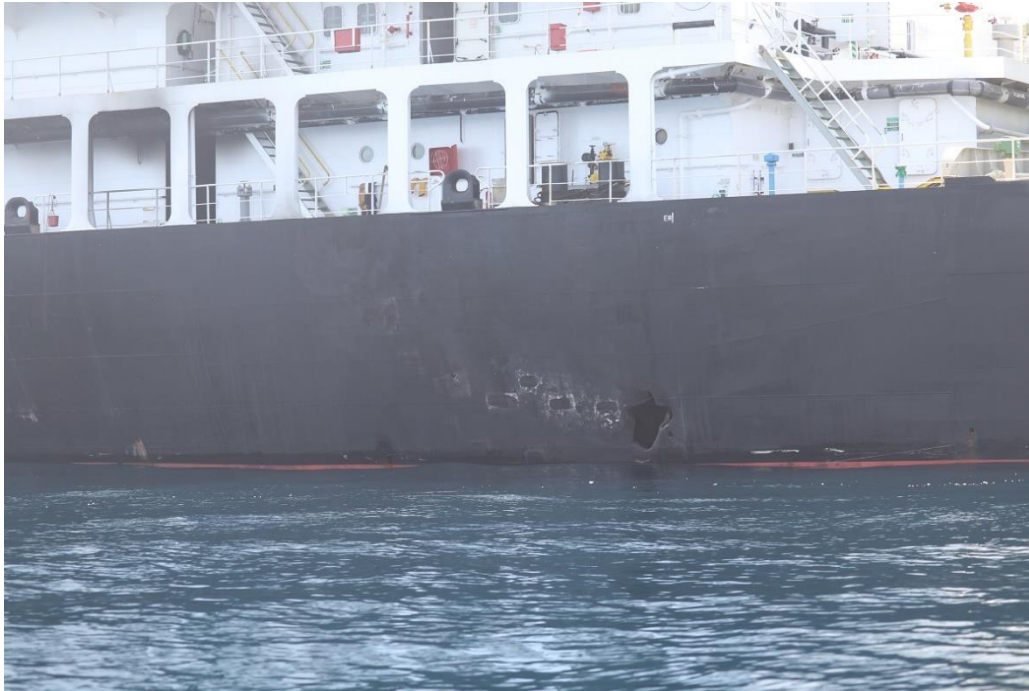
7710 – This is a view of hull penetration/blast damage on the starboard side of motor vessel M/T Kokuka Courageous, which was sustained from a limpet mine attack while operating in the Gulf of Oman, on June 13th.

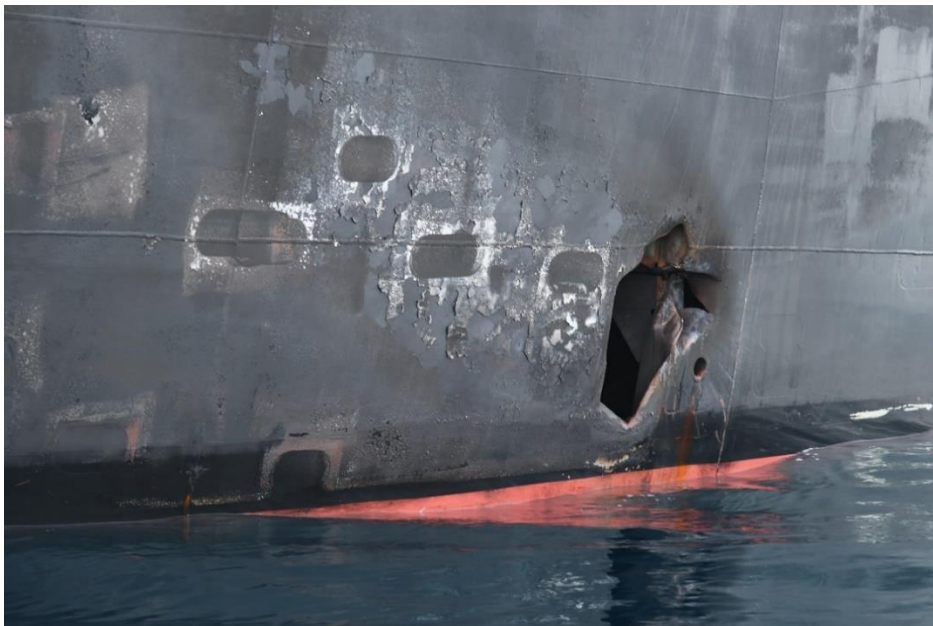
7725 - This photo is a view of hull penetration/blast damage sustained from a limpet mine attack on the starboard side of motor vessel M/T Kokuka Courageous, while operating in the Gulf of Oman, June 13.

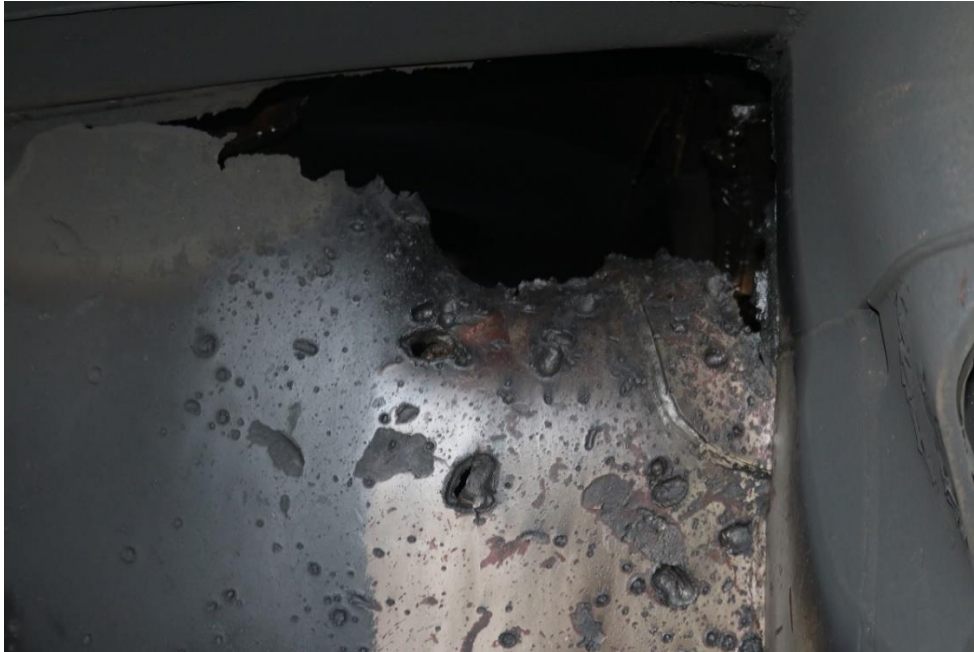
7729 - This photo is a view of internal hull penetration/blast damage sustained from a limpet mine attack on the starboard side of motor vessel M/T Kokuka Courageous, while operating in the Gulf of Oman, June 13.

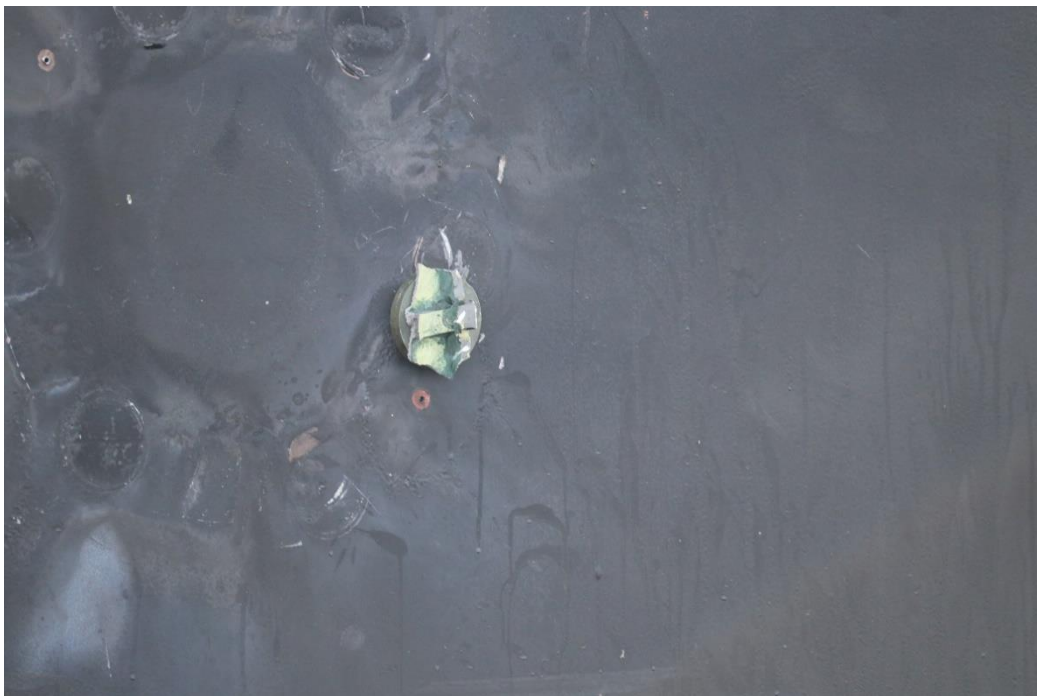
7714 – This is the view of the remnants of a removed limpet mine's placement, location, and damage sustained from a limpet mine attack, on the starboard side of motor vessel M/T Kokuka Courageous, while operating in the Gulf of Oman, June 13. A limpet mine is attached to a vessel via magnet and/or nails. The holes seen were created by nails used to hold the mine in place.

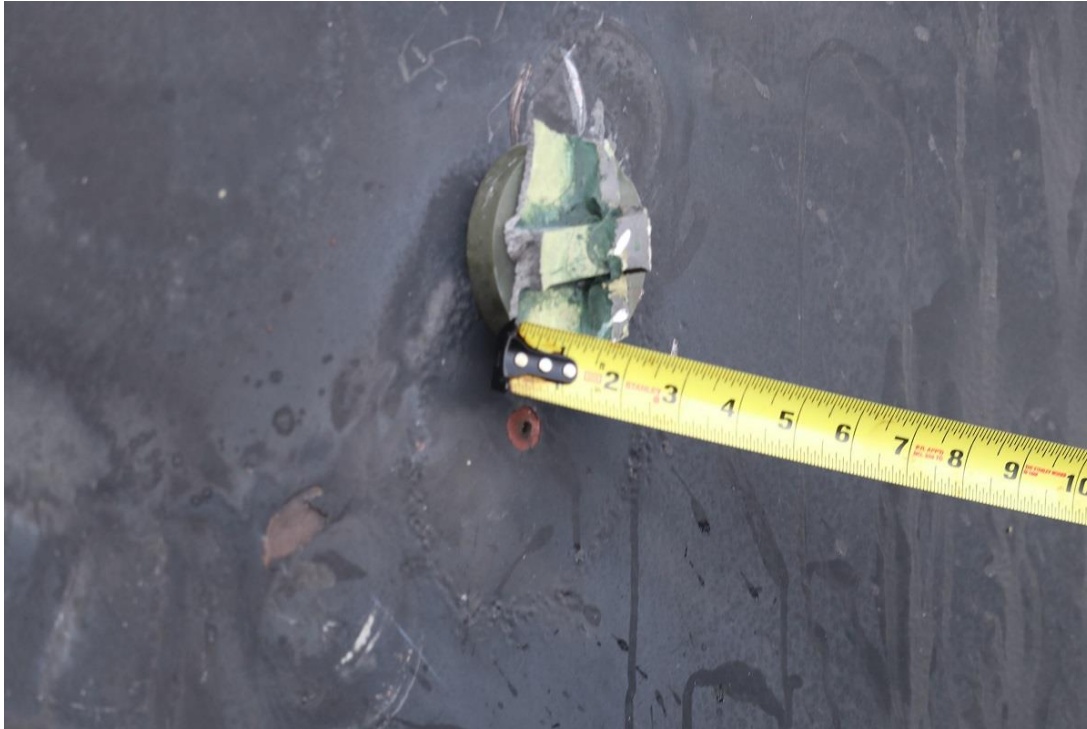
7761 –This photo depicts the aluminum and green composite material left behind following removal of an unexploded limpet mine used in an attack on the starboard side of motor vessel M/T Kokuka Courageous, while operating in the Gulf of Oman, June 13th.

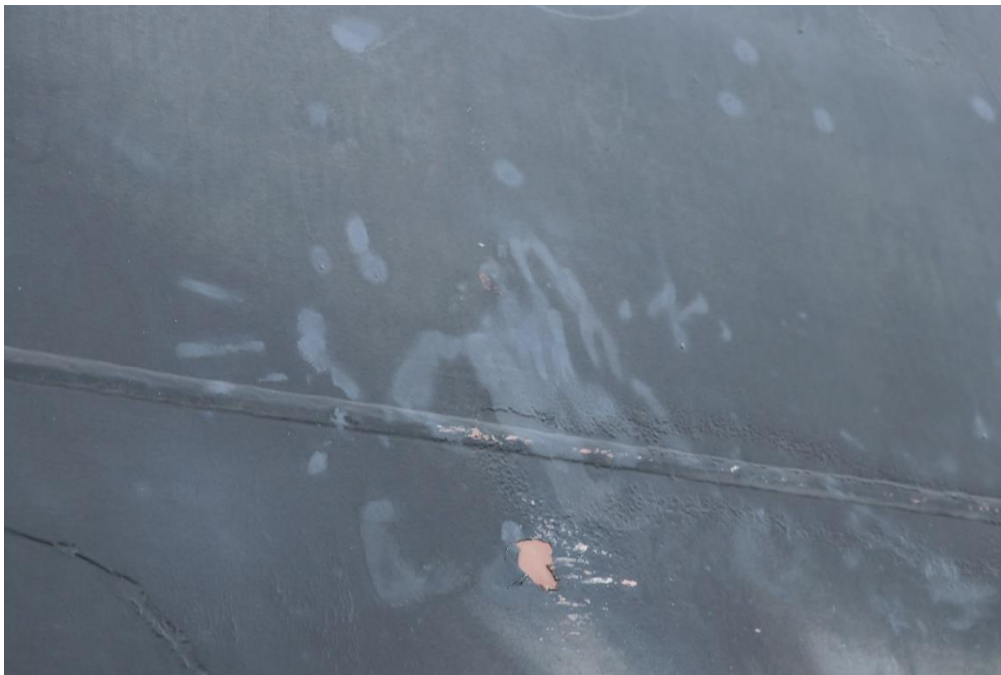
7760 – This photo depicts a handprint from the individual who removed the limpet mine used to attack the motor vessel M/T Kokuka Courageous, attacked while operating in the Gulf of Oman, June 13.
