RCFA for the Keystone Milepost 14 Release

Stephanie Flamberg, Bill Amend, Peter Martin, Michael Rosenfeld, Adam Steiner, and Benjamin Zand

April 21, 2023

Final Report

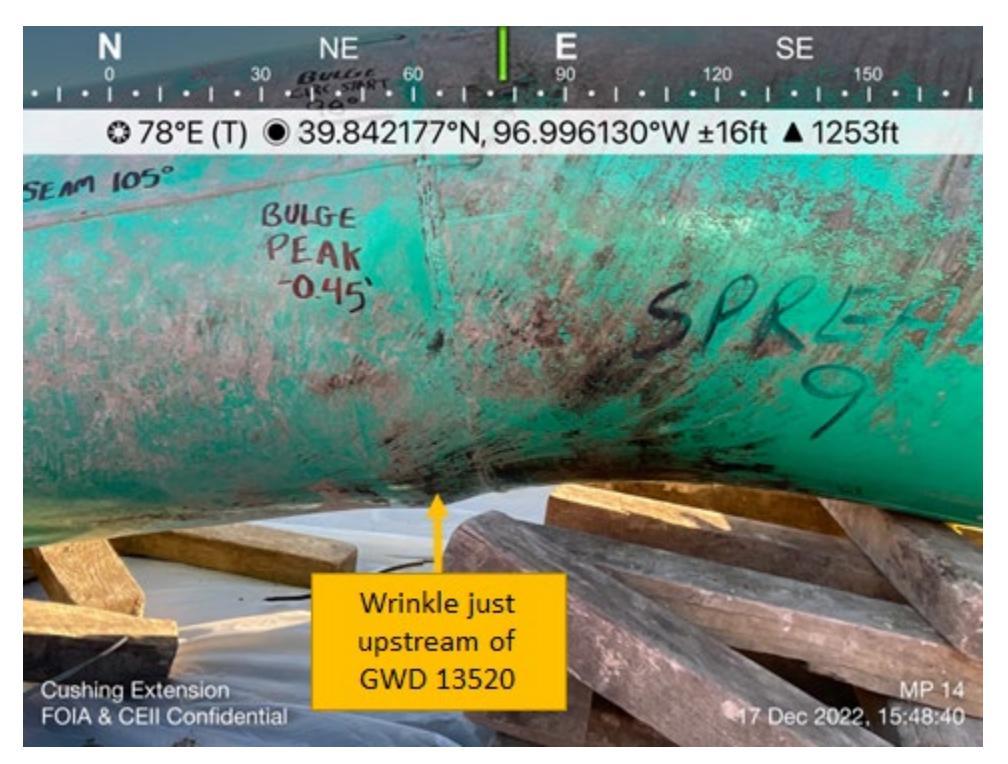
Figure 7. Wrinkle Feature Upstream of GWD 13520 – December 17, 2022

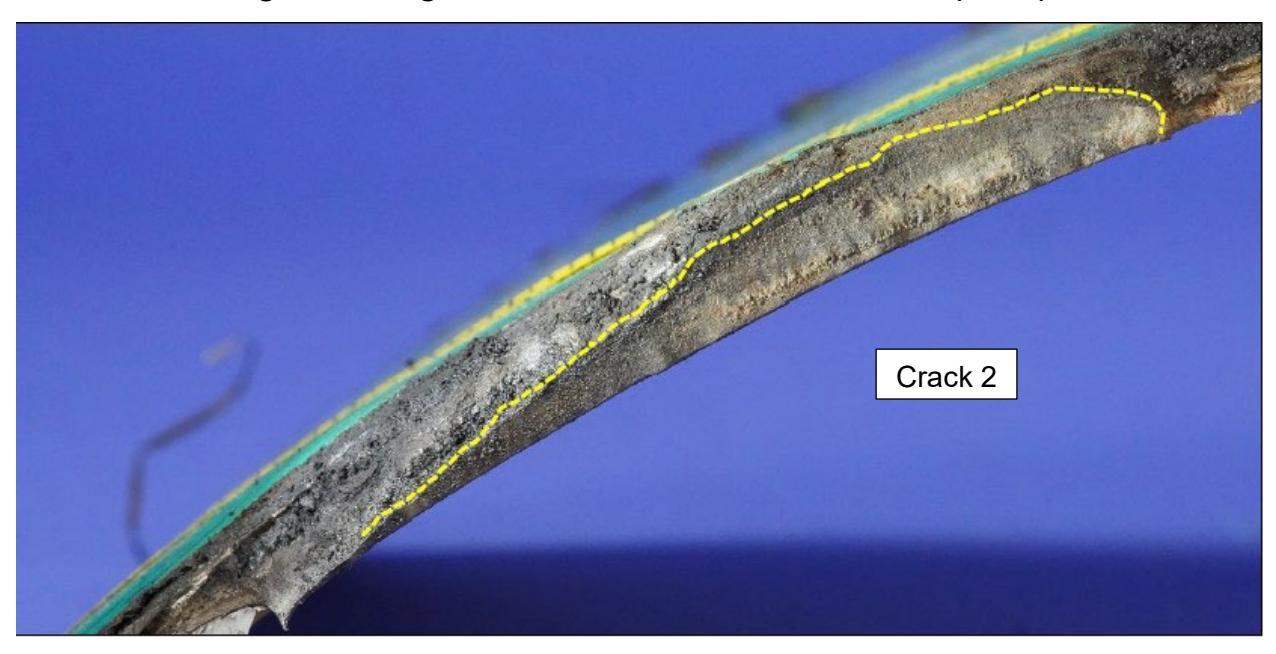
The three crack features were identified as originating at or near the inner diameter (ID) toe of the GWD 13530 and had multiple, radially oriented crack initiation features (ratchet marks). Each crack showed evidence of progressive cracking in the form of multiple crack arrest features. Crack 1 and Crack 2 exhibited 10 to 15 distinct "beach marks" or macroscopic features marking the position of the crack front over time, characteristic of a progressive or fatigue cracking mechanism from the ID surface.

Figure 16. Magnified View of Crack 2 in GWD 13530 (G59B)

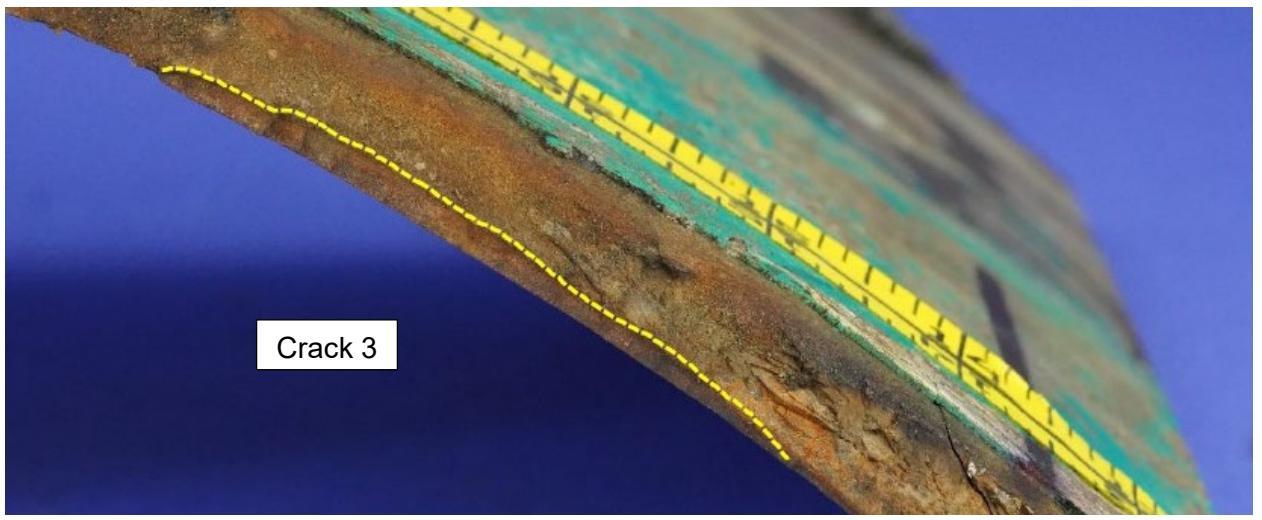
Figure 17. Magnified View of Crack 3 in GWD 13530 (G59B)

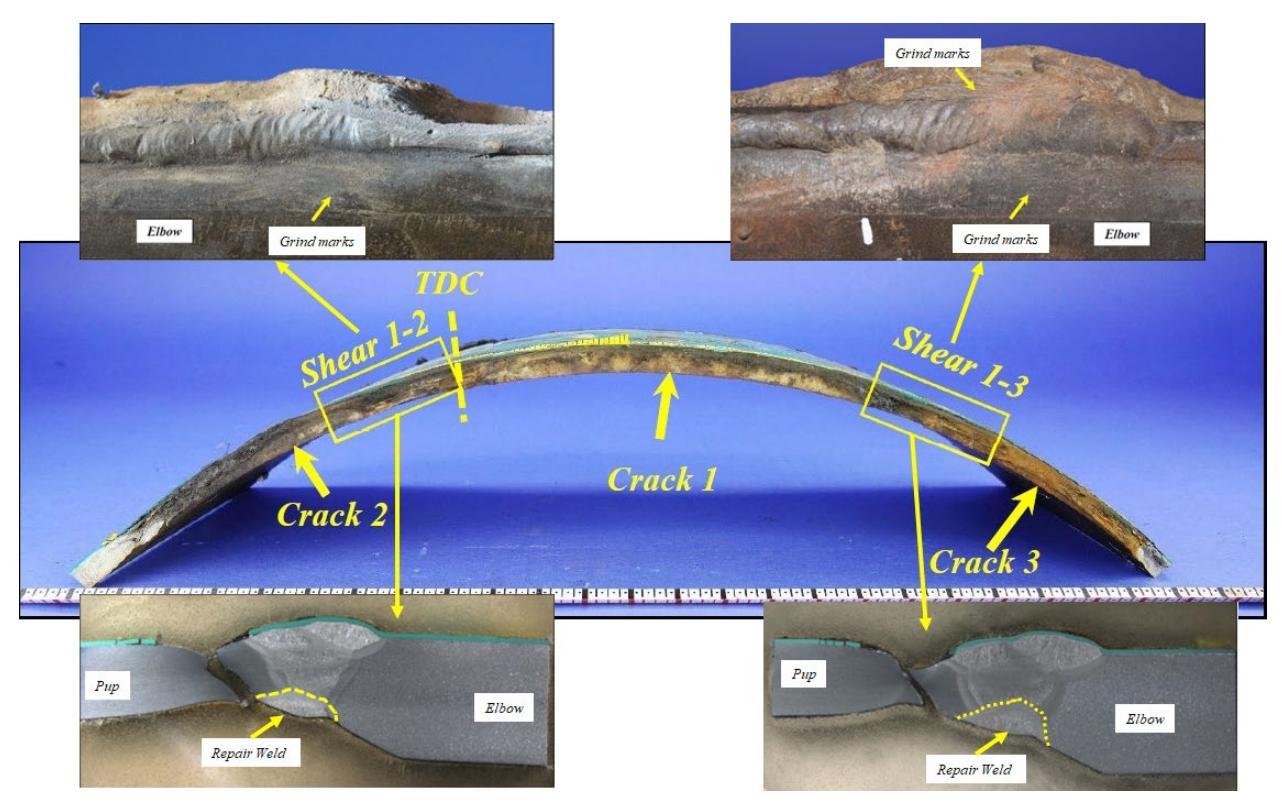
As shown in Figure 18, separating Crack 2 and Crack 3 from Crack 1 were two regions exhibiting a shear morphology (fracture surfaces oriented at approximately 45°). Examination of the upstream portion of these regions (weld side) showed that they coincided with weld repairs as confirmed by grind marks and a thicker weld bead.

Figure 18. Images and Metallographic Sections Showing the Location of Repairs in GWD 13530 (G59B) Between Fatigue Crack Locations

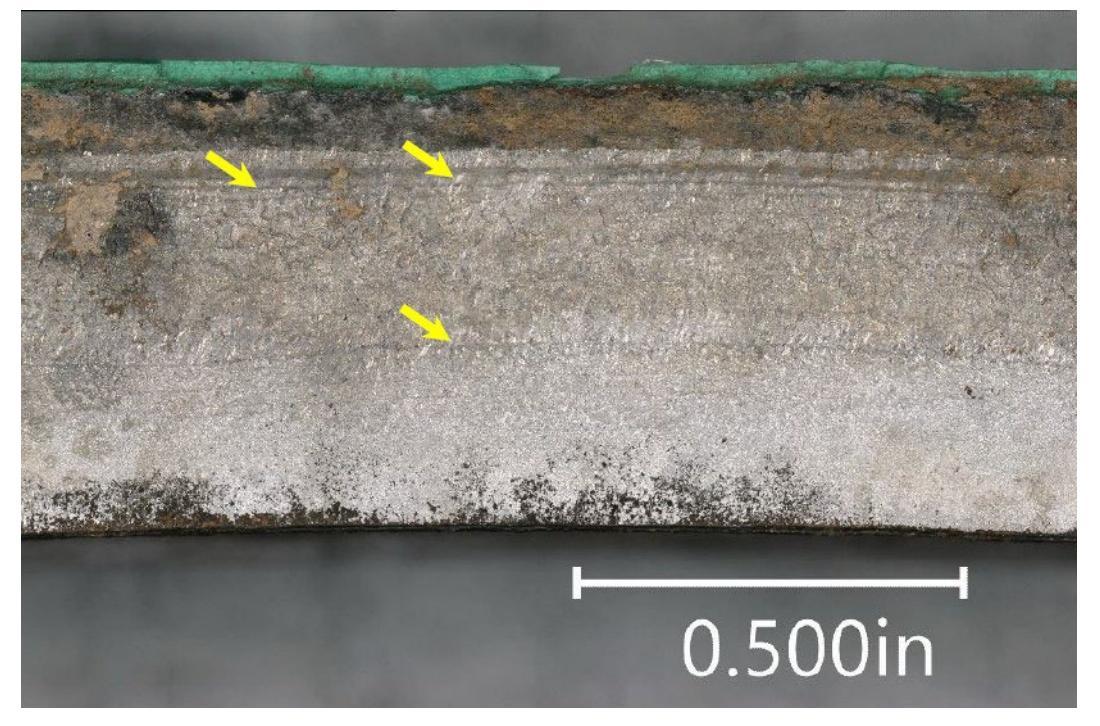
Figure 21. Low Magnification SEM Showing the Center Region of Crack 1 (most prominent crack arrest lines identified with yellow arrows)

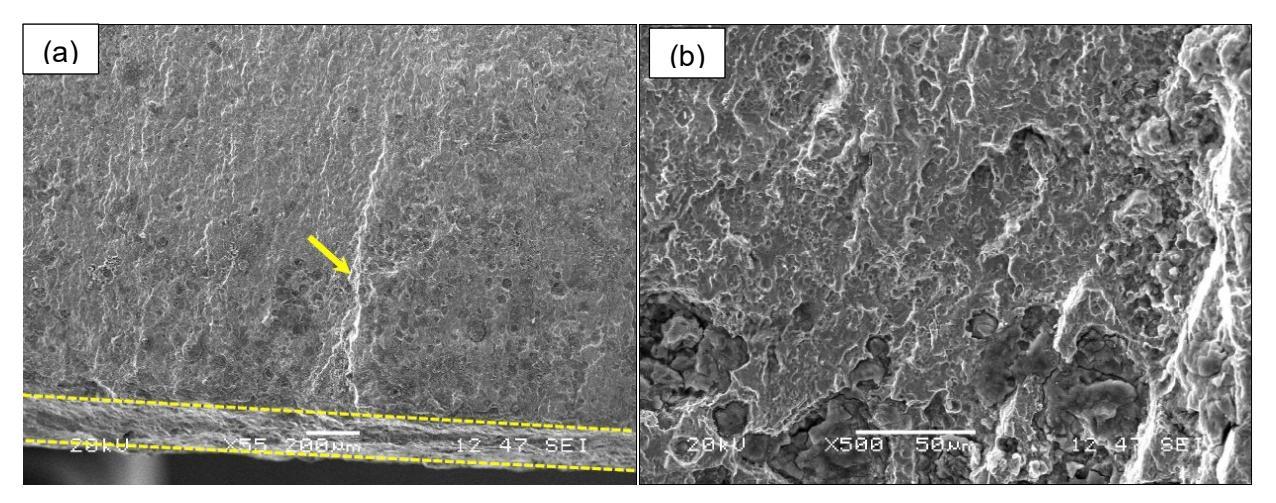
A "ratchet mark" identified by the yellow arrow in Figure 22(a) is emanating radially from the edge of the LOF (the region between the dashed yellow lines) onto the fracture surface. Ratchet marks occur where a fracture initiates at multiple sites that are not quite coplanar. They disappear where the individually initiated crack surfaces merge to a common plane. Figure 22 (b) shows the fracture morphology near the ID of GWD 13530, Crack 1 to have been consumed by oxidation.

Figure 22. (a) Low Magnification SEM Fractograph Showing the ID Region of GWD 13530, Crack 1 and (b) Higher Magnification SEM Fractograph Showing that the Fracture Surface near the ID of GWD 13530, Crack 1 had been Consumed by Oxidation

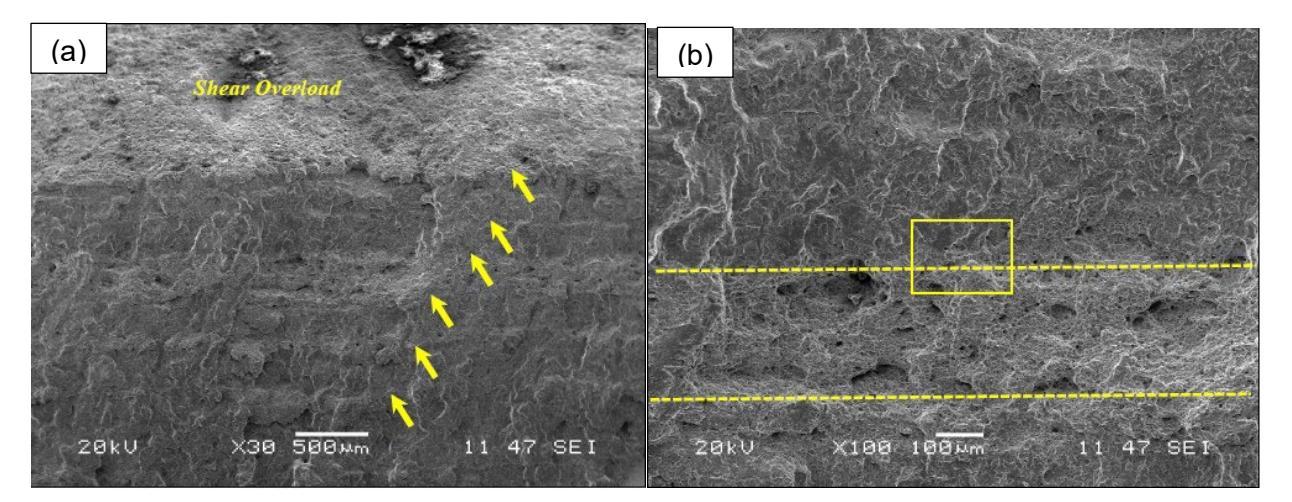
The fracture surface near the mid-wall to OD surface of Crack 1 showed several distinct crack arrest lines near the transition to shear overload (denoted by the yellow arrows in Figure 23(a)) with thin bands of micro-void coalescence (MVC) or dimpled rupture between some of the crack arrest lines (region between the dashed yellow lines in Figure 23(b)). According to Anderson, the space between the crack arrest lines appeared to be brittle with no evidence of striations (incremental cyclical crack growth). The shear overload region consisted of MVC which is consistent with ductile overload. RSI considers that the featureless fracture surfaces between the arrest marks are inconclusive as to mode of fracture due to corrosion. The surfaces do not entirely resemble the one region of cleavage fracture identified. The mechanism for stable but brittle crack advance defined by periodic ductile arrest marks is also not obvious. The arrest marks are spaced approximately 0.040-inch on average (0.500-inch / 12 marks), while the estimated plastic zone size assuming a fracture toughness derived from the average weld metal CTOD values (which were lower than the HAZ values), even assuming a constrained plainstrain condition is four times larger. Stable incremental non-ductile crack advance might occur if the crack is forced to extend into a compressive residual stress zone in the weld by periodic high loadings, but this is speculation. The Anderson metallurgical report (see Figure 33 of the Anderson report) identified a single, narrow band of cleavage fracture surface 0.040-inch in radial dimension on Crack 2. No similar feature was observed anywhere else on Crack 2 or any other crack. Its cause is unknown but could have occurred in a zone affected by a transient, nonoptimal welding condition over a short arc length of weld deposit. There is no evidence in the weld CVN or CTOD test results that would suggest a tendency for brittle fracture at the construction or operating temperatures. Since no similar feature was observed on the other fractures and it was very small in radial extent it was concluded to not have significantly influenced the formation or growth of the crack.

Figure 23. (a) Low Magnification SEM Fractograph of GWD 13530, Crack 1Showing Multiple Crack Arrest Lines (crack arrest lines identified with the yellow arrows) and (b) Higher Magnification SEM Fractograph of GWD 13530, Crack 1 Showing a Band of Dimpled Rupture Associated with a Crack Arrest Line Near the Shear Overload Region

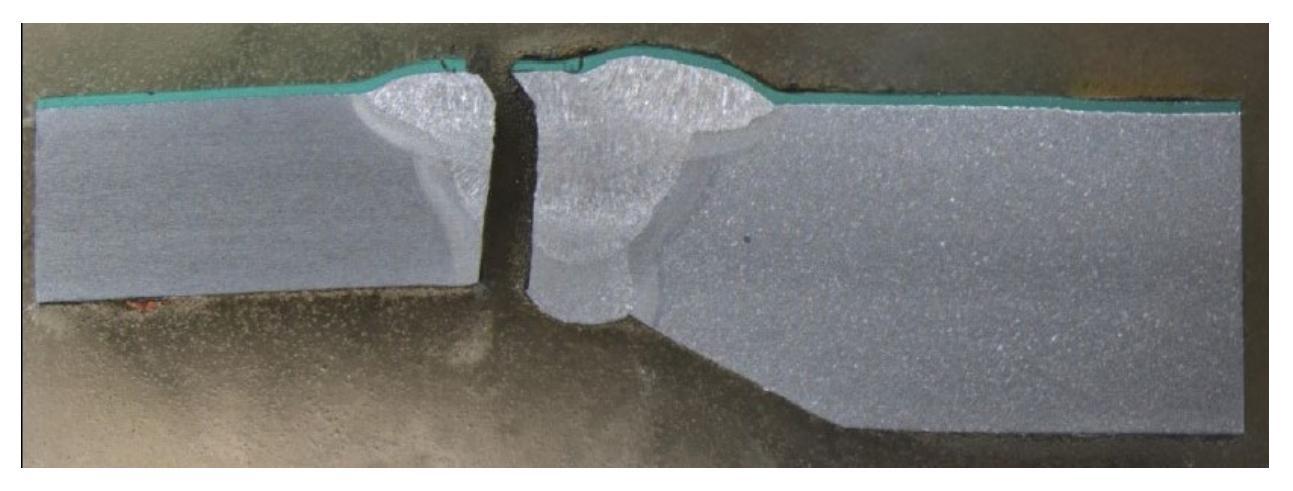
Metallographic cross sections were prepared across the fractured and intact portions of GWD 13530 (G59B) and the intact GWD 13520 (G59A). Figure 24 is a section across the fractured weld at Crack 1. Figure 25 is a montage of the fracture at higher optical magnification. The crack grew from a small angular feature (lip) in the root pass at the inner toe of the girth weld. The prominent lip was observed at the ID intersection of the crack and appeared to parallel the fusion line. The lip feature was approximately 0.008-inch (200 μ m) in length. The crack enlarged in a single radial plane which is typical of fatigue cracks enlarged by cyclic loading conditions. The final fracture occurred by ductile shear represented by the slanted fracture in the outer portion of the weld cap.

Figure 24. Metallographic Cross Section Through GWD 13530, Crack 1

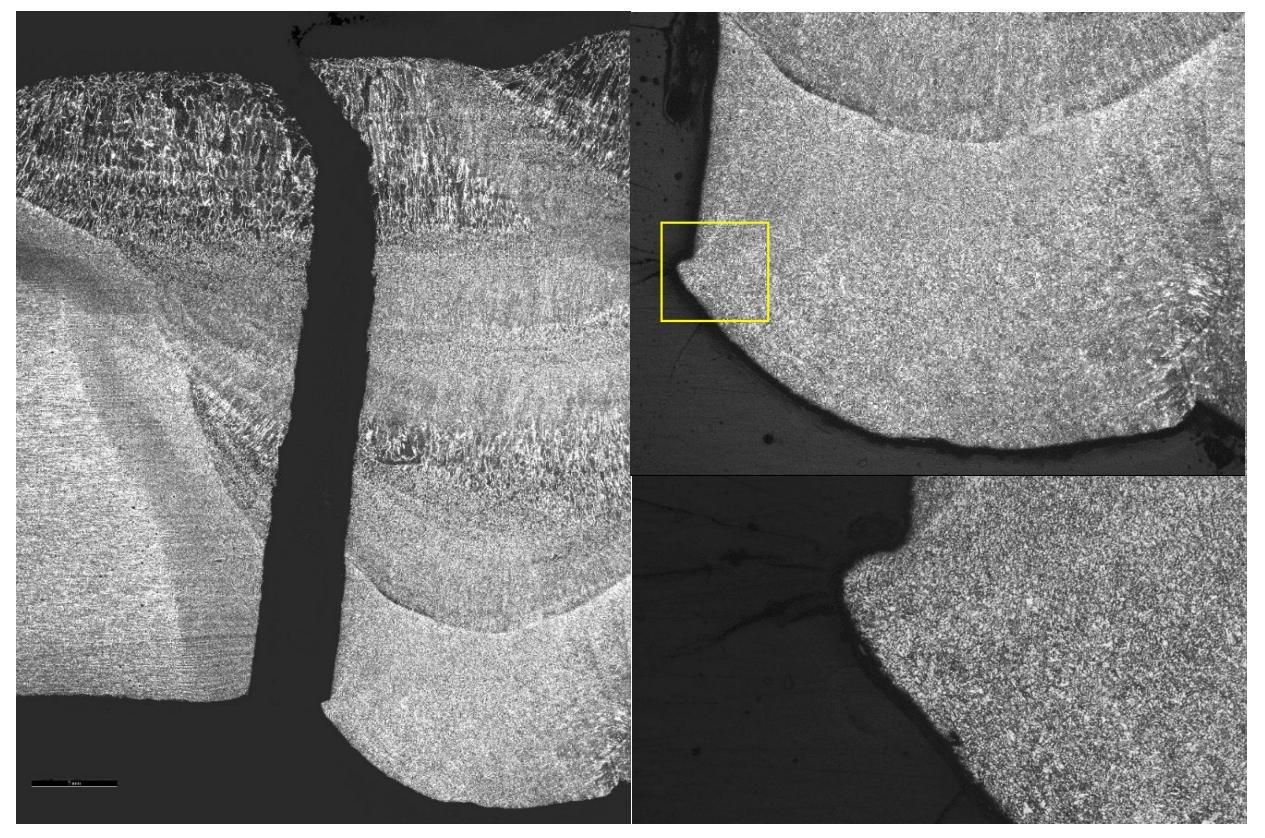
Figure 25. Photo Montage of Optical Micrographs Showing GWD 13530, Crack 1 (left 12.5x, top right 12.5x, and bottom right 50x)

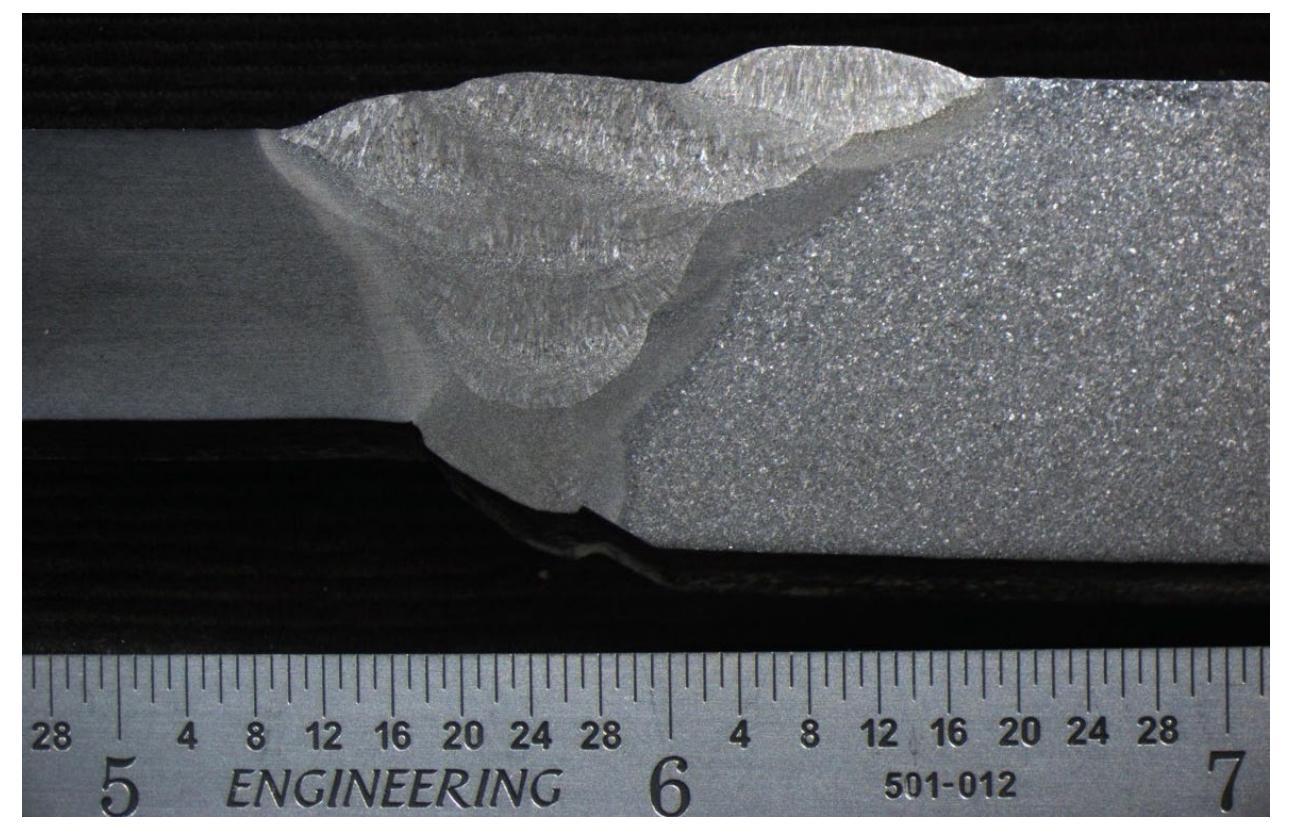
Figure 26. Metallographic Section of an Intact Portion of GWD 13530 at 139° from TDC Consistent with PAUT Indication 2

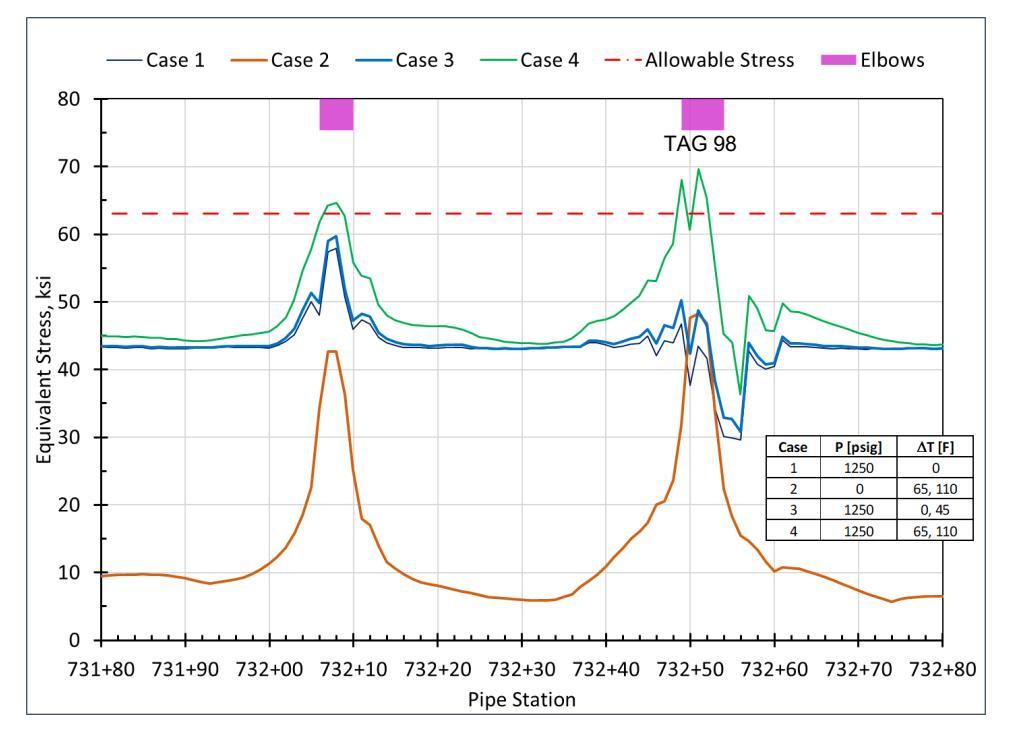
The worst-case results for the four loading combinations are shown in Figure 28 (model using elbow elements and lower-bound soil conditions). The purple boxes in Figure 28 show the locations of the upstream (TAG 114C; BND 349) sag bend and the TAG 98 (BND 350) overbend and the dashed dotted red line shows the 90% SMYS longitudinal stress limit for restrained pipe. The longitudinal stress results indicate maximum compressive stresses of 38.1 ksi (263 MPa) and maximum strain of 0.14% for the TAG 98 (BND 350) overbend. The maximum equivalent stress is high (69.6 ksi; 99.4% SMYS), and, although it exceeds the allowable combined stress for the pipe material, it is insufficient to cause permanent deformation in the form of ovalization and a wrinkle.

Figure 28. FEA von Mises Stresses with Elbow Elements and Lower-Bound Soil Properties (worst-case)

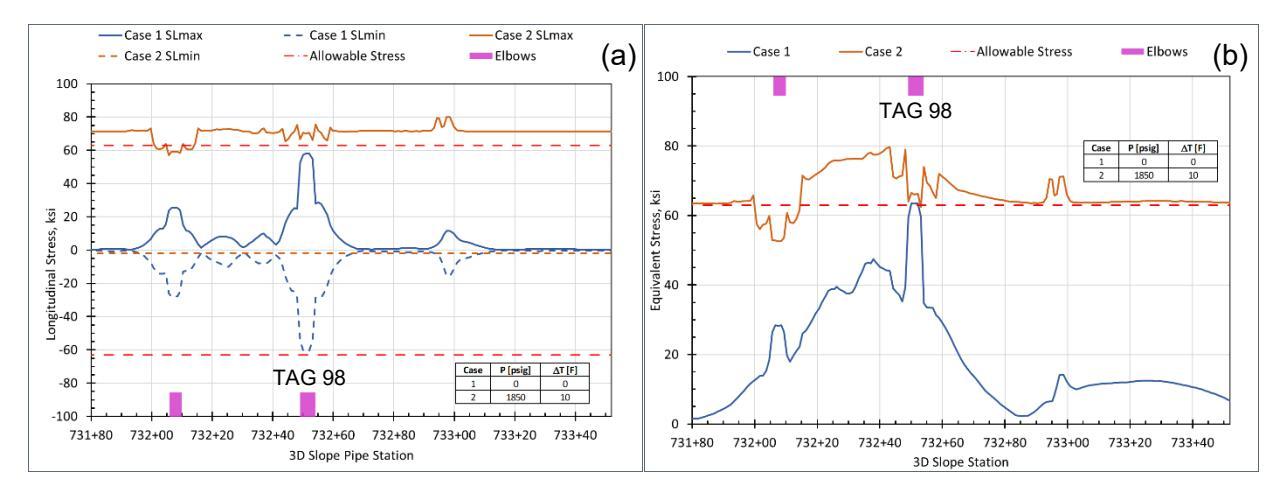
TAG 98 (BND 350) elbow if the end deflection was at least 6-ft. This amount of end deflection is excessive and could only happen if the pipe length on the south slope was supported above ground before the hydrostatic test and lost the support after it was filled with water. This type of movement would have been noticeable by construction crews and most likely would have resulted in a safety standdown (which there is no evidence of in the daily inspection reports).

Figure 35. FEA (a) Longitudinal Stresses with 6-ft End Deflection and (b) von Mises Stresses with 6-ft End Deflection (Elbow Elements and Lower-Bound Soil Properties)

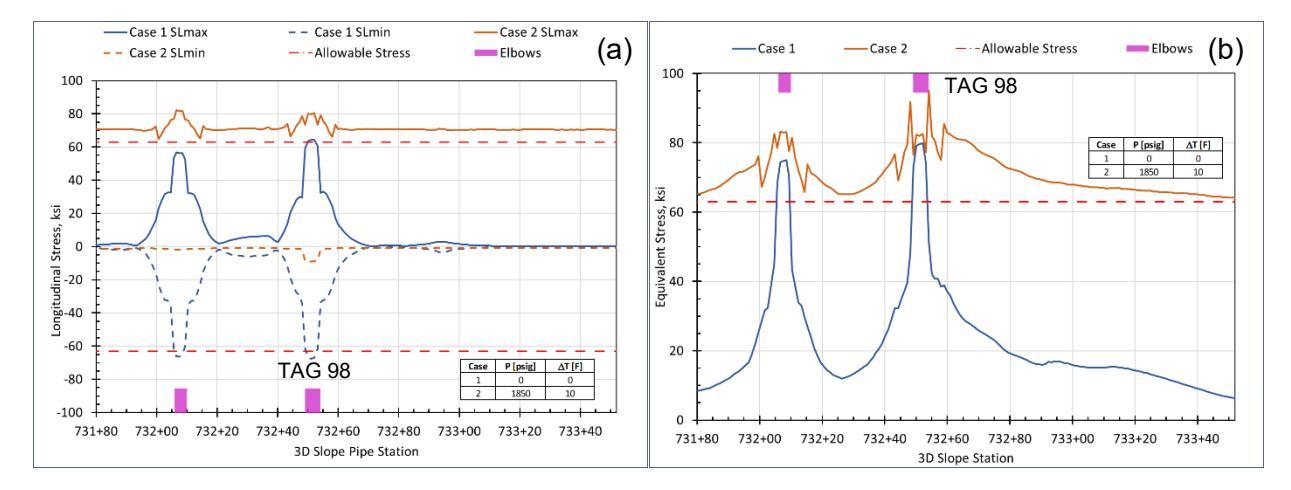
The results of the FEA for the sliding displacement scenario are shown in Figure 36. A sliding displacement of 6-inches in the downhill direction was applied to the end of the cantilever length and the model was run to calculate stresses. The results of this analysis are shown in Figure 36(a) for the longitudinal stresses and Figure 36(b) for the equivalent stresses. The results show that sliding of the pipeline down the slope can also create excessive bending stress at the elbow; however, the weight of the pipe filled with hydrostatic water is insufficient to cause the sliding. In other words, some outside loading had to act on the pipeline to force it to slide.

Figure 36. FEA (a) Longitudinal Stresses with 6-inches of Sliding Displacement and (b) von Mises Stresses with 6-inches of Sliding Displacement (Elbow Elements and Lower-Bound Soil Properties)

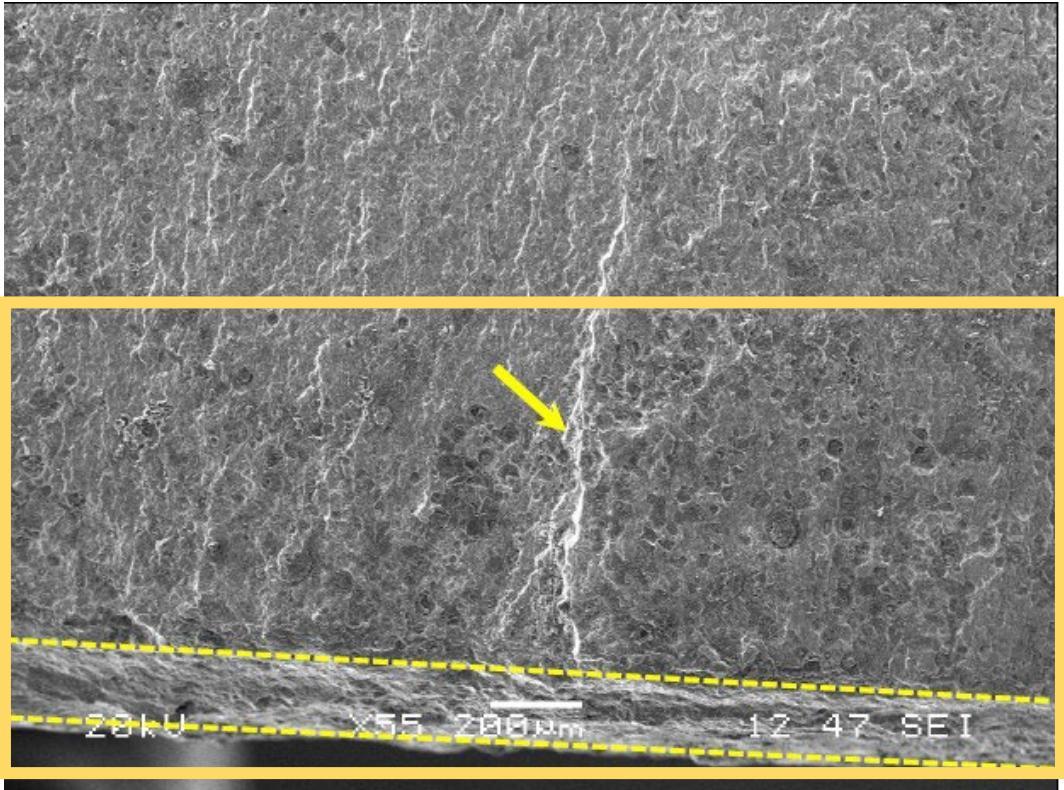
Figure 37. Region on the Crack 1 Fracture Surface with Corrosion Indicating Crack Initiation Early in the Life of the Crack

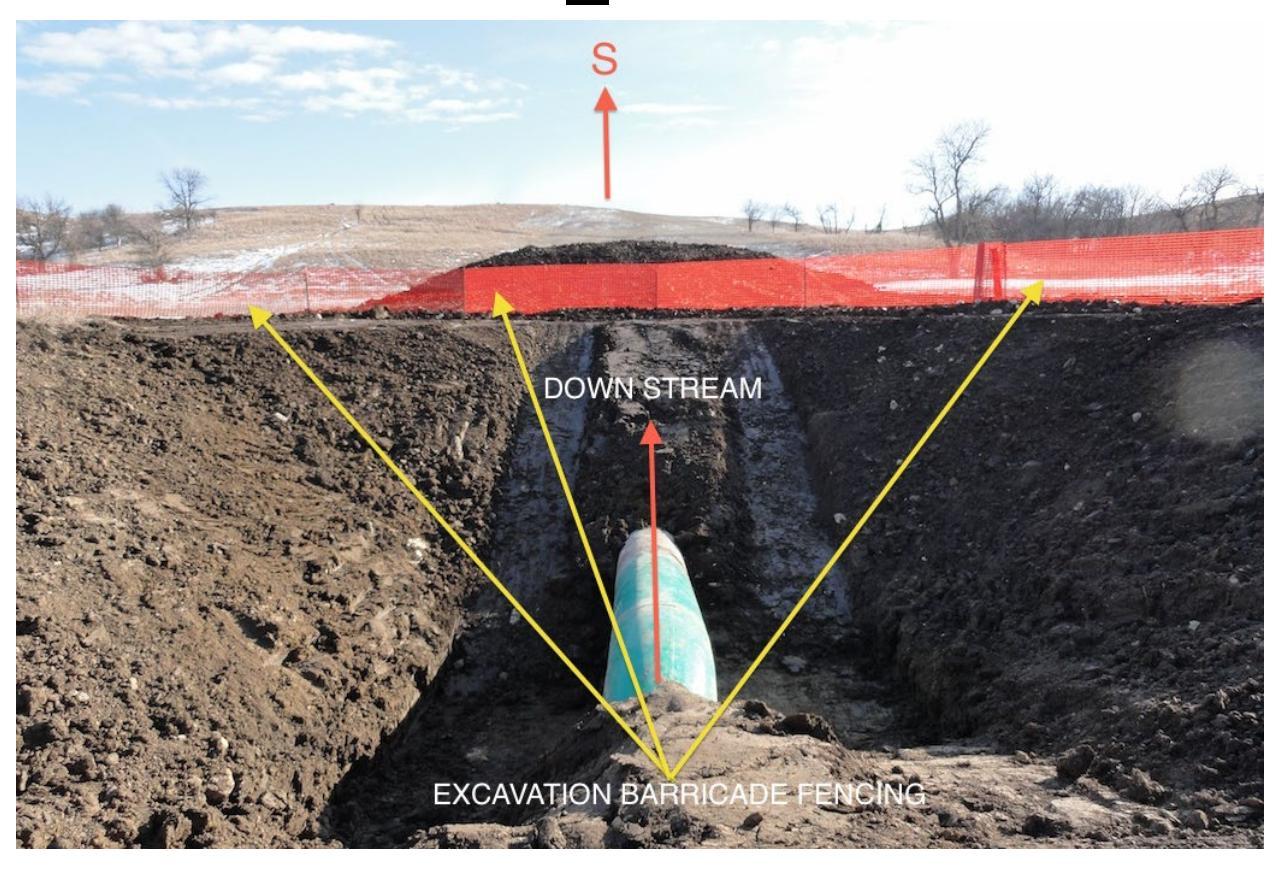
The 2012 profile caliper ILI tool identified a DID restriction (due to ovality) in the TAG 98 bend assembly that had damaged the cleaner and gauge tools run prior to the caliper tool. An excavation was performed in March 2013 to evaluate the restriction. A disconsistent ovality was measured in the field and ultrasonic wall thickness measurements were taken. The ovality was determined not to be an integrity concern at the time as it pertained to future ILI runs and the bend assembly was backfilled without any further interventions. While the excavation was still open, discussions occurred between the Pipe Integrity team and ILI vendor about how best to proceed. Several possible options were evaluated including (1) having the ILI vendor modify their tool so that it would pass through the elbow, (2) using a multi-diameter tool, or (3) cutting out the ID restriction. The option to cut out the feature was determined not to be the most favorable option at the time. Instead, the vendor agreed that they could navigate the feature with a tool redesign. Subsequent ILI runs have successfully navigated the ID restriction without any significant issues.

Figure 83. View of TAG 98 Looking South (Downstream) During 2013 Dig
