UNITED STATES ENVIRONMENTAL PROTECTION AGENCY
REGION 10
IDAHO OPERATIONS OFFICE
1435 N. Orchard St.
Boise, Idaho 83706

MEMORANDUM

SUBJECT: May 15, 2008 Site Inspection at Sackett Property

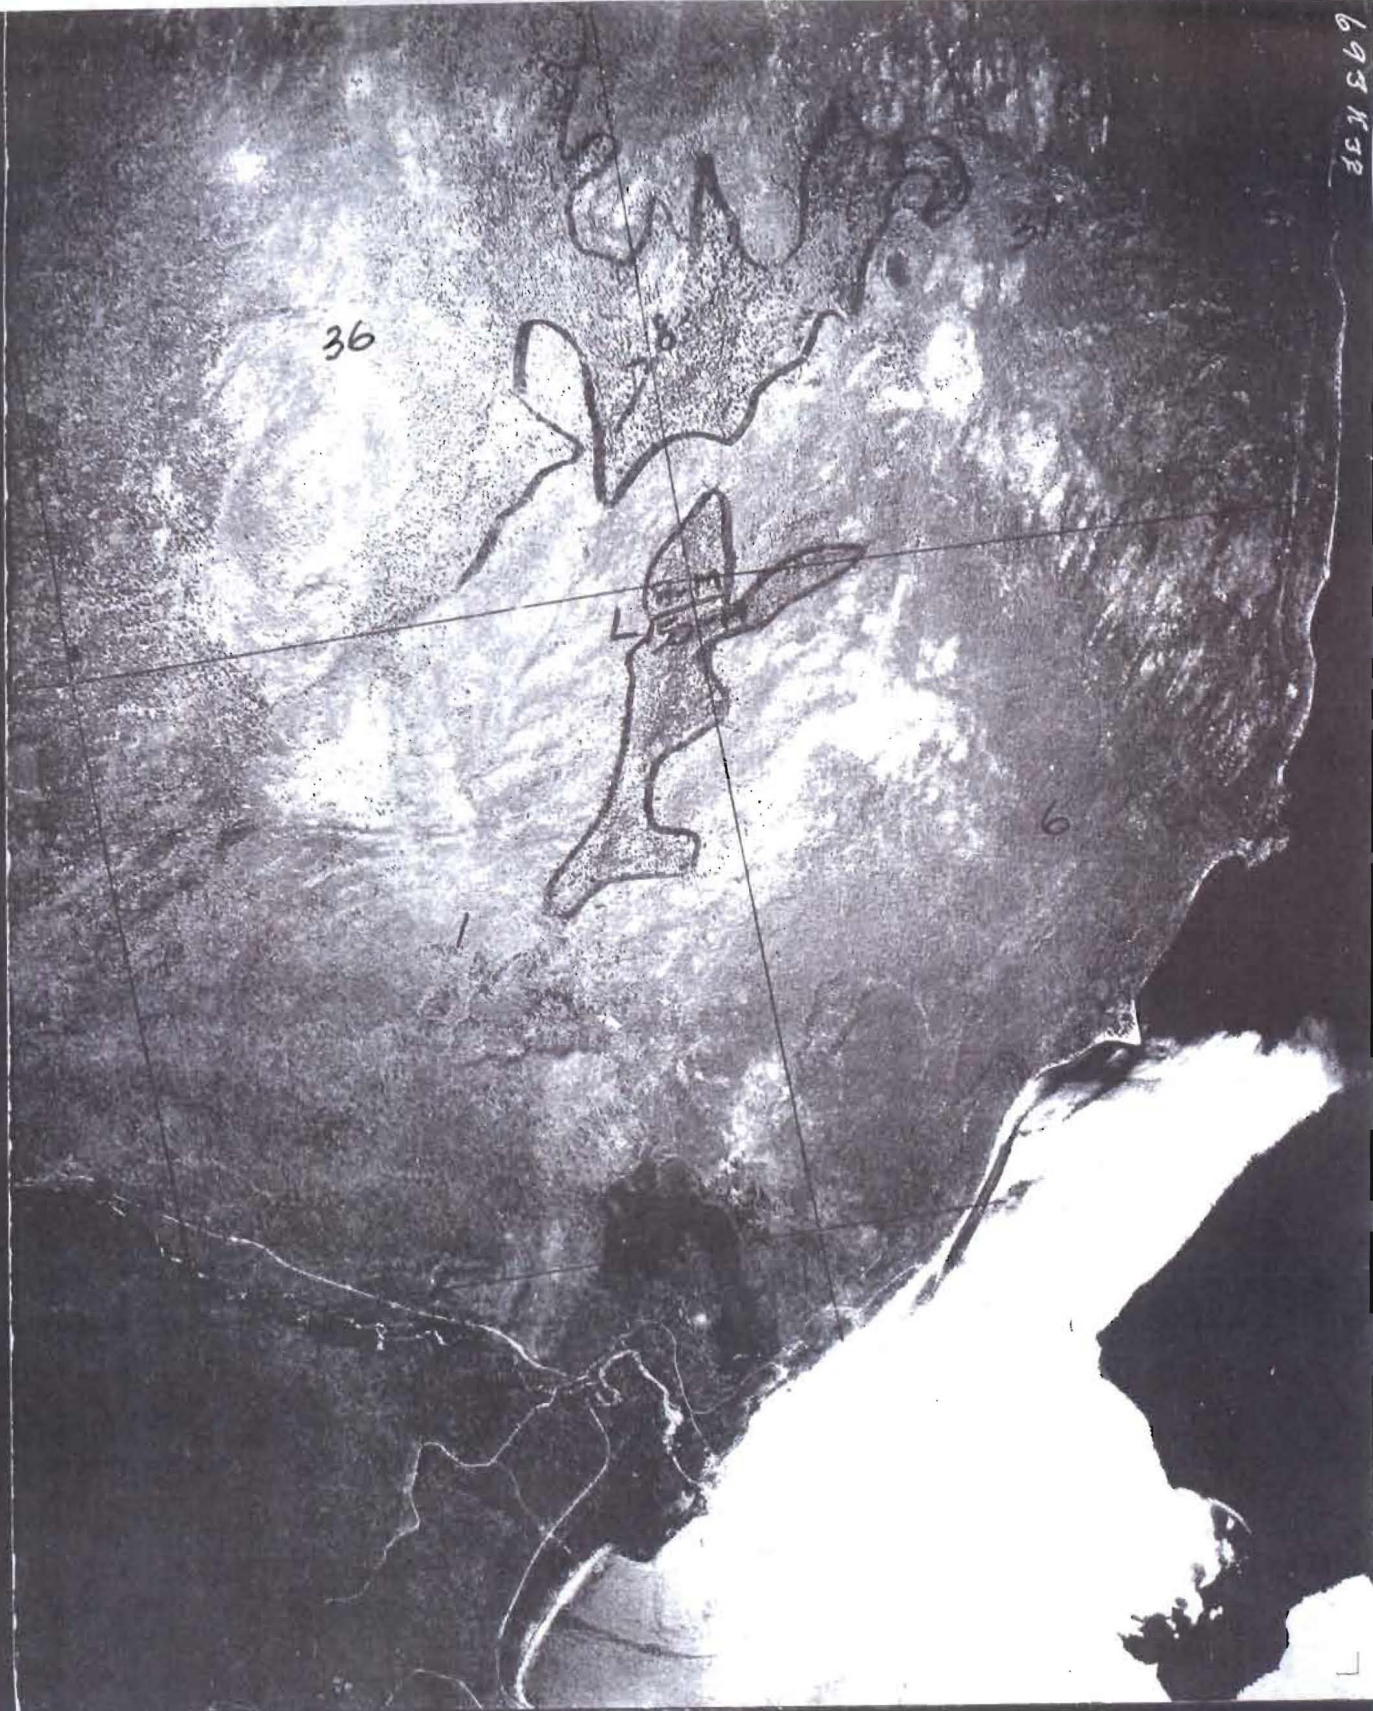
ATTACHMENT 2 – U. S. Forest Service 1932 Aerial Photographs
(photocopies)

B. Prior to visiting the site, I went to the U. S. Forest Service Priest Lake Ranger District and examined historic aerial photographs of the project area. I examined original black and white aerial photographs from 1932 (labeled 693K32 and 694K32). These photographs were taken prior to Kalispell Bay Road being constructed. In these photographs the wetlands on the Sackett property appear contiguous with the wetlands to the north and appear as a continuous wetland to Priest Lake. A primitive road or trail appears to exist near the lakefront and a shoreline beach appears to constrict the wetland toward the west near Priest Lake. Photocopies of these original photographs are included as Attachment 2.

(a) Shallow subsurface flow to Priest Lake due to elevation gradient from the wetland down to Priest Lake, the underlying soils, and the flow gradient from north of Kalispell Bay Road following the historic flow route to Priest Lake (per 1932 USFS aerial photographs). The drainage pipes providing flow to Priest Lake (see 2.F. above) could also be an indication of shallow subsurface flow between the wetland and Priest Lake. Such drainage pipes are typically used to provide drainage for development with high ground water conditions. High ground water conditions would be expected in areas where a wetland has a shallow subsurface connection between the wetland and discharge to a down gradient waterbody. The high ground water at the Sackett wetland, the down gradient slope to Priest Lake, and the drainage pipes between the Sackett wetland and Priest Lake are strong indications of this shallow subsurface flow.

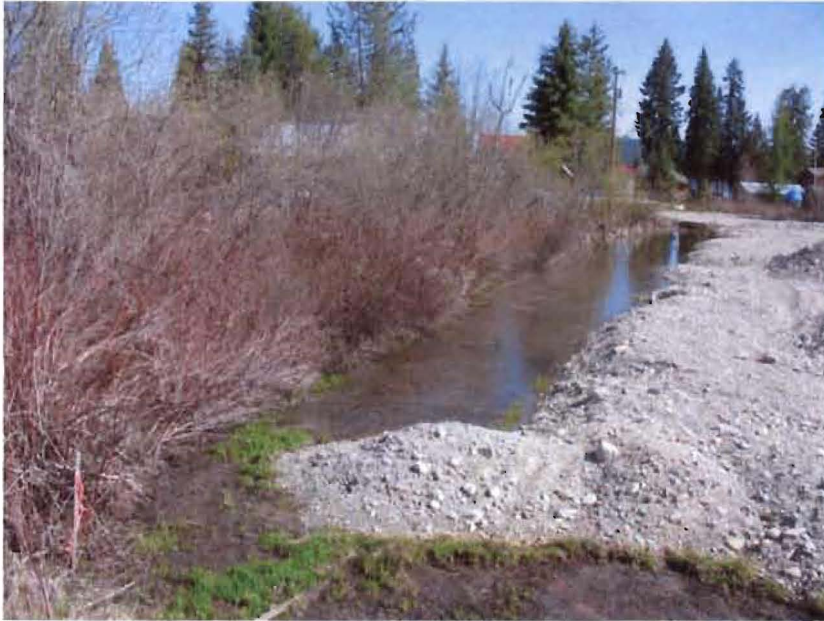
A. I observed that all portions of the Sackett property where native soil was removed but fill material had not been placed (*i.e.*, along the east, south, and west edges of the property) were inundated or ponded/saturated to the surface

(Attachment 3, photographs 1 - 4). The water surface levels along the east side of the fill appeared to be approximately 6 to 12 inches higher than the water surface level along the west side of the fill (*i.e.*, inundated along east side, ponded/saturated to the surface along west side).

Photograph 1 - View south from Kalispell Bay Road along east edge of Sackett property

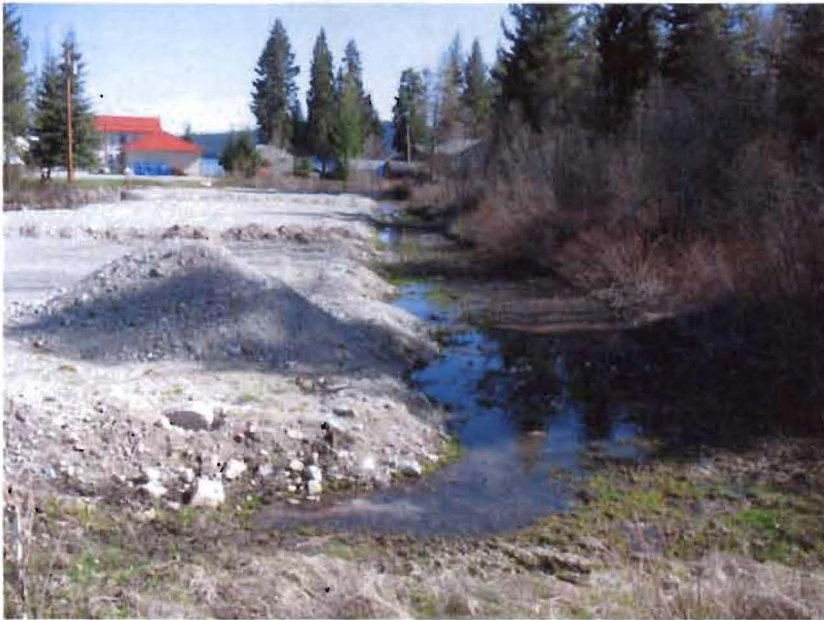
Photograph 2 - View south from Kalispell Bay Road along west edge of Sackett property

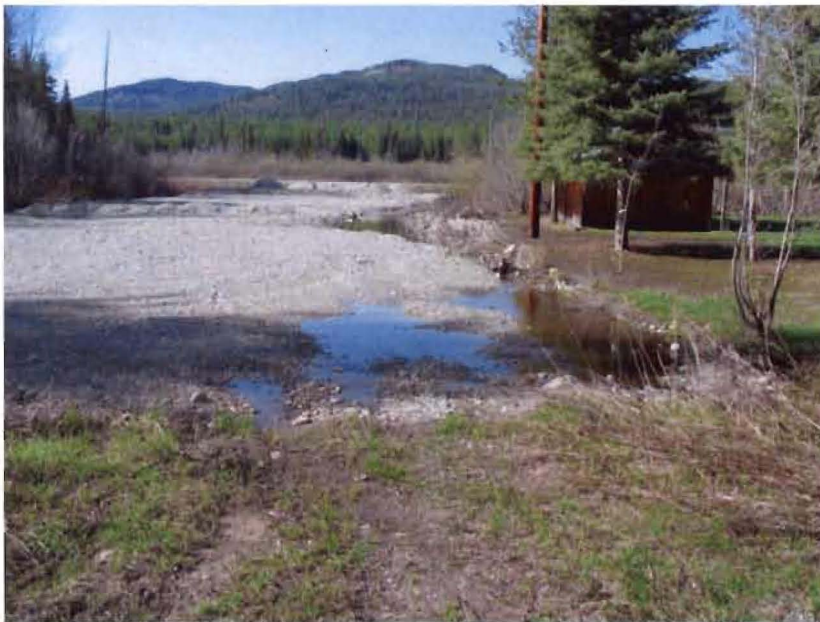
Photograph 3 - View north from Old Schneiders Road of south and east edges of Sackett property

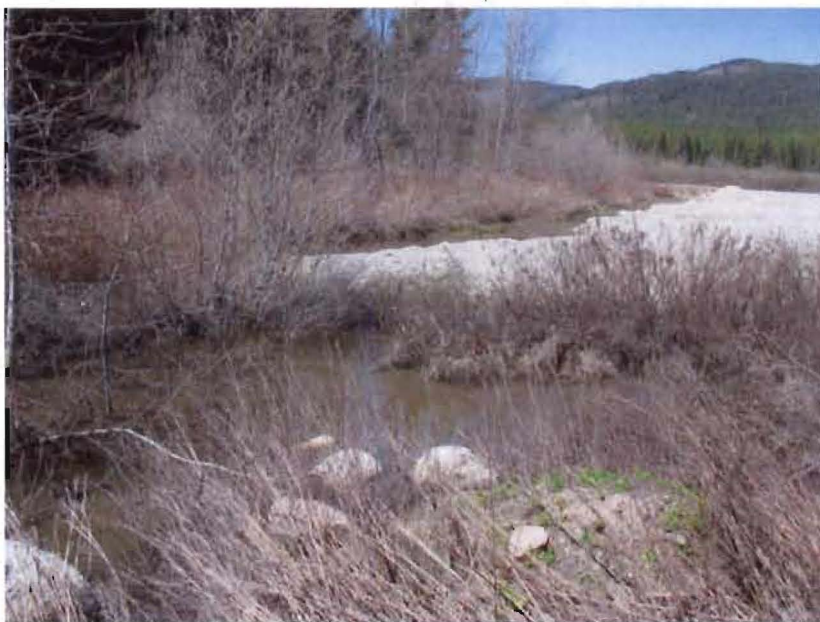
Photograph 4 - View north from Old Schneiders Road of south and west edges of Sackett property

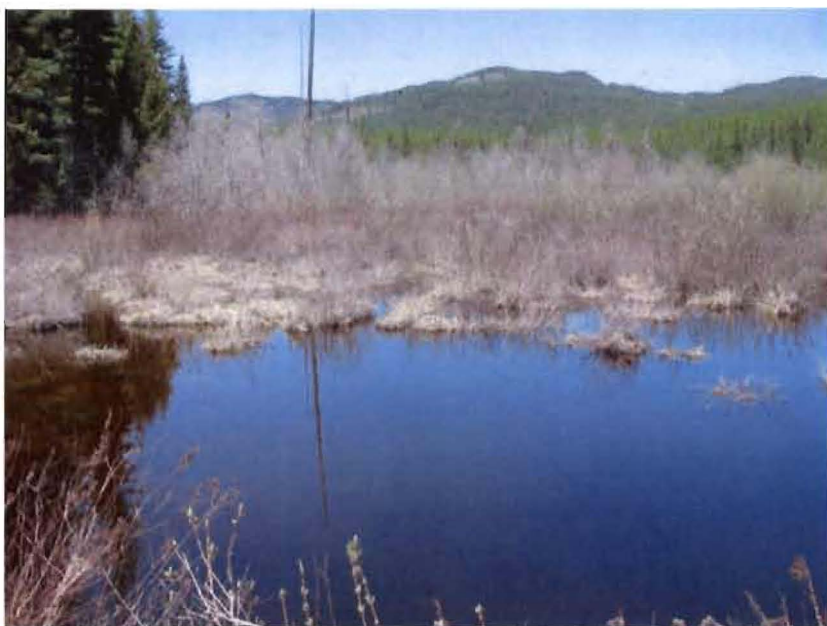
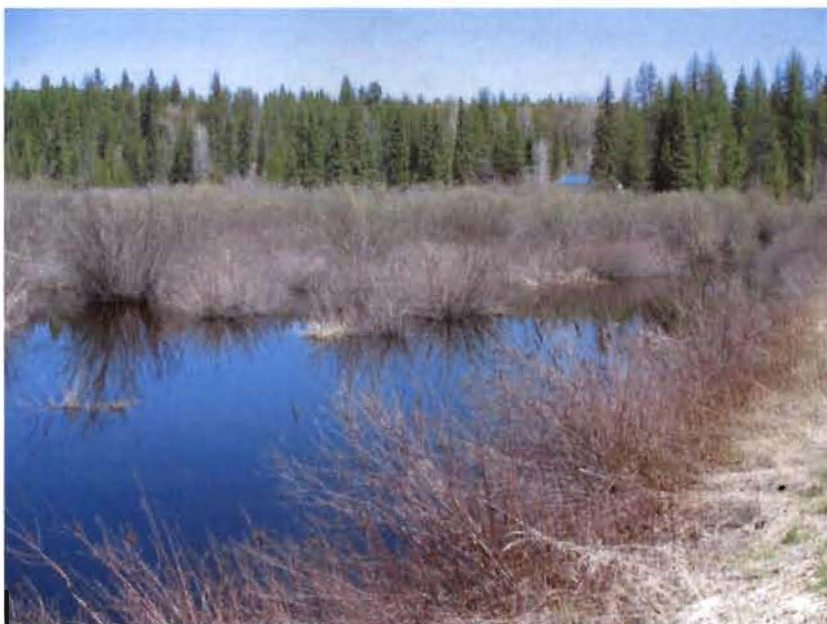
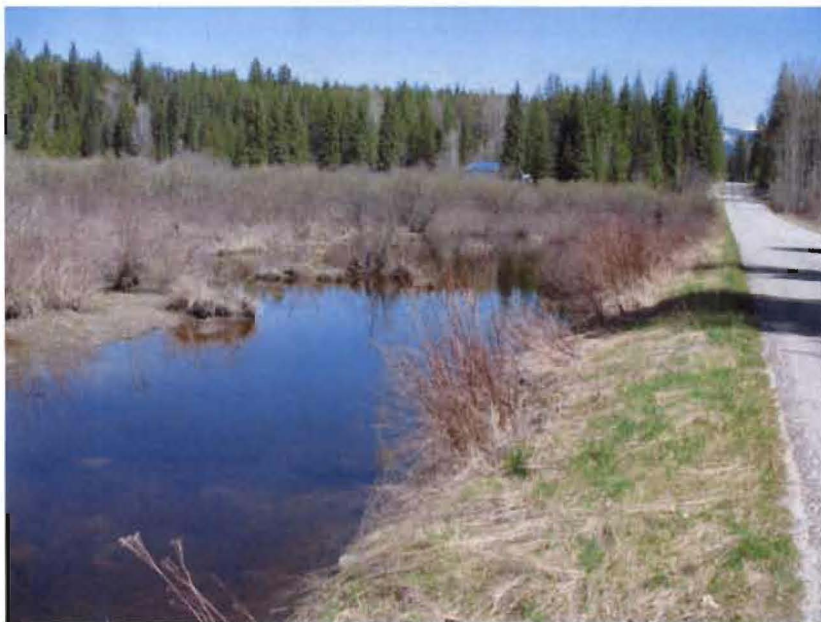
C. I observed that the wetland north of Kalispell Bay Road was inundated with 1 to 2 feet of water (Attachment 3, photographs 5 - 7). There is a substantial flow (estimated approximately 5 to 10 cubic feet per second) of surface water flowing through the outlet stream along the north side of Kalispell Bay Road to Kalispell Creek (Attachment 3, photographs 8 - 12). Beaver have been active in the outlet stream as evidenced by vegetation cut and placed in the channel (Attachment 3, photograph 16). A relatively large trout (perhaps 14 inches) was observed near the upstream end of the outlet stream. The water surface elevation on the north side of Kalispell Bay Road was approximately 2 feet below the road surface elevation.

Photograph 5 - View from Kalispell Bay Road of wetland on north side of Kalispell Bay Road

Photograph 6 - View from Kalispell Bay Road of wetland on north side of Kalispell Bay Road

Photograph 7 - View from Kalispell Bay Road of wetland on north side of Kalispell Bay Road

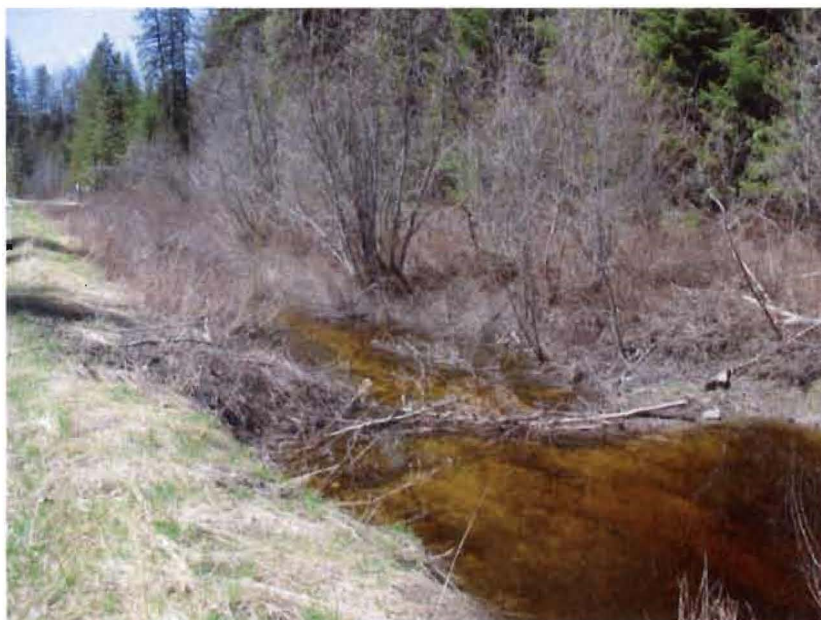
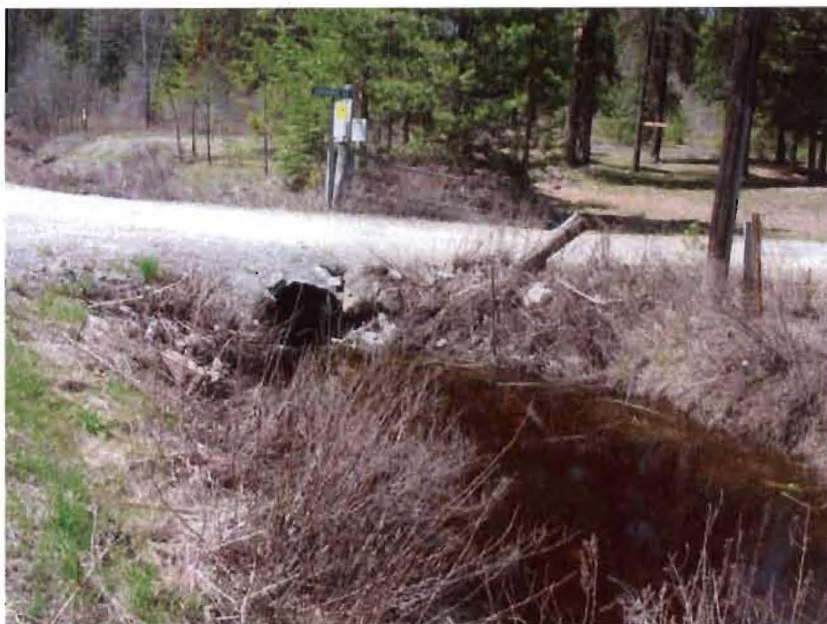
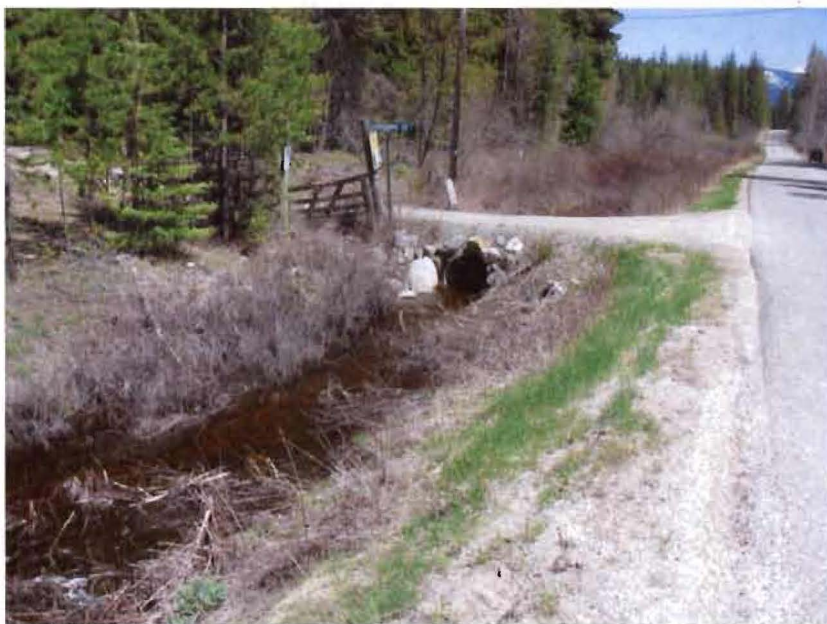
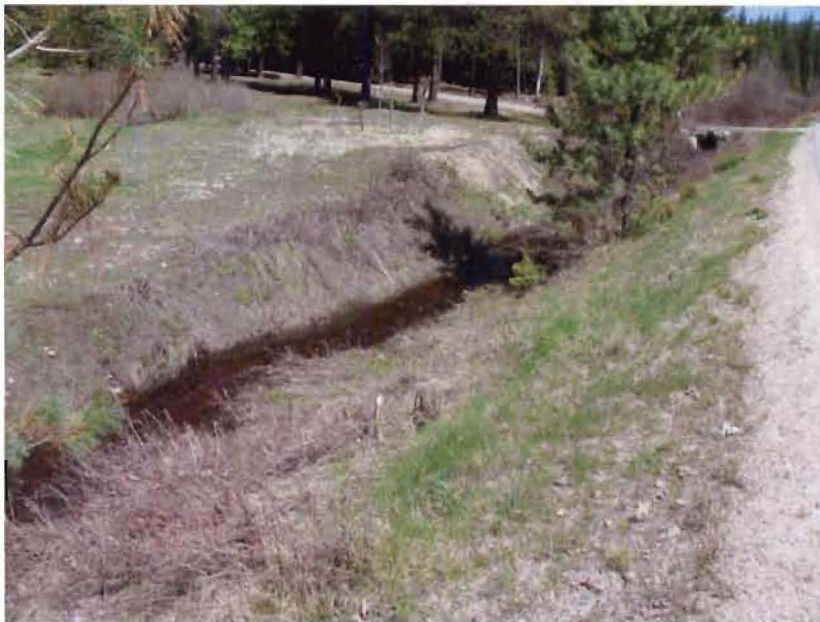
Photograph 8 - View of outlet channel on north side of Kalispell Bay Road flowing west toward Kalispell Creek

Photograph 9 - View of outlet channel on north side of Kalispell Bay Road flowing west toward Kalispell Creek

Photograph 10 - View of outlet channel on north side of Kalispell Bay Road flowing west toward Kalispell Creek

Photograph 11 - View of outlet channel on north side of Kalispell Bay Road flowing west toward Kalispell Creek

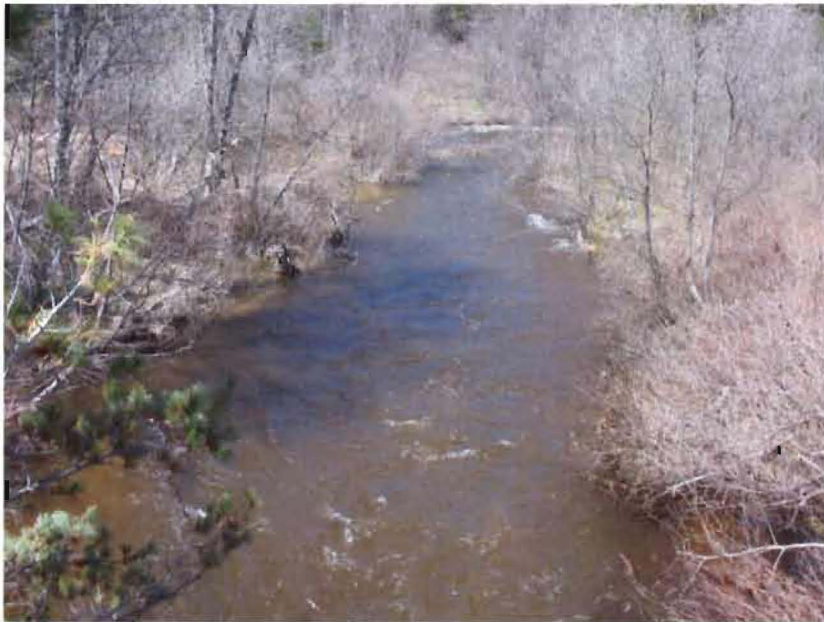
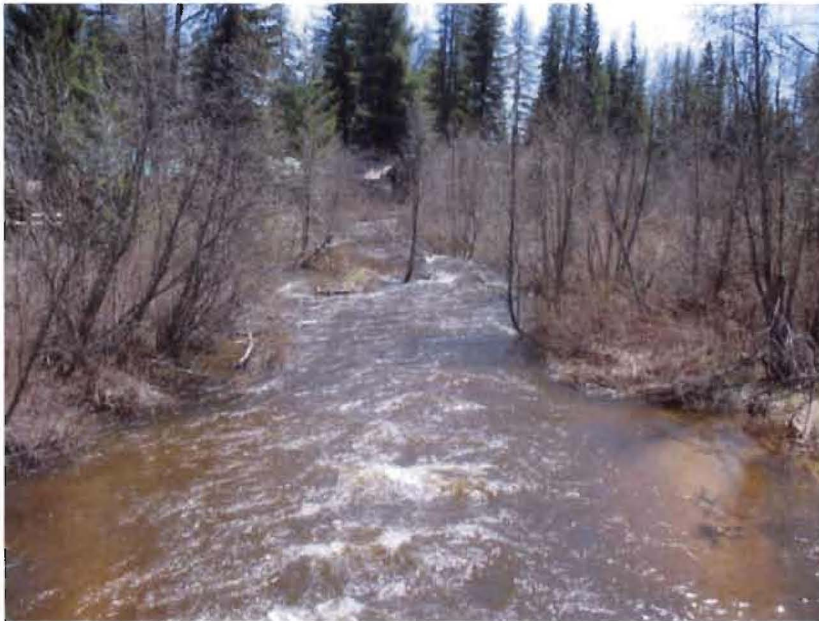
(5) The Sackett wetland is adjacent to, but does not abut, the unnamed tributary to Kalispell Creek. The Sackett wetland is separated from the unnamed tributary to Kalispell Creek by Kalispell Bay Road, a man-made barrier. Kalispell Bay Road consists of a paved road surface on top of a road fill measuring approximately 30 feet wide at its base and approximately 3 to 4 feet above the ground elevation of the wetlands on both the north and south sides of the road. This road fill appears to consist of typical road fill material for the area, including gravels, sands, and fine soil material. This road fill acts a barrier to prevent surface water flow from the northern wetland to the Sackett wetland on the south side of the road and to divert that surface water into the unnamed tributary leading to Kalispell Creek. The unnamed tributary to Kalispell Creek is most likely a perennial stream as described above and it is certainly a relatively permanent tributary based on USGS mapping and its flow and channel size and form. Kalispell Creek (Attachment 3, photographs 13 - 15) is a

perennial stream based on USGS mapping, its flow (summer base flow at the mouth of Kalispell Creek is estimated at 15 - 20 cfs⁵), its channel size and form, and Mike's personal knowledge of the stream. To evaluate the significant nexus of the Sackett wetland to the nearest downstream traditional navigable water (Joint Corps of Engineers and EPA Memorandum "Clean Water Act Jurisdiction Following the U. S. Supreme Court's Decision in Rapanos v. United States & Carabell v. United States" dated June 5, 2007) requires an evaluation of the relevant reach of the tributary and all wetlands adjacent to that stream reach. The relevant reach of the unnamed tributary near the Sackett wetland is from the upstream location where two first order streams join to form the second order stream downstream to the junction of this second order stream with Kalispell Creek (approximately 3500 linear feet).

Photograph 13 - View upstream of Kalispell Creek at Kalispell Bay Road

Photograph 14 - View downstream of Kalispell Creek at Kalispell Bay Road

Photograph 15 - View downstream of Kalispell Creek at Kalispell Bay Road

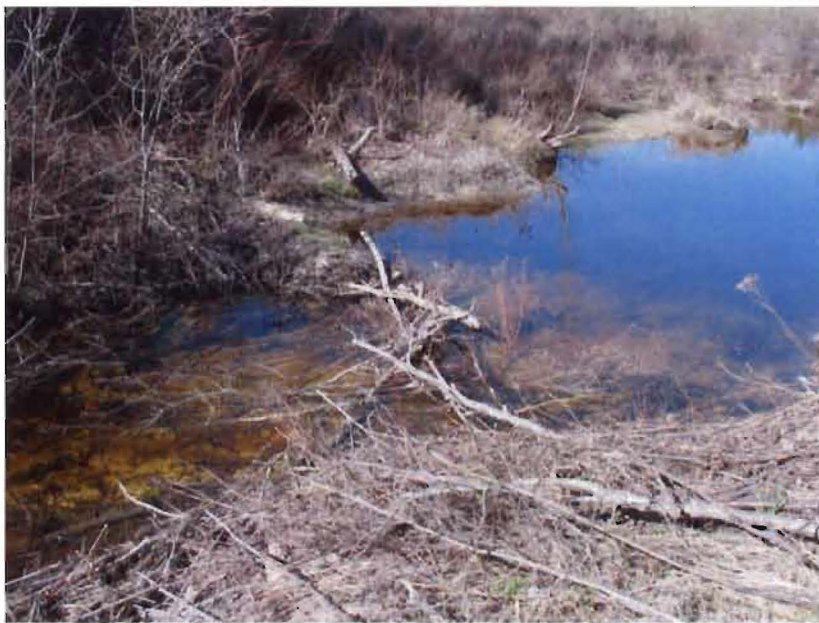
Photograph 16 - View of recent beaver activity in outlet channel on north side of Kalispell Bay Road

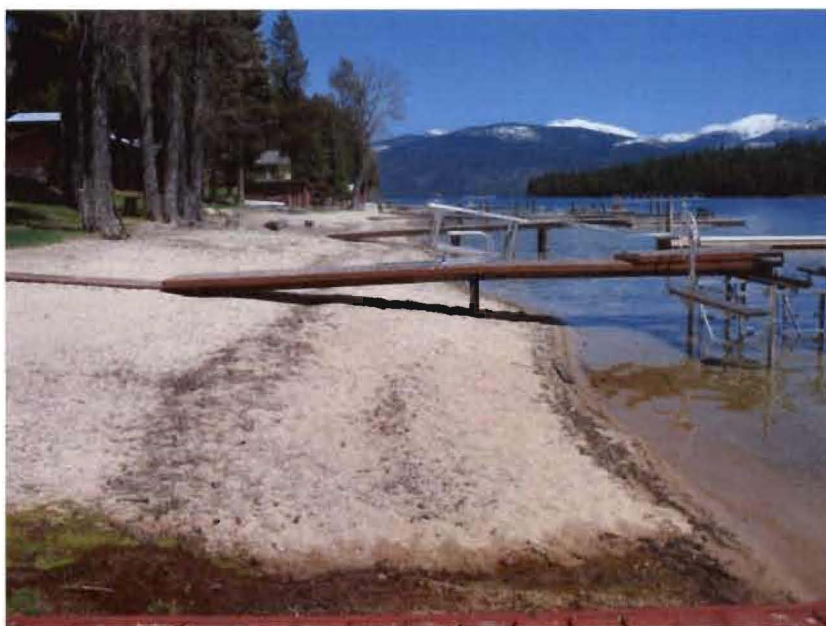
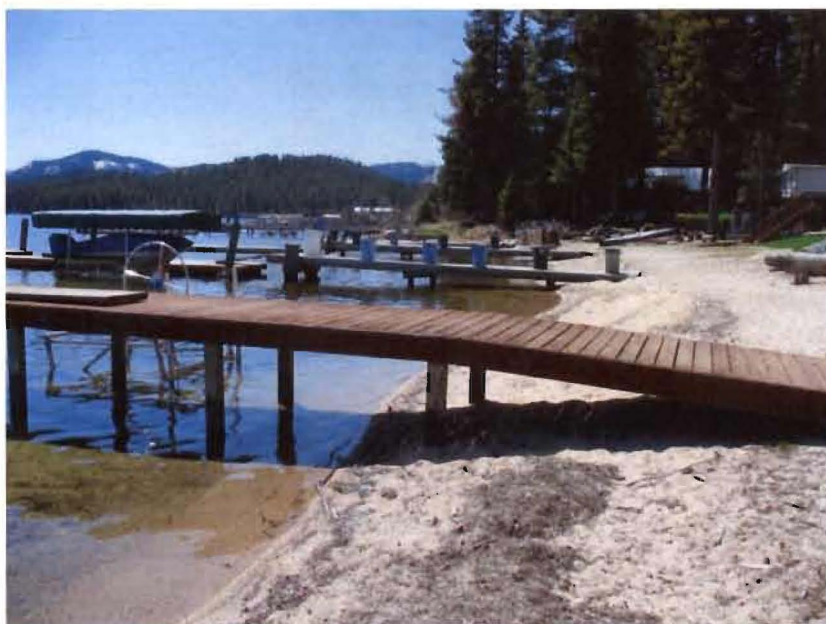
F. Priest Lake appeared to be approximately 2 feet below its normal high water elevation (Attachment 3, photographs 17 - 18). Along the lake shoreline immediately south of the Sackett property were 2 small drainage pipes (approximately 4 inch diameter) emerging from the shoreline (Attachment 3, photograph 19). One of the pipes had a discharge flow of approximately 2 to 3 gallons per minute going directly into Priest Lake (Attachment 3, photograph 20). These discharge pipes are located along the shoreline in front of the red-roofed house shown on the left side of photograph 21 (Attachment 3). It is approximately 300 linear feet from the southern edge of the Sackett wetland to the discharge pipes and Priest Lake. The water surface elevation in Priest Lake appeared to be approximately 8 to 10 feet below the elevation of the Sackett property wetlands (Attachment 3, photograph 21).

Photograph 17 - View east along shoreline of Priest Lake south of Sackett property

Photograph 18 - View west along shoreline of Priest Lake south of Sackett property

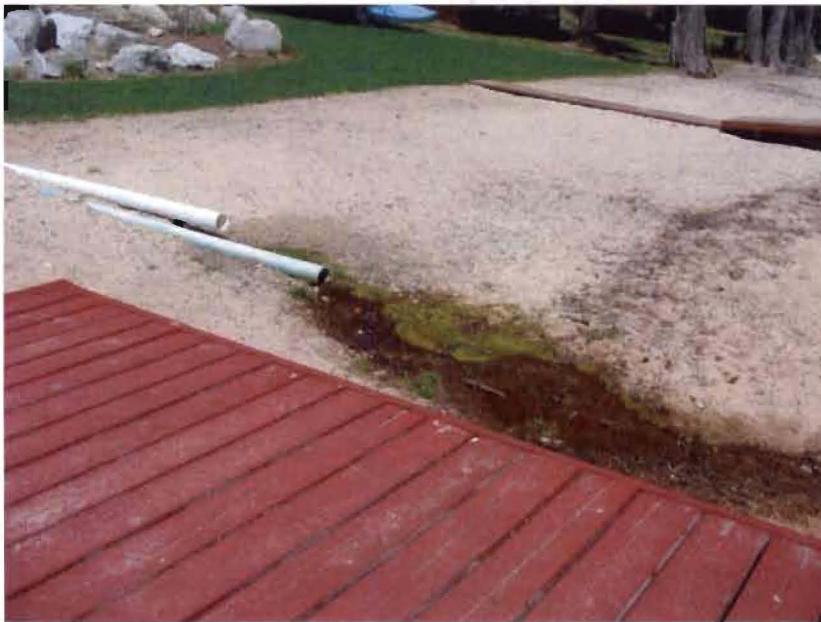
Photograph 19 - Drainage pipes at shoreline of Priest Lake south of Sackett property

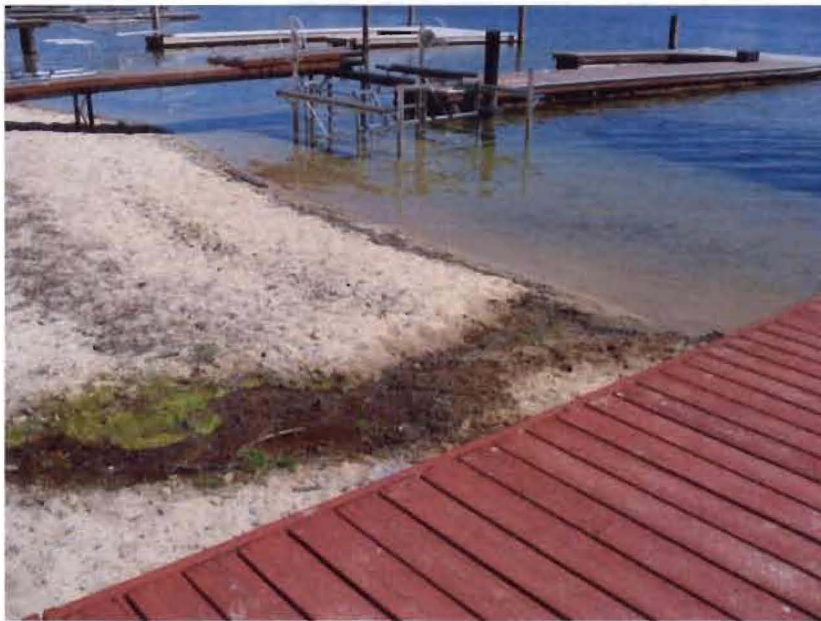
Photograph 20 - Flow from drainage pipes entering Priest Lake south of Sackett property

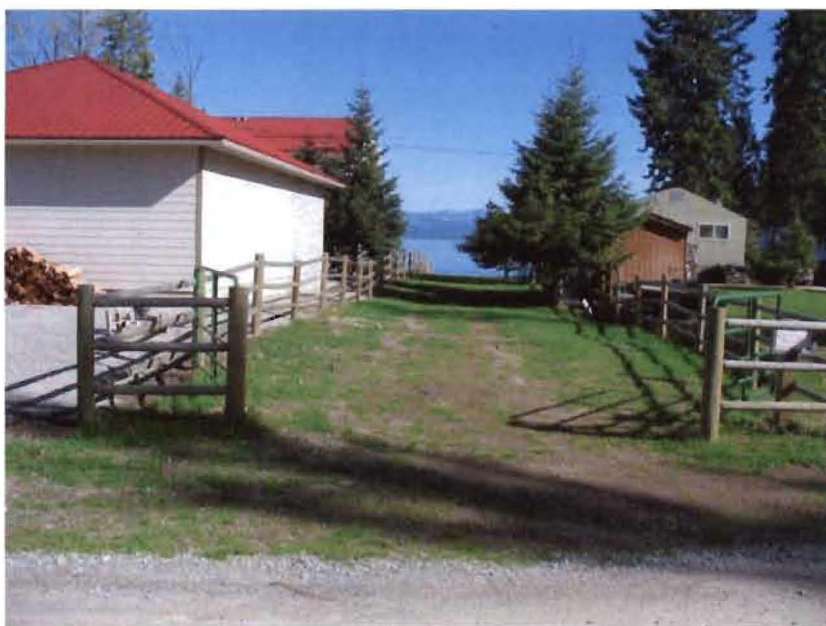
Photograph 21 - View south to Priest Lake from Old Schneiders Road on south edge of Sackett property. Priest Lake is approximately 300 linear feet from south edge of Sackett property.
