Pipeline Investigation Report: NTSB/PIR-22/02

# Enbridge Inc. Natural Gas Transmission Pipeline Rupture and Fire

Danville, Kentucky  
August 1, 2019

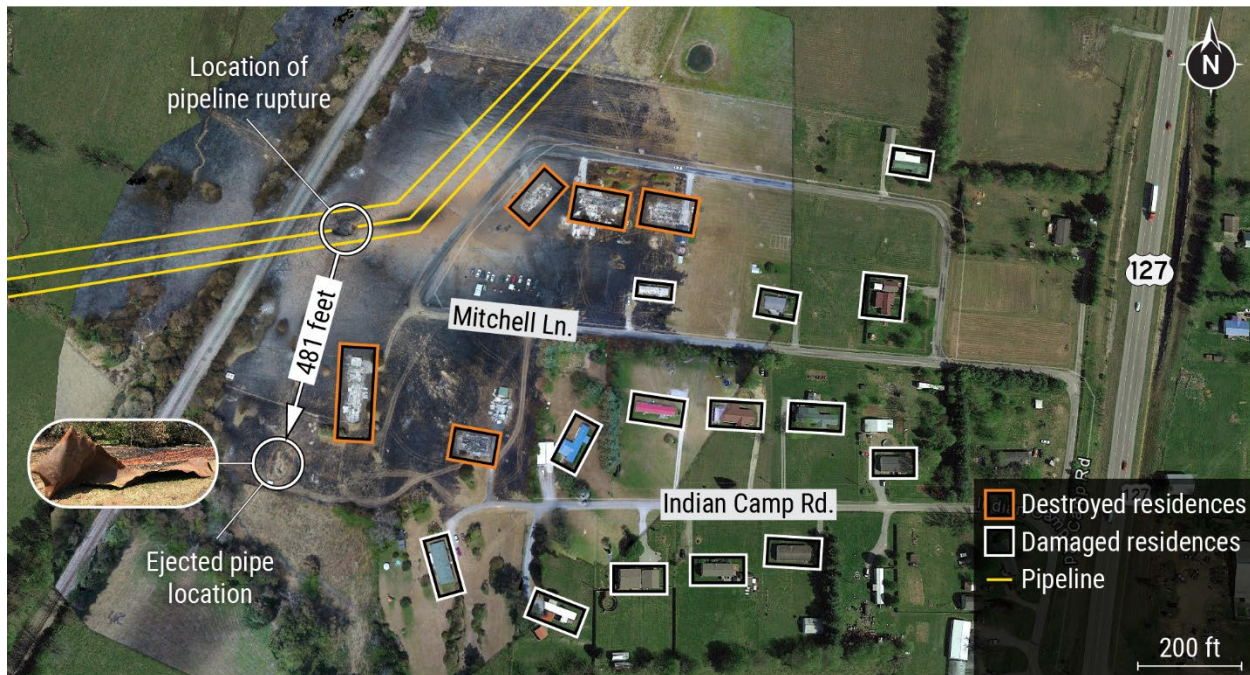
On August 1, 2019, at 1:23 a.m. local time, a 30-inch-diameter natural gas transmission pipeline, Line 15, owned and operated by Enbridge Inc. (Enbridge), ruptured near Danville, Kentucky.<sup>1</sup> As a result of the rupture, 1 person was fatally injured, 6 people were hospitalized, and over 75 residents were evacuated from the Indian Camp Subdivision, a residential community. The rupture released about 101.5 million cubic feet of natural gas and ejected a 33.2-foot-long section of pipeline that landed about 481 feet southwest of the rupture site. The releasing gas ignited and burned. Five residences in the subdivision were destroyed by fires, and an additional 14 were damaged. (See figure 1.) A nearby railroad track owned and operated by the Norfolk Southern Corporation sustained fire damage.

**Figure 1.** Aerial view of the Indian Camp Subdivision overlaid on Google Earth image.

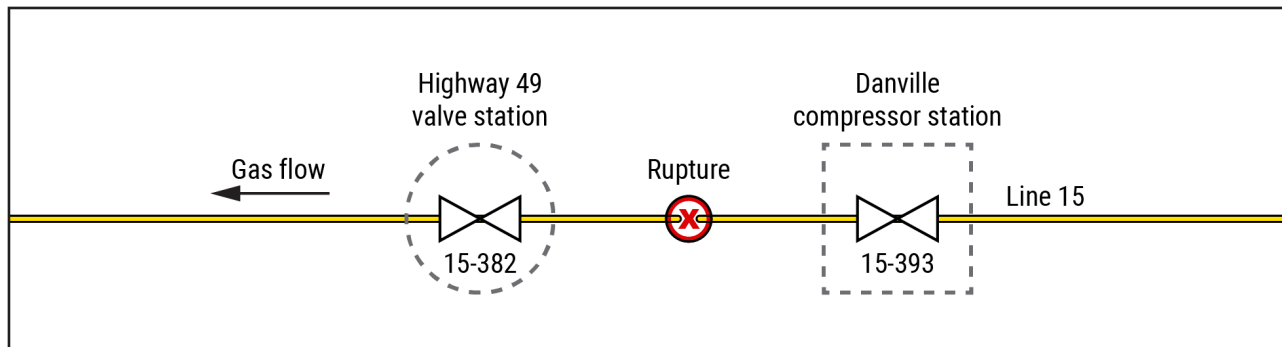
To isolate the affected pipeline segment, Enbridge personnel needed to close valves manually at the Danville CS (valve 15-393) and at a valve station located near Highway 49 (valve 15-382). (See figure 2).

**Figure 2.** Process flow diagram for pipeline isolation.
