## TransCanada Keystone Pipeline, LP

# Root Cause Failure Analysis of Pipeline Rupture at Ludden +17

April 18, 2018

**Final Report**

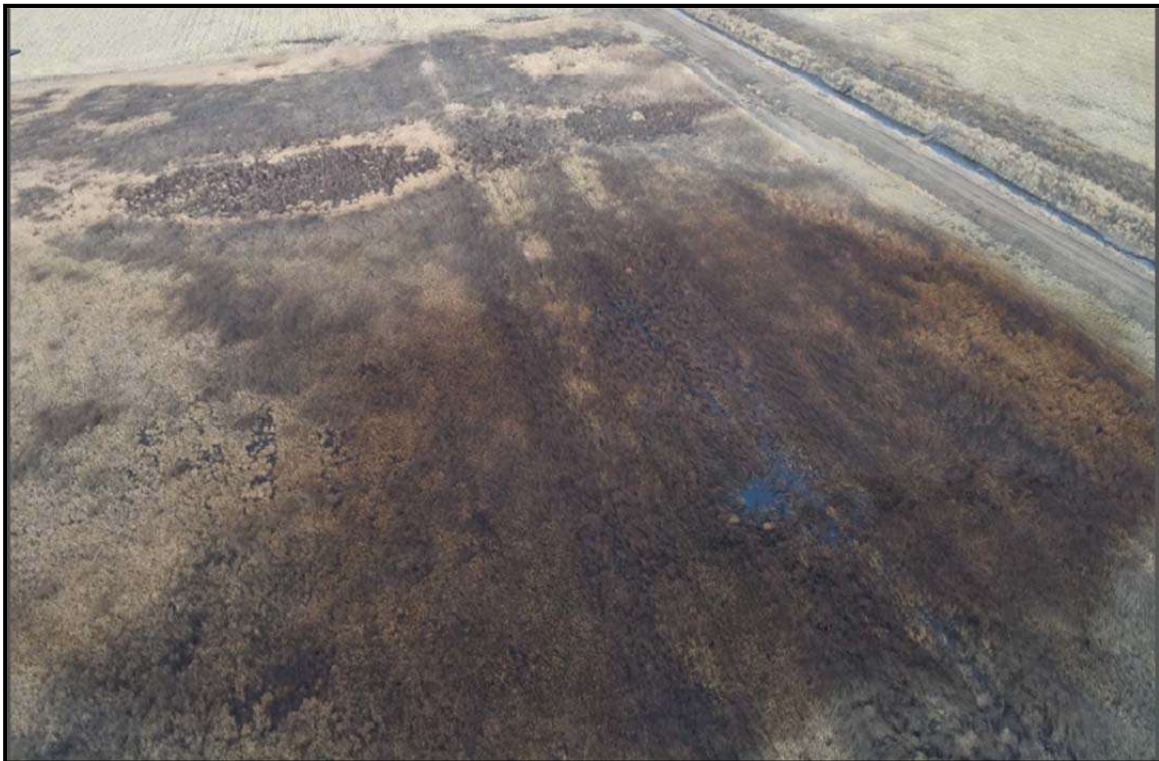
**Figure 3. Aerial View of the Rupture Location**

On November 16, 2017, a rupture occurred on the 30-inch diameter Keystone Phase 1 Pipeline near MP 234.5 between the Ludden Pump Station and Ferney Pump Station releasing an initially reported volume of 5,000 barrels of crude oil. An aerial view of the release extent is shown in Figure 3. At 5:33 AM central time, the SCADA system indicated a pressure drop at the mainline valve 23.8 miles downstream of the Ludden Pump Station ( ). One minute later, the LDS alarmed indicating a leak, the size of which exceeded the 400 m<sup>3</sup>/hr detection threshold over a two minute averaging window. Immediately upon receipt of the leak alarm within the OCC, TransCanada's oil operations shut down the entire pipeline between Hardisty, Alberta and Cushing, OK<sup>2</sup> in accordance with standard procedures, isolated the affected pipeline

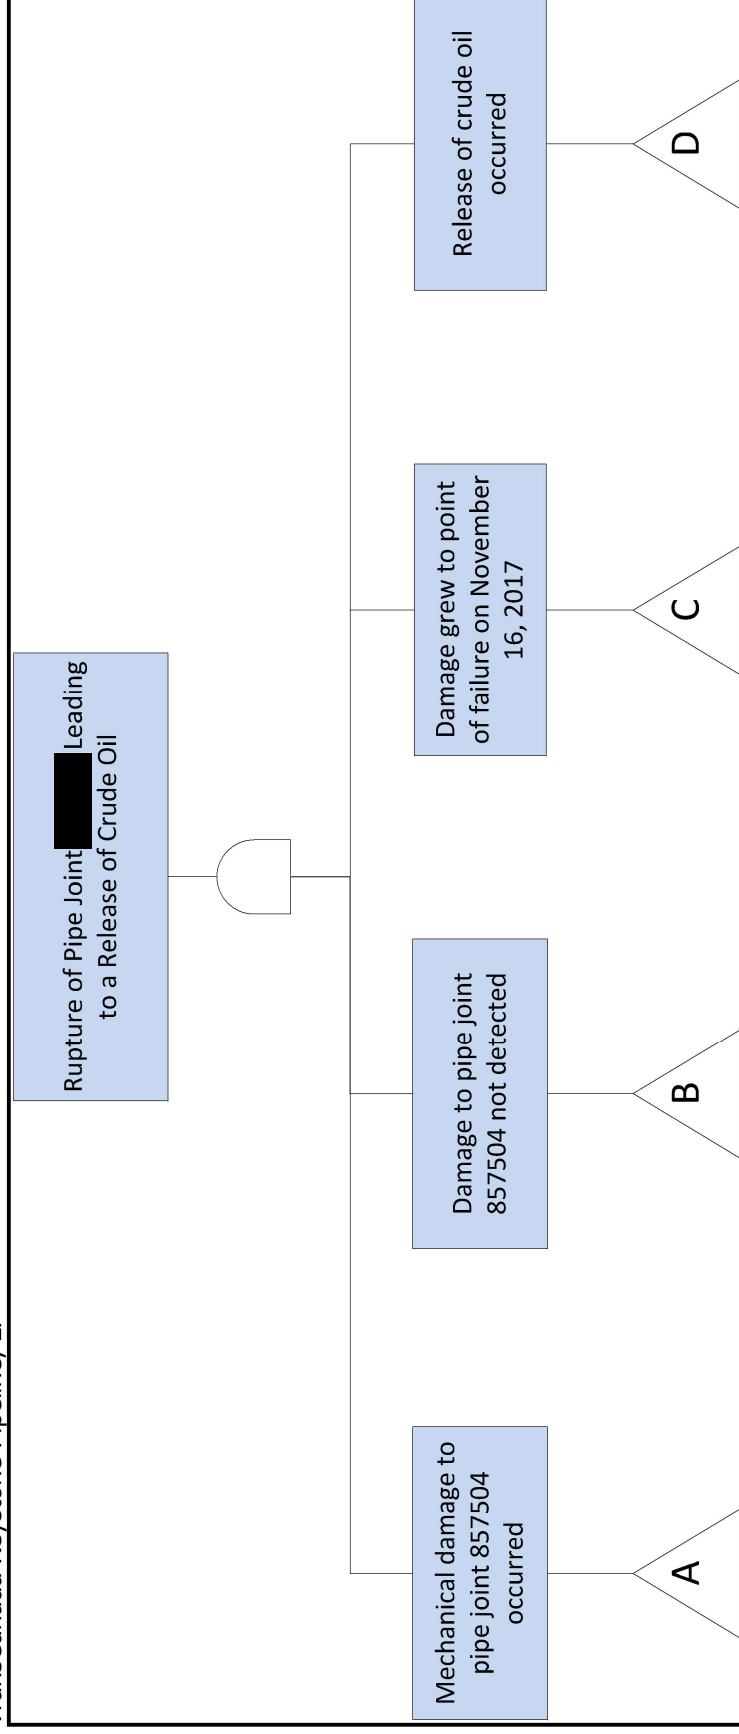
**Figure 6. Pipe Rupture and Crude Oil Release - Root Cause Analysis Cause and Effect Tree**

The loss event was defined as: rupture of pipe joint 857504 leading to the release of an initially reported volume of 5,000 barrels of crude oil. Causal factors were recognized for event sequences pertaining to (1) mechanical damage to the pipe joint and (2) the damage to the pipe joint remaining undiscovered. Contributing factors were identified related to the damage growing to a point of failure. The investigation also evaluated the control room response and pipeline isolation which limited the volume of the release. The incident Cause and Effect Trees are shown in Figure 6, Figure 10, Figure 29, Figure 39, and Figure 47 and are discussed in the following sections.

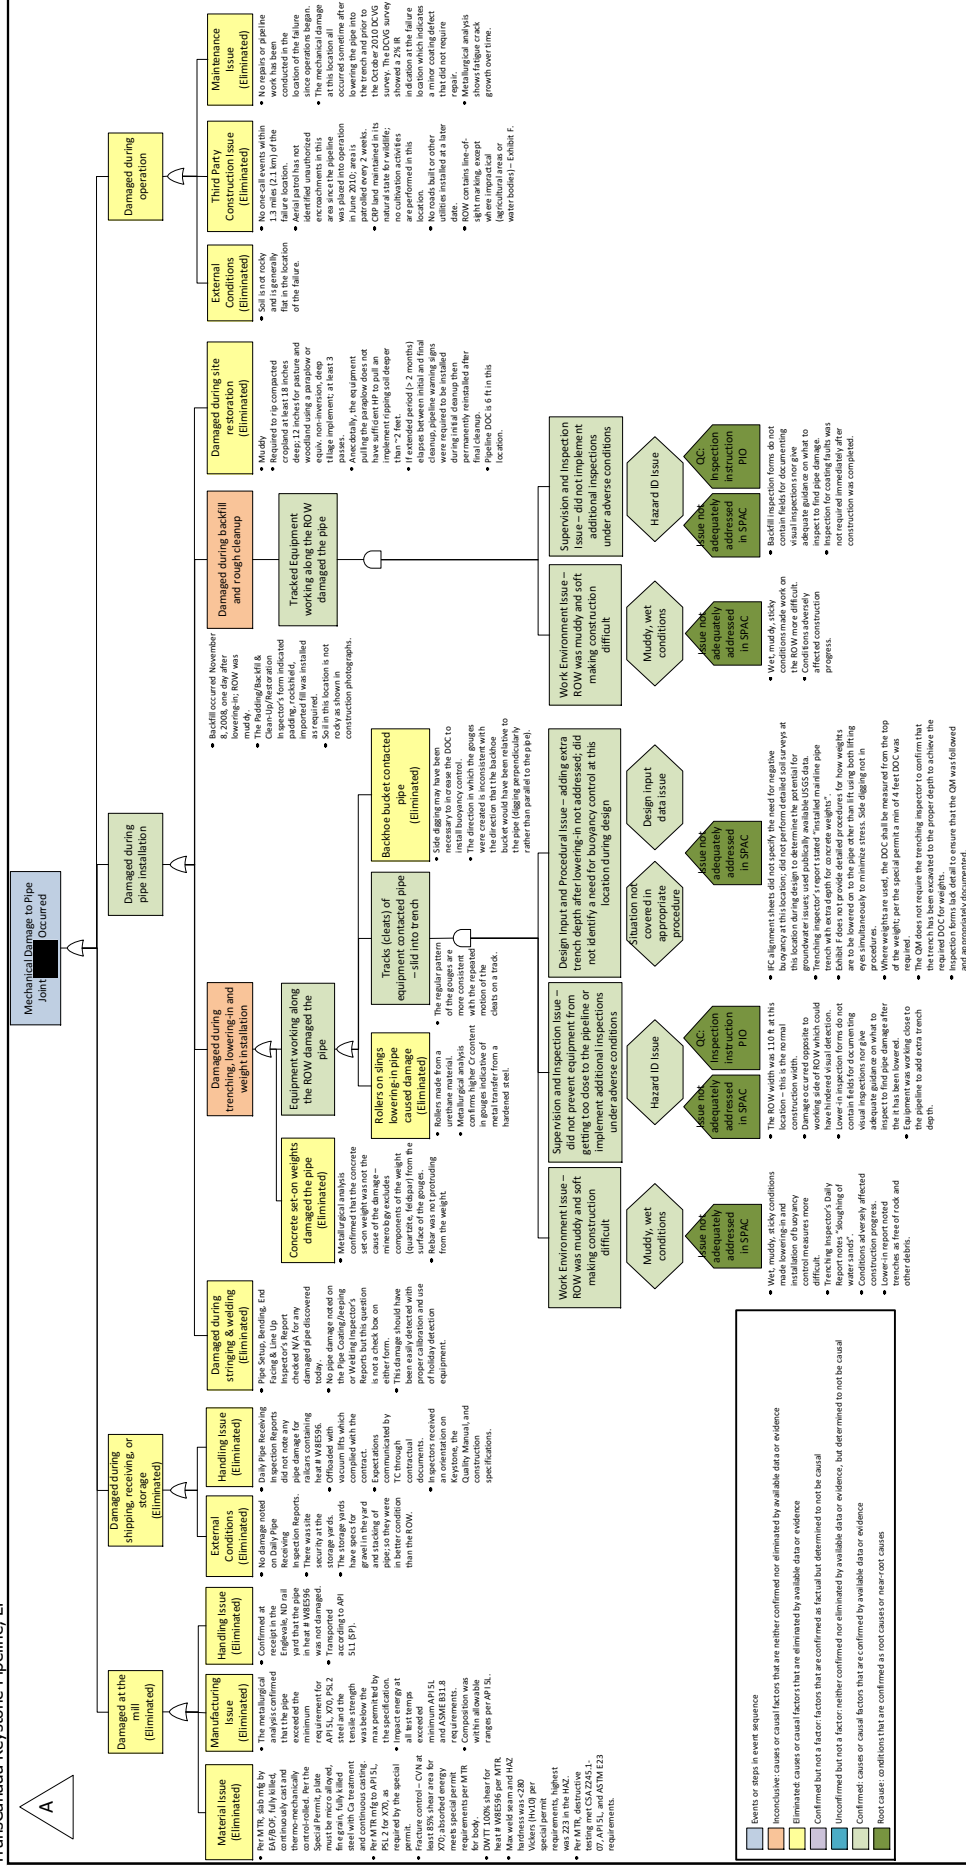
Figure 10. Mechanical Damage to Pipe Joint 857504 Occurred Event Sequence - Cause and Effect Tree

- Mechanical damage occurred at the pipe mill (Eliminated)
- Mechanical damage occurred during pipe shipping, receiving, or storage (Eliminated)
- Mechanical damage occurred during pipe installation (Causal Factor)
- Mechanical damage occurred during operations (Eliminated)

The Cause and Effect Tree for the pipe mechanical damage sequence is shown in Figure 10 followed by an analysis of potential causal factors and root causes.

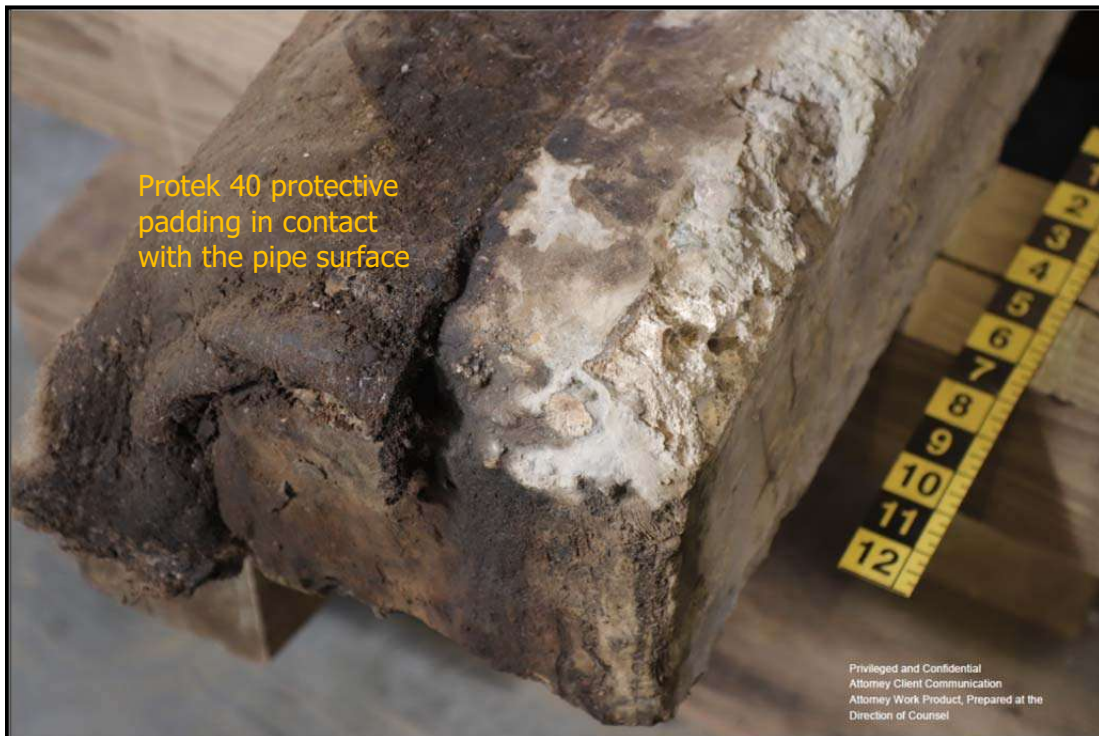
Each set-on, concrete weight was a nominal 9,000 pounds and contained steel reinforcing bars with lifting hooks. The weights were formed in the field around a felt-like 40-oz protective padding and were designed to have a minimum of three inches of concrete covering the rebar to prevent damage to the pipe when the weight was installed (see Figure 14 and Figure 15). Each weight extended 14 inches above the top of pipe, 15 inches laterally on each side, and was 5 feet long.

**Figure 15. Cut Section of Set-On Concrete Weight Showing Protek 40 Protective Padding (left hand side of photo)**

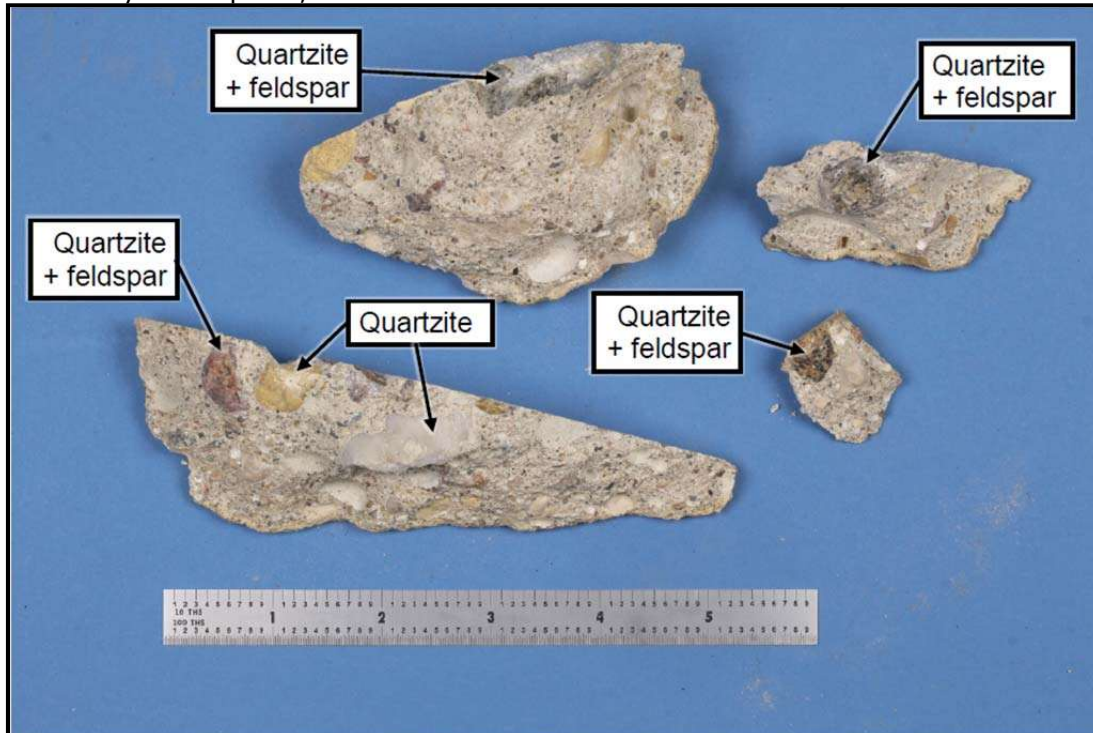
The metallurgical analysis performed by the NTSB examined the minerology of the aggregate comprising the concrete weights which might be hard enough to damage the Grade X70 pipe. They identified quartzite and feldspar with Mohs hardness of 7 and 6, respectively, as the most likely materials to produce gouges in steel (see Figure 16). If these minerals caused the damage found on pipe joint 857504, they would tend to break up in the process leaving pieces of quartzite and feldspar in the sliding contact marks. The NTSB did not find any evidence of these minerals embedded in the sliding contact marks. As discussed in Section 3.6.1.3.2.2, the NTSB found evidence of transferred metal consistent with hardened steels used in construction equipment. Because of the protective padding on the concrete weights, the low probability that the concrete weights were slid horizontally along the pipe, and the lack of concrete residue in the sliding contact marks, accidental contact between the concrete weights and the pipe surface was eliminated as a potential cause for the damage to pipe 857504.

**Figure 16. Concrete Aggregate Material Used to Manufacture Set-On, Concrete Weights Highlighting Locations with Quartzite and Feldspar**

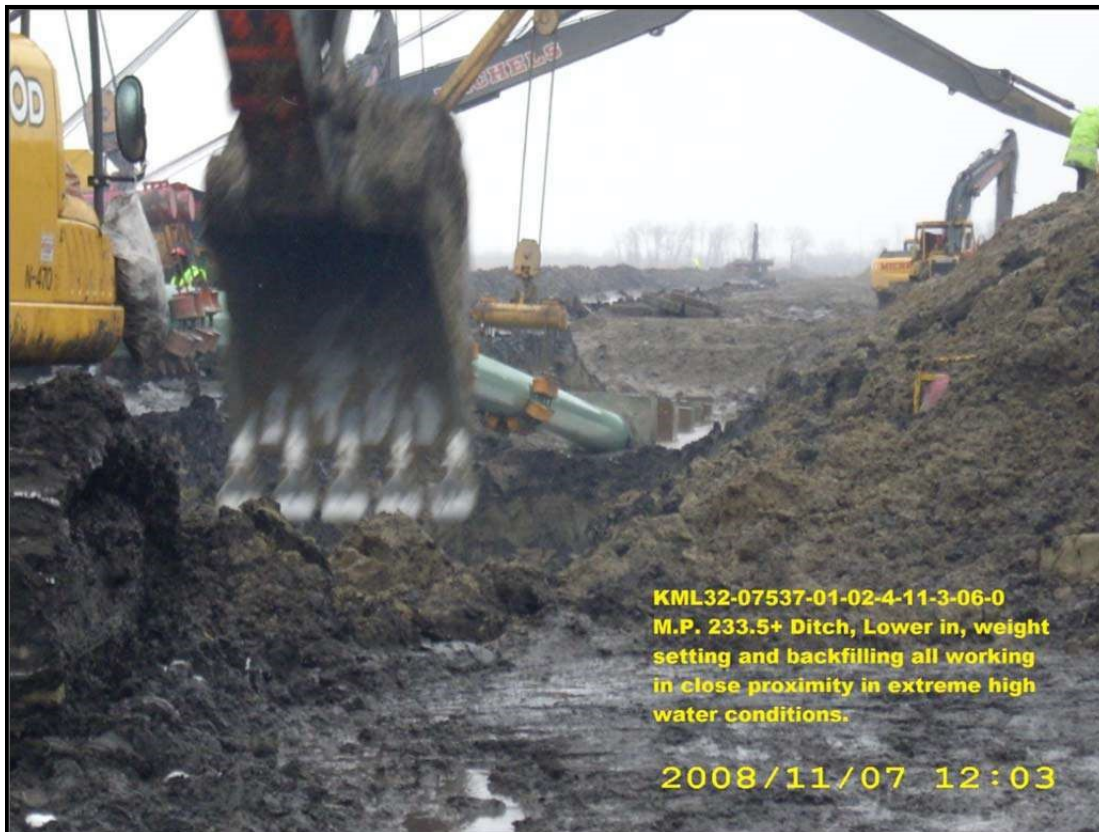
Trenching in the area between 115<sup>th</sup> Street and 116<sup>th</sup> Street occurred on the same day that the pipe was lowered-in, November 7, 2008. The Trenching Inspector's Daily Report<sup>25</sup> indicated that there were abnormal conditions that adversely affected construction progress and sloughing of the trench in water sands. This inspection report also stated that extra depth was required for the installation of the set-on concrete weights used for buoyancy control. The need for buoyancy control and its associated depth of cover should have been documented in a technical variance report but no such documentation was provided to the investigation team. The conditions along the ROW on the day pipe joint 857504 was lowered-in are shown in Figure 17.

**Figure 17. ROW Conditions along Spread 2A on November 7, 2008**

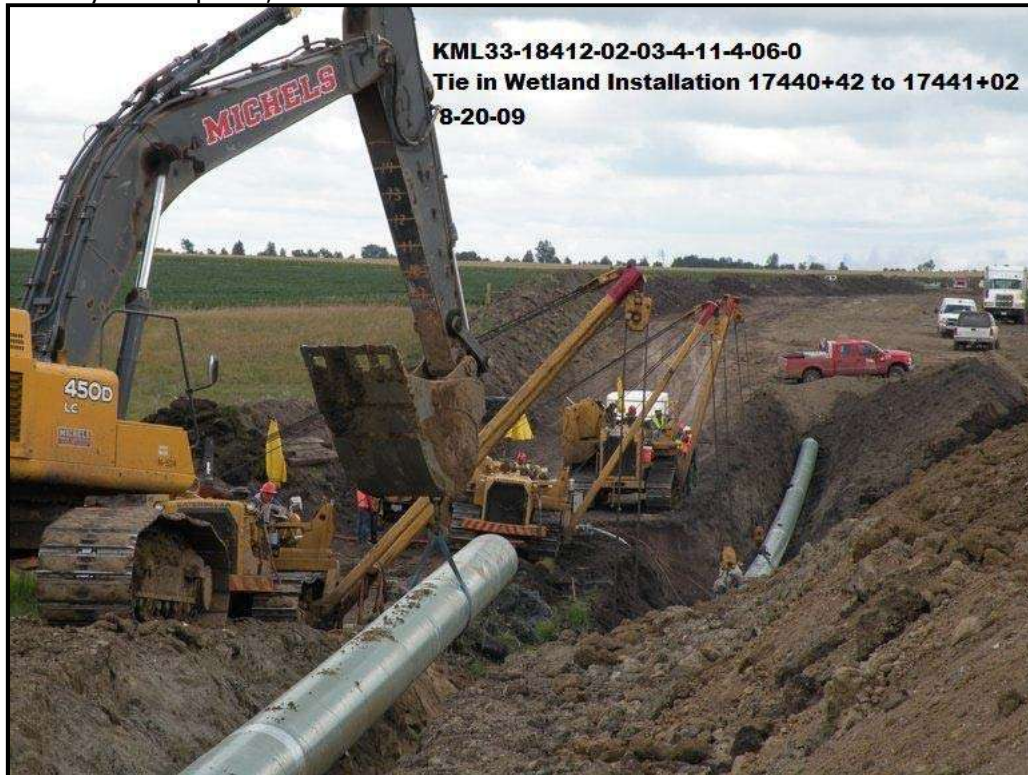
Anecdotal information indicated the possibility that the trench may not have been deep enough to accommodate the set-on concrete weights and still attain the four foot DOC from the top of the weight. Some Daily Construction Progress Reports<sup>28</sup> indicated that side-digging may have occurred to achieve the required DOC after the pipe had been lowered into the trench. In this situation it would have been possible for the bucket from a backhoe to contact the pipe. However, the mechanical damage feature that failed consisted of a regular pattern of long scrapes oriented approximately axially and spaced approximately a ¼-inch apart. This damage signature is not consistent with the damage expected from a backhoe bucket operating perpendicular to the pipeline. Impact from the tooth of the bucket would be expected to show more randomly sized and positioned gouging oriented in the circumferential direction. Moreover, several people involved in the construction of Spread 2A indicated that a bar would be welded across the teeth of a backhoe to minimize damage from a tooth if it did contact the pipe (see Figure 22).

**Figure 22. Photo Showing Backhoe Bucket with Welded Bar**

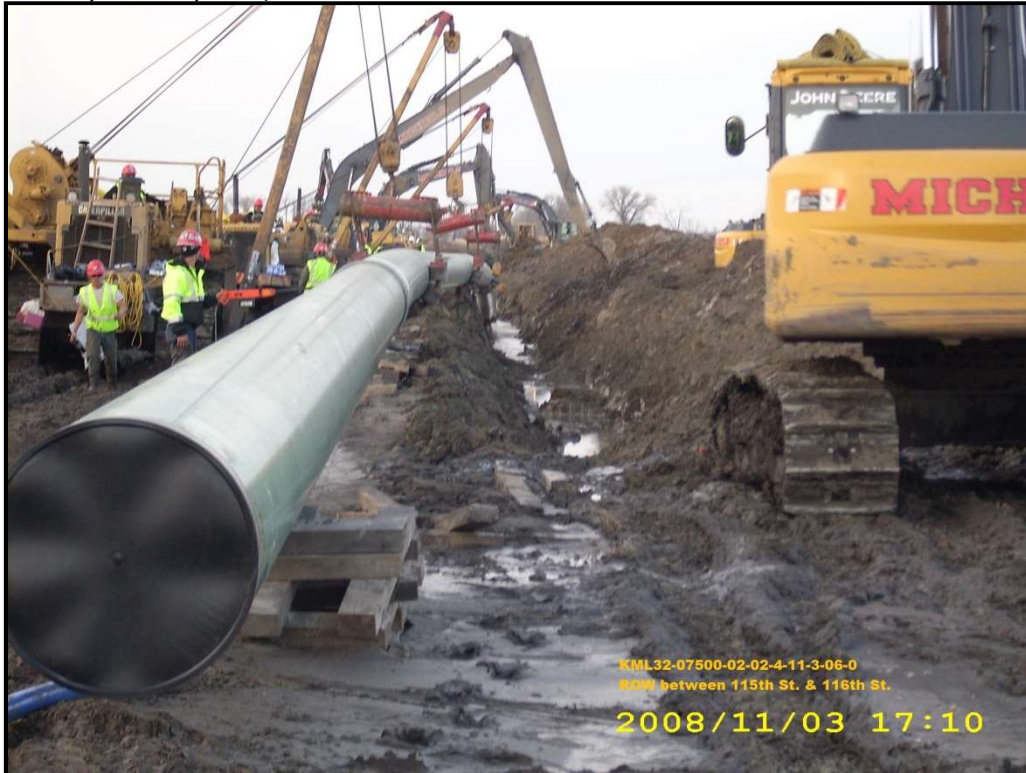
The mechanical damage found on pipe joint 857504 is more consistent with what would be expected from repeated contact with the pipe. Considering the types of machines in use during construction, contact by tracks or cleats of moving tracked equipment, such as a backhoe or sideboom, is the most likely cause of the damage pattern. As already discussed, the ROW conditions were muddy and soft making construction difficult. Construction was performed from the north to the south, with the working side for the sidebooms being on the west. As shown in Figure 23, backhoes used for trenching were working along the east side of the trench which was the side on which the mechanical damage occurred (between the 11:00 and 12:00 clock positions). The trenching equipment appears to have been in relatively close proximity to the pipeline during lowering-in.

**Figure 23. Backhoe Working on the East Side of the Trench on November 3, 2008**

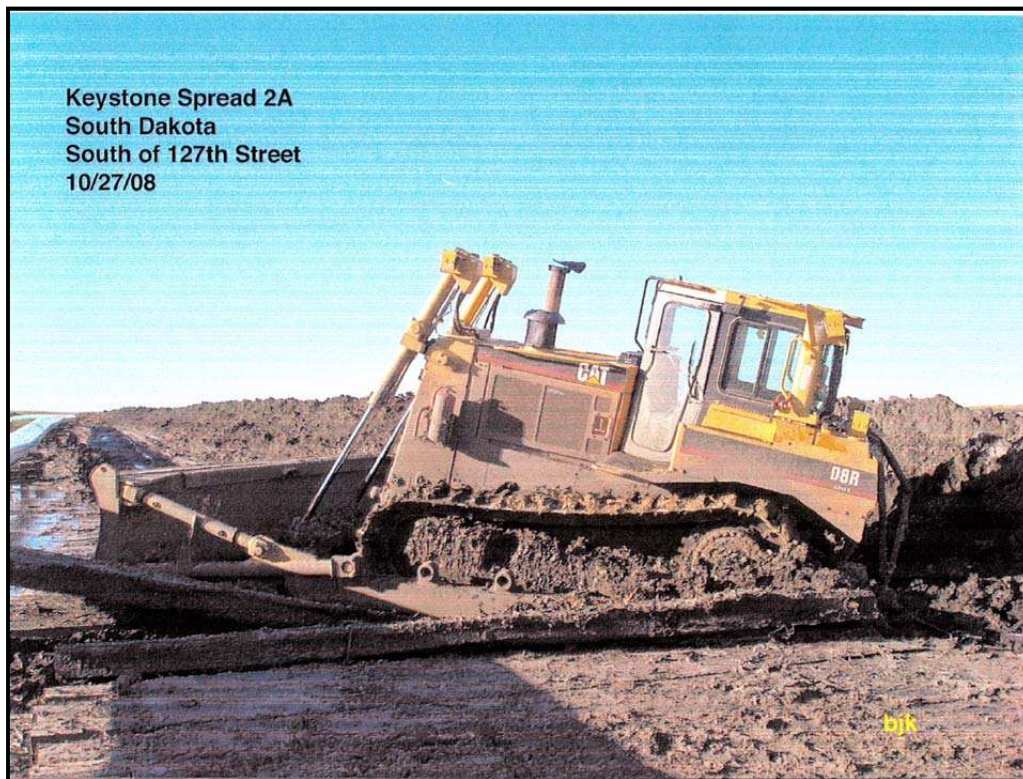
The ROW conditions were such that it was possible for equipment to sink and get stuck in the mud (see Figure 25). Therefore, it is plausible that as a dozer was working to achieve rough grade during backfill that the blade could have been resting on top of the concrete weight and the back of the dozer sunk down enough to contact the pipe with its track between the weights. Because, the DOC in this location was six feet and the damage occurred in close proximity to a concrete weight, this would have had to occur prior to achieving the full DOC. Additionally, because pipe inspections during backfill activities were performed when the pipe was still visible, damage occurring after the pipe was partially covered would not have been detected. It

is company policy that dozers are not permitted to operate over the pipeline during backfilling, so the postulated damage scenario would be contrary to that policy.

**Figure 25. Example of Dozer Stuck in the Mud Along the ROW**

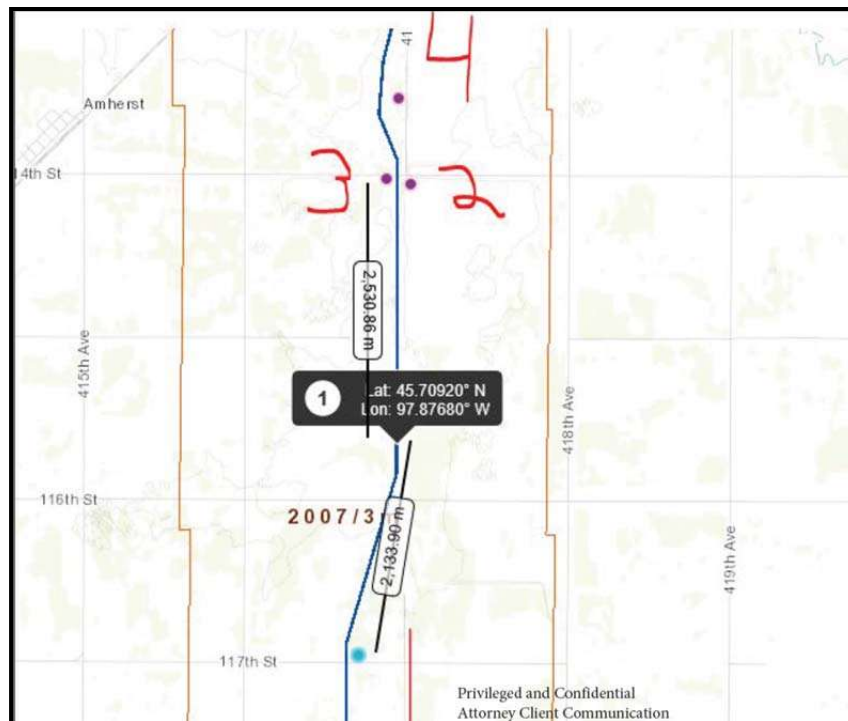
Since initial operation of Keystone Phase 1, there have been no one-call events within 1.3 miles (2.1 km) of the failure location (see Figure 28). In addition, the aerial patrol program was not aware of any unauthorized encroachments in the area of the failure dating back to initial operations. A DCVG survey was conducted in October 2010, only four months after the original in-service date of the Phase 1 Keystone pipeline, and had identified a 2% IR indication directly over the location of the failure. Although this indication was not actionable, it can be interpreted as indicating that the damage had occurred prior to the survey. Because the land is not used for cultivation activities, there have been no one-calls or unauthorized encroachments in the immediate vicinity, and there was indication that damage had already occurred by October 2010, damage to the pipeline during operations was eliminated as a potential causal factor.

**Figure 28. One-Call Notifications Closest to the Failure Location (represented by purple and blue dots)**

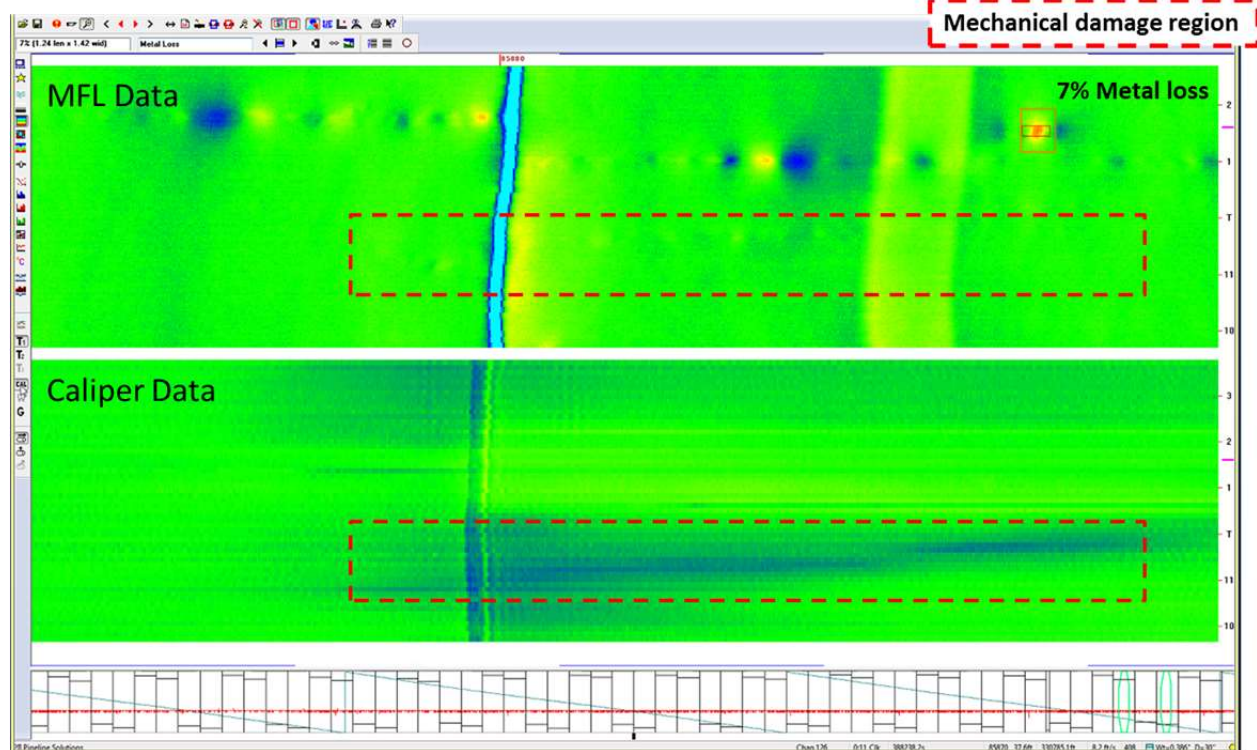
**Figure 32. MFL and Caliper Data at High Sensitivity**

The TransCanada reporting threshold for the caliper tool was 1% of the OD, hence 0.3 inches, while the industry standard is typically 2% (0.6 inches) of the OD. Kiefner reviewed the MFL and caliper data at high sensitivity to see if any low level metal loss or denting below the reporting threshold was detectable. Figure 32 shows an image of the MFL and caliper data at high sensitivity with the region of the mechanical damage illustrated. The MFL image shows that no metal loss signal was detectable even at high sensitivity; note an unrelated 7% metal loss signal was clearly seen at this sensitivity level. The high sensitivity caliper image shows a slight deformation with a depth between 0.2% and 0.4% of the OD in the mechanical damage region. The shape of the deformation in the image corresponds well to the observed sliding contact marks as it starts at the 11:00 position at the girth weld and tracks to the top of the pipe further downstream; the length and width also correspond well. This dent is on the order of the natural variation of the pipe curvature as another 0.2% variation unrelated to mechanical damage can be seen upstream of the girth weld at the 3:00 position. Therefore, it is unlikely that caliper data analysis would have reported this slight dent.

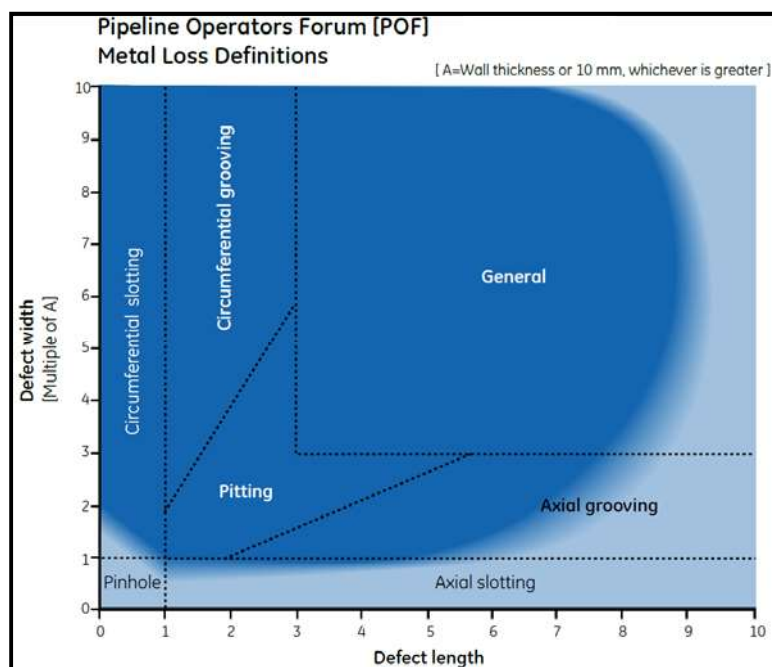
**Figure 33 POF Definitions of Metal Loss Anomaly Classes and Detection Capability for Conventional MFL Tools<sup>61</sup>**

the metallurgical analysis, the mechanical damage feature consisted of multiple, linear sliding contact marks in the axial direction with maximum depth of 12% WT and varied individual lengths up to 13 inches, and varied individual widths up to 0.20 inch. (These dimensions are approximate and may not be fully inclusive of all individual contact marks on the pipe surface.) Metal loss that is long in the axial direction (length) and narrow in the circumferential (width) direction is challenging for axially-oriented MFL tools to detect. Axially-oriented MFL tools do not have the ability to detect an axial crack, which by definition is a long, narrow anomaly. To quantify the applicability of MFL tools for various geometry types, the Pipeline Operators Forum (POF), a group of European pipeline operators, has developed a classification method for metal loss anomalies as illustrated in Figure 33. The definitions of length and width are based on the greater of the wall thickness or 0.4 inch (10 mm) which for the Keystone Pipeline is nominally the same. The darker blue regions illustrate where MFL is most accurate whereas the lighter blue regions illustrate where MFL is more challenged. As indicated by Figure 33, MFL tools have more difficulty detecting anomalies that are less than one wall thickness in width, referred to as axial slotting. Axially-oriented MFL tools also have difficulty detecting anomalies when the length to width aspect ratio is larger than 3 to 1. The dimensions of the anomaly that failed falls into the light blue areas of Figure 33 indicating that detection by axially-oriented MFL would have been challenging.

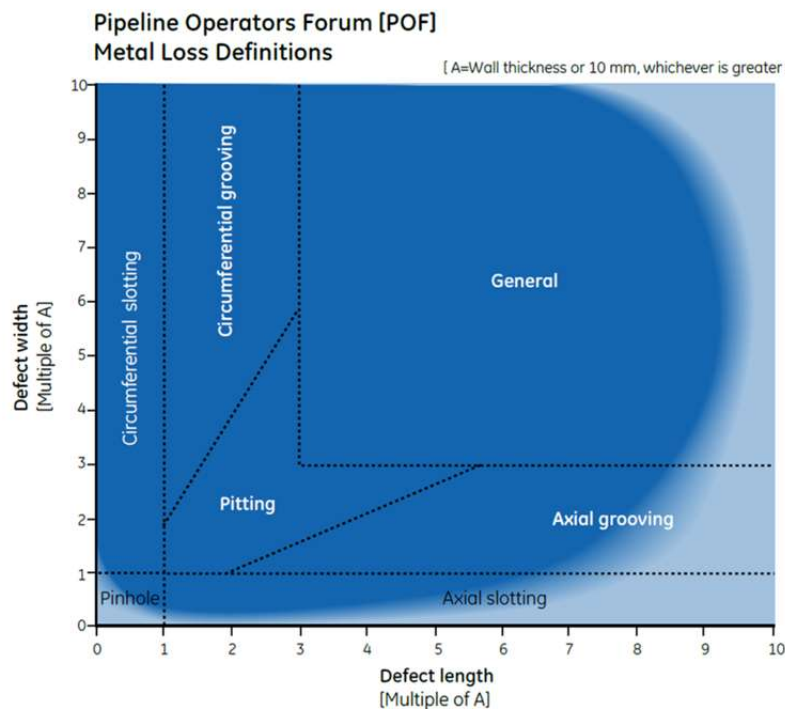
**Figure 34. POF Definitions of Metal Loss Anomaly Classes and Detection Capability for MFL Tools with Triaxial Sensors**

An incremental improvement in detecting some anomalies can be achieved with ILI tools that measure all three components of the magnetic field, referred to by the inspection vendor as triaxial sensors. As shown in Figure 34, this sensor configuration improves detection of axial slotting and grooving. However, the anomaly that failed had dimensions that would fall into the lighter blue regions for either conventional or triaxial MFL sensor configurations and therefore would have been challenging regardless of the MFL technology used.

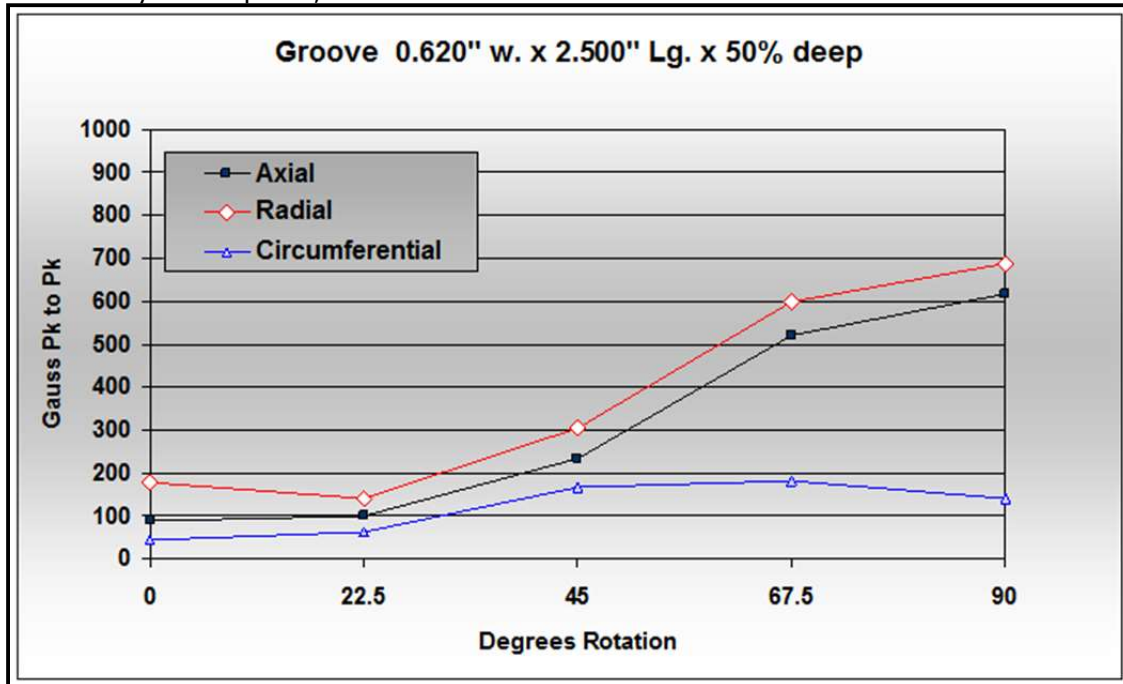
**Figure 36. Flux Leakage Amplitude as a Function of Angle for Long Narrow Metal Loss<sup>62</sup>**

The furrows and ridges were at a slight angle to the pipe axis, about 10 degrees. If the furrows and ridges were circumferentially aligned, perpendicular to the magnetic flux direction, the ridges would carry negligible magnetic flux and the effective metal loss reported would be the wall thickness of the furrows. Figure 36 shows that the flux leakage amplitude for a long, narrow metal loss anomaly does not increase significantly below an angle of 22.5 degrees, doubles at an angle of 45 degrees, and is six times larger when perpendicular to the direction of the magnetic flux. Therefore the slight angle of the sliding contact marks found at Ludden +17 would not have improved its detectability. Figure 36 shows three sensor orientations, the same sensor configuration used on the tools run on Keystone.

Even though multiple ILIs were conducted along Spread 2A, the types of tools used by TransCanada and required by the Special Permit were not capable of finding the mechanical damage or cracking that occurred on pipe joint 857504. If other tools such as circumferential MFL (CMFL) or low-field MFL were run, they may have detected the mechanical damage or the associated cold work. Alternatively, if an ultrasonic crack detection (UTCD) tool were run it likely would have detected the subsequent fatigue cracking. Not recognizing the potential for fatigue crack growth in mechanical damage that does not exhibit appreciable denting and not implementing ILI tools to address this threat was determined to be causal to this incident. There is a PIO for TransCanada to enhance their IMP to baseline newly constructed pipelines with ILI tools capable of detecting flaws that do not exhibit appreciable metal loss or denting. Recognizing this gap, TransCanada chose to run GE's UltraScan CD+ tool subsequent to the failure to find axial cracking damage at other locations along Spread 2A. Additionally, TDW's multi-data set (MDS) tool was run in KS6 (spanning the majority of spread 2A) to determine if additional mechanical damage, that may give rise to cracking in the future, was present.

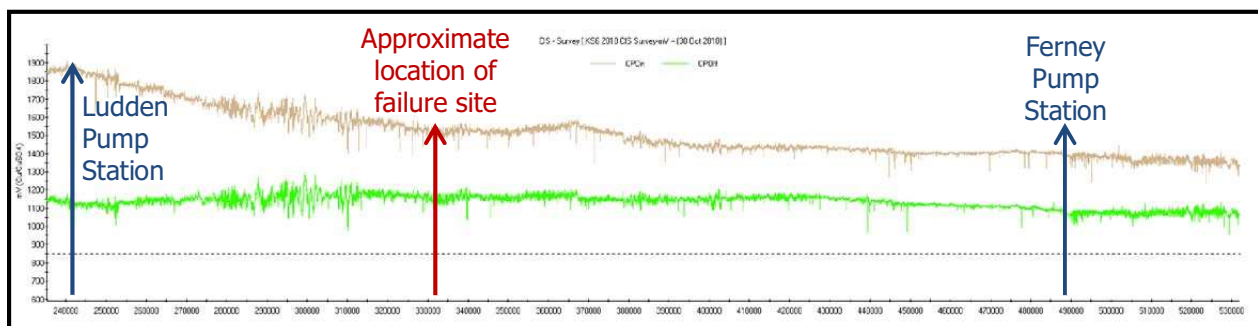
**Figure 38. October 30, 2010 CIS Findings. The location of the failure is at virtual pipeline model distance from start 332,979.7 ft.**

As required by the Special Permit, an initial CIS was conducted October 30, 2010. These results were integrated with the baseline ILI data to determine whether any action was required to mitigate external corrosion along Keystone Phase 1. As shown in Figure 38, the lowest CP OFF potential measured within 500 feet of the release location was -1,114 mV which exceeded the minimum instant-off criterion of -850 mV per NACE SP 0169<sup>64</sup>. At the location of the mechanical damage feature, there were no localized dips in the CIS potential profiles which would have indicated the presence of poor quality coating. The difference between the ON and OFF potential was also fairly constant which would indicate a good distribution of protective current along the pipeline.

As discussed in Section 3.6.2.4, neither the 2012 nor 2016 ILI identified metal loss in excess of 10% WT in depth, or with a FPR less than 1.42 within 500 feet of the release location. Even though the set-on concrete weights can act as a localized area of high resistivity potentially shielding CP, the results of both the CIS and ILI show that corrosion was not a concern at the failure location. This was also confirmed by the metallurgical analysis which did not find any evidence of external corrosion within the mechanical damage area.

The CIS results integrated with the ILIs and metallurgical analysis confirmed that CP was protecting the pipe at the failure location and therefore was eliminated as a causal factor.

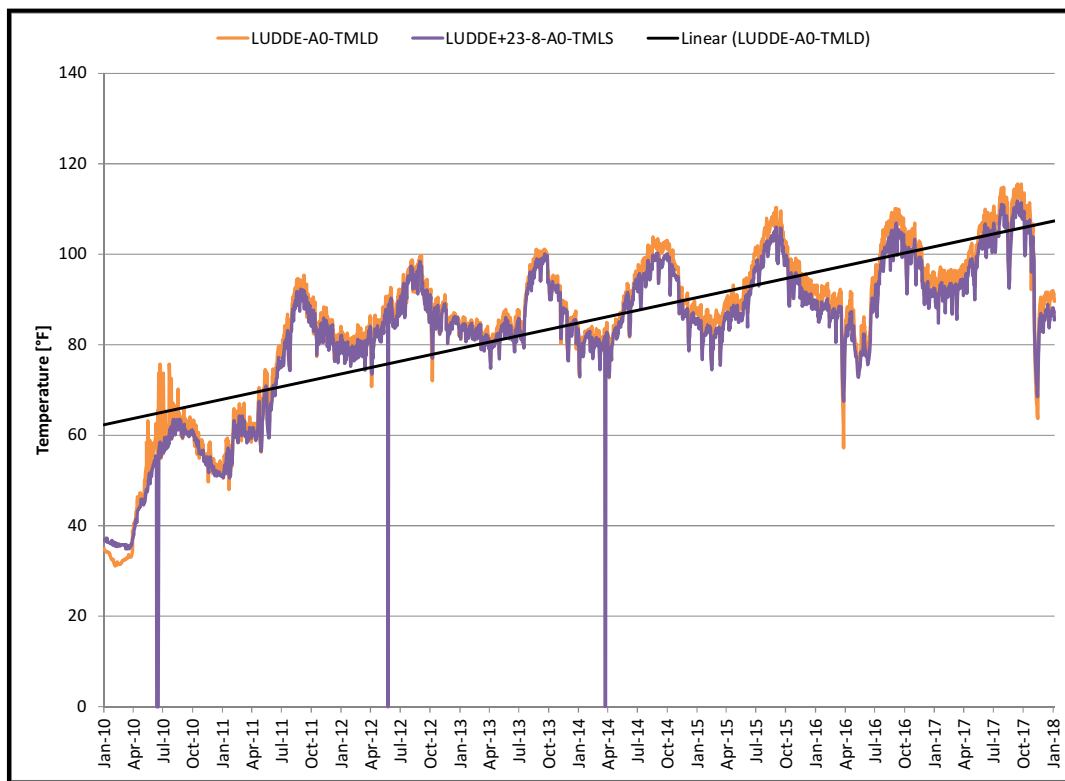
**Figure 46. Temperature Data for the Ludden to Ludden +23-8 Mainline Valve Segment (2010 to 2018)**

Keystone Phase 1 is restricted to a maximum operating temperature of 150°F by the Special Permit. As shown in Figure 46, the operating temperatures have been maintained below this requirement for the operational life of the pipeline. The temperature varies seasonally and has demonstrated an increasing trend over time which can be tied to the increases in operating pressures and flowrates. ASME B31.4<sup>65</sup> and other pipeline design codes and standards require no derating of line pipe strength at 150°F.

room temperature,<sup>66</sup> possibly due to dynamic strain-aging effects. Thus operating temperatures are not considered to be a contributing factor.

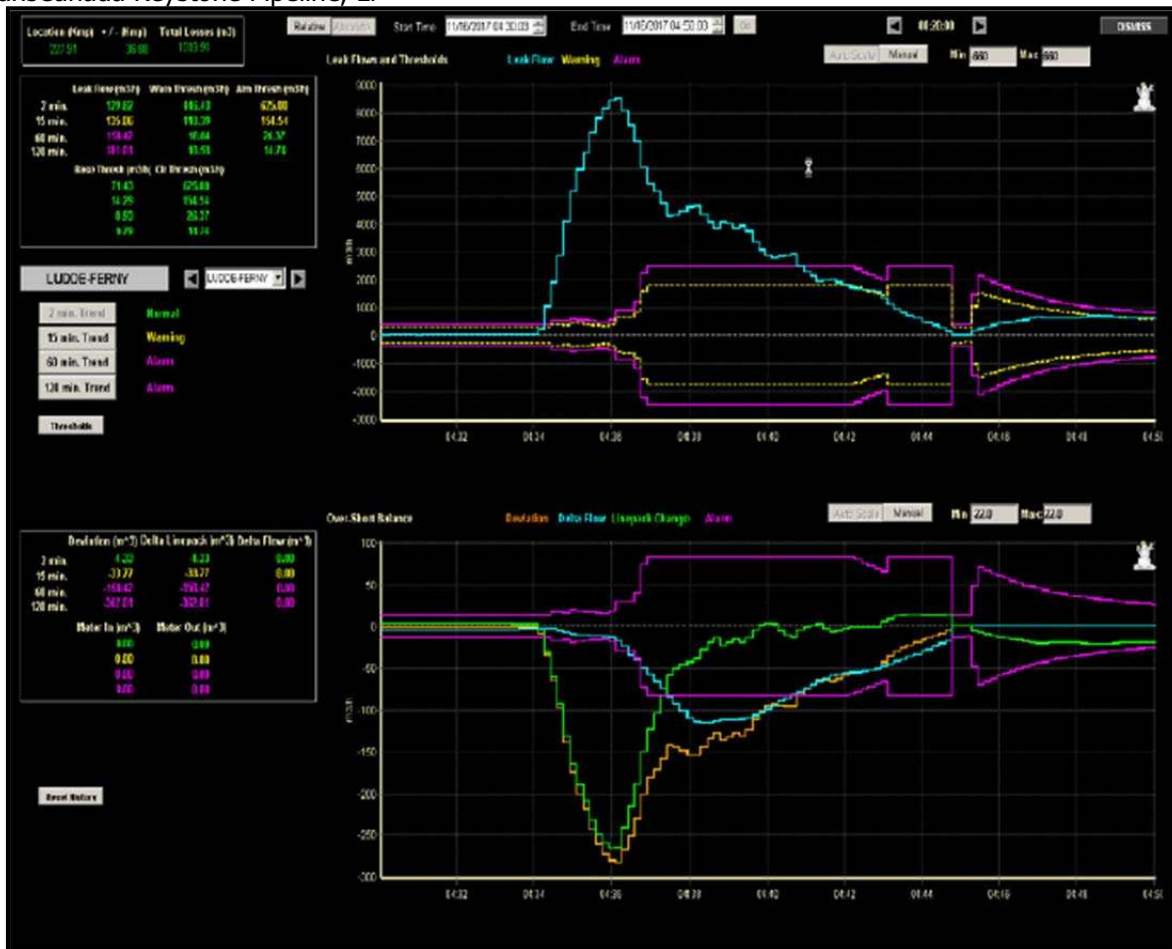
**Figure 48. Ludden Pump Station to Ferney Pump Station Simulation Suite Alarm Indications**

TransCanada's LDS is state-of-the-art and has been proven to exceed industry standards for detection sensitivity by a factor of two or more (1% of throughput compared with 2% for industry norms). At 5:34 AM central time, the Keystone LDS identified an immediate loss of line pack and flow<sup>67</sup>. The leak flowrate in the affected segment reached a maximum of [REDACTED] m<sup>3</sup>/hr which exceeded the [REDACTED] m<sup>3</sup>/hr threshold over a two minute averaging window (see Figure 48).

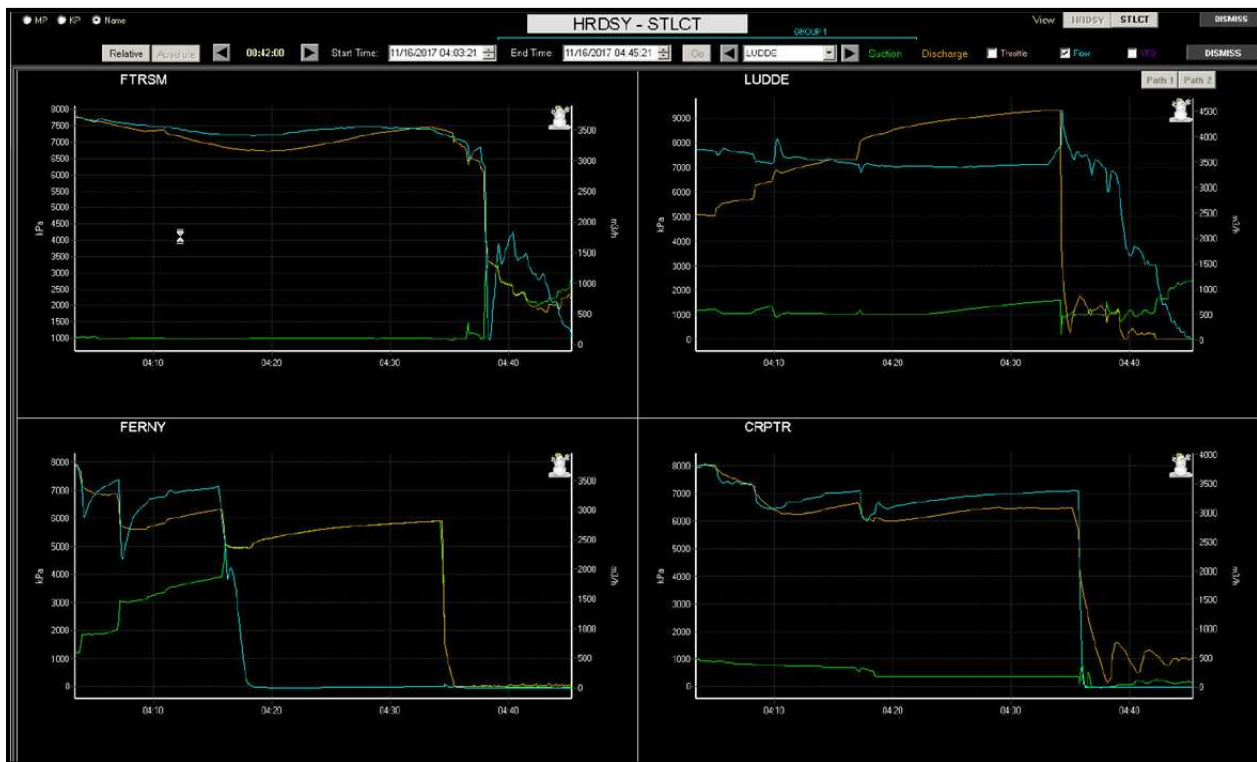
**Figure 50. SCADA Screenshots at the Fort Ransom, Ludden, Ferney, and Carpenter Pump Stations at the Time of the Incident (time scale is Mountain Time zone)**

On November 16, 2017, at 5:33 AM central time, the Keystone SCADA system detected a pressure drop at LUDDE+23-8. One minute later the SCADA system detected a pressure drop and increase in flow at the Ludden Pump Station and a pressure drop at Ferney Pump Station (see Figure 50). The Ferney Pump Station had been placed into by-pass mode at 5:24 AM central time, nine minutes before the rupture occurred. Corresponding drops in pressure and flow were seen at the upstream pump station (Fort Ransom) and the downstream pump station (Carpenter) approximately two minutes later.

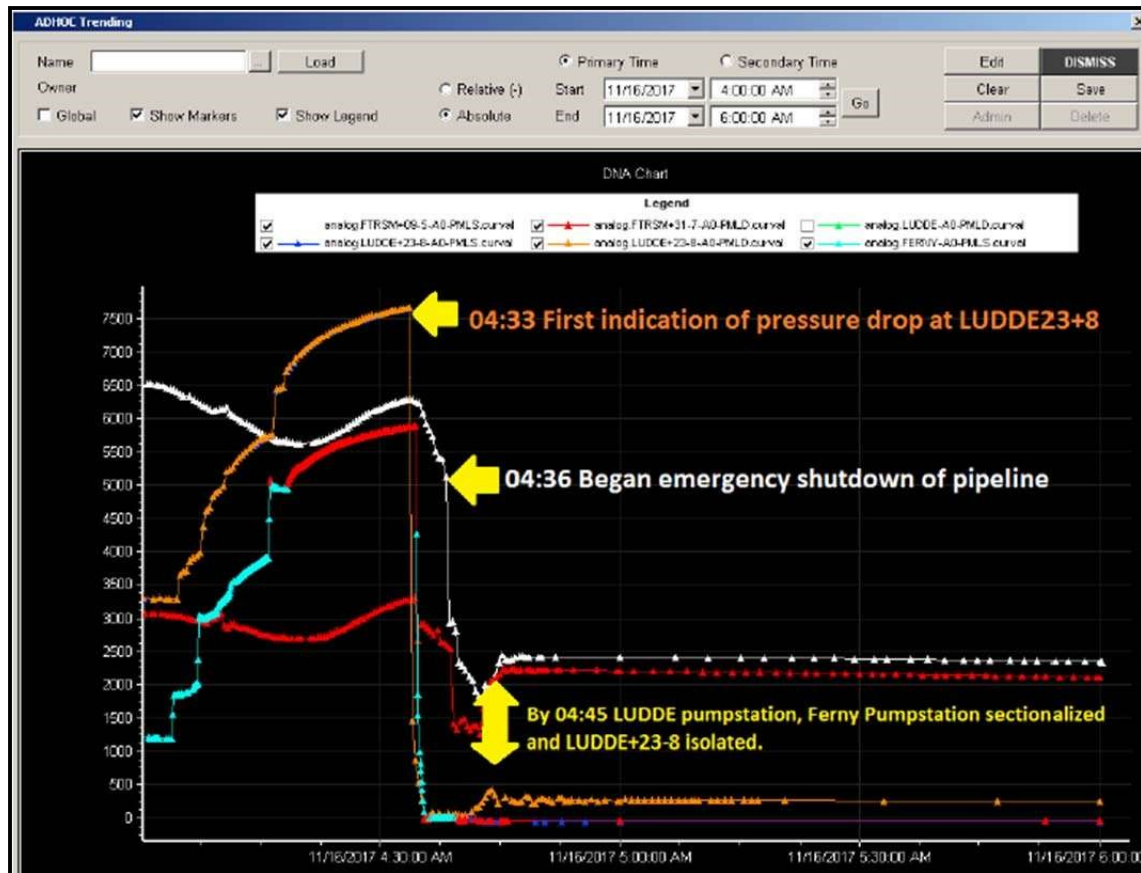
**Figure 51. Pressure Trends in the Ludden to Ferney Segment (time scale is Mountain Time zone)**

were sectionalized and at 5:45 AM mainline valves LUDDE+23-8, FERNY+14-3, and CRPTR+15-7 were closed. By 5:49 AM Fort Ransom was sectionalized and FTRSM+9-5, FERNY+30-8, and FTRSM+31-7 mainline valves were closed (see Figure 51).

The SCADA timeline and actions taken by the control center prior to and during this event were reviewed. This review showed that all control center actions were in line with best practices and TransCanada's procedures<sup>69</sup>. No delays in responses were found whether from initial notification to shutdown; shutdown to isolation; isolation to notification of field technicians; or in initiation of the Emergency Operations Center (EOC) through the Emergency Operations Manager. Even though the event occurred toward the end of the night shift, when fatigue would have been at its highest, the control room performance exceeded expectations. For these reasons the control room response was eliminated as a causal factor to the release volume.
