RCFA for the Keystone Milepost 14 Release

Stephanie Flamberg, Bill Amend, Peter Martin, Michael Rosenfeld, Adam Steiner, and Benjamin Zand

April 21, 2023

Final Report

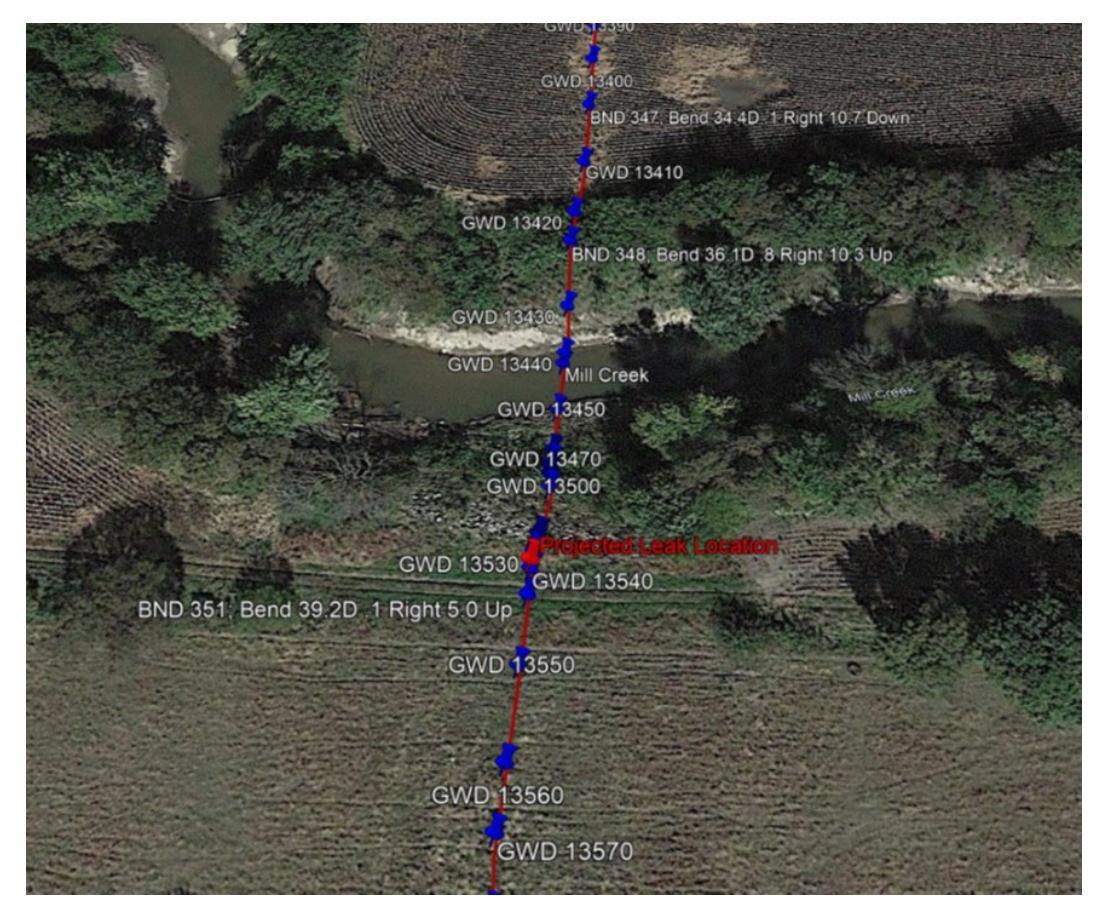
Figure 3. Overview of Release Area Showing the Location of GWD 13530

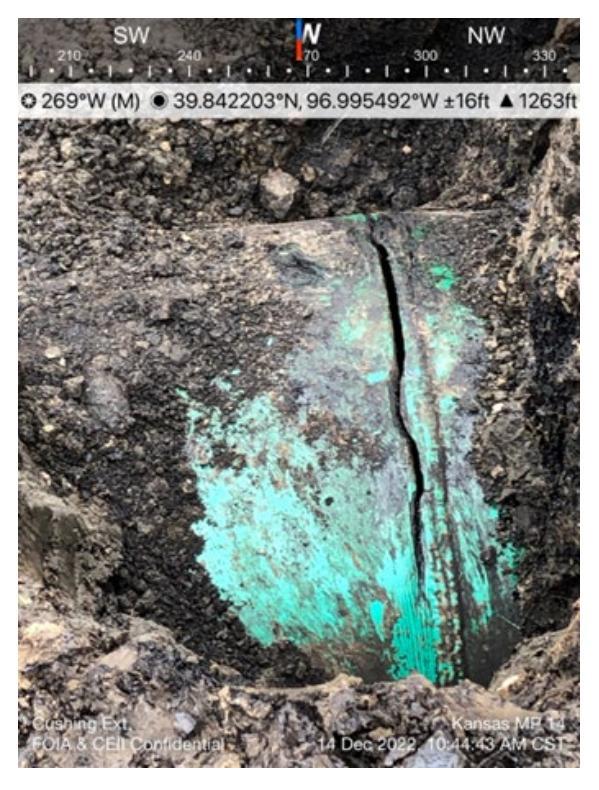
On December 13, 2022, the failure feature was first exposed. As shown schematically in Figure 5, the failure feature was confirmed to be a large crack in the girth weld (see Figure 6) connecting a 3D, 30° overbend to an approximately 8.5-foot-long pup (downstream) within a fabricated bend assembly (TAG 98). Upon further excavation, a wrinkle was also found just upstream of the overbend as shown in Figure 7. Between December 17 and 18, 2022, the bend assembly containing the failure feature and wrinkle was cut-out, removed, and prepared for shipment to Anderson & Associates (Anderson) of Houston, Texas for metallurgical evaluation to determine the direct cause of the rupture (see Figure 8 and Figure 9). The remaining pipe ends were prepared for welding of a new bend assembly as preparations for restarting the pipeline and cleanup operations continued. Restart of the pipeline began on December 29, 2022, under a temporary 20% pressure reduction in the actual operating pressure immediately prior to the failure on December 7, 2022 along the entire length of the affected segment.

Figure 6. Excavated Failure Feature Showing Girth Weld Crack – December 14, 2022

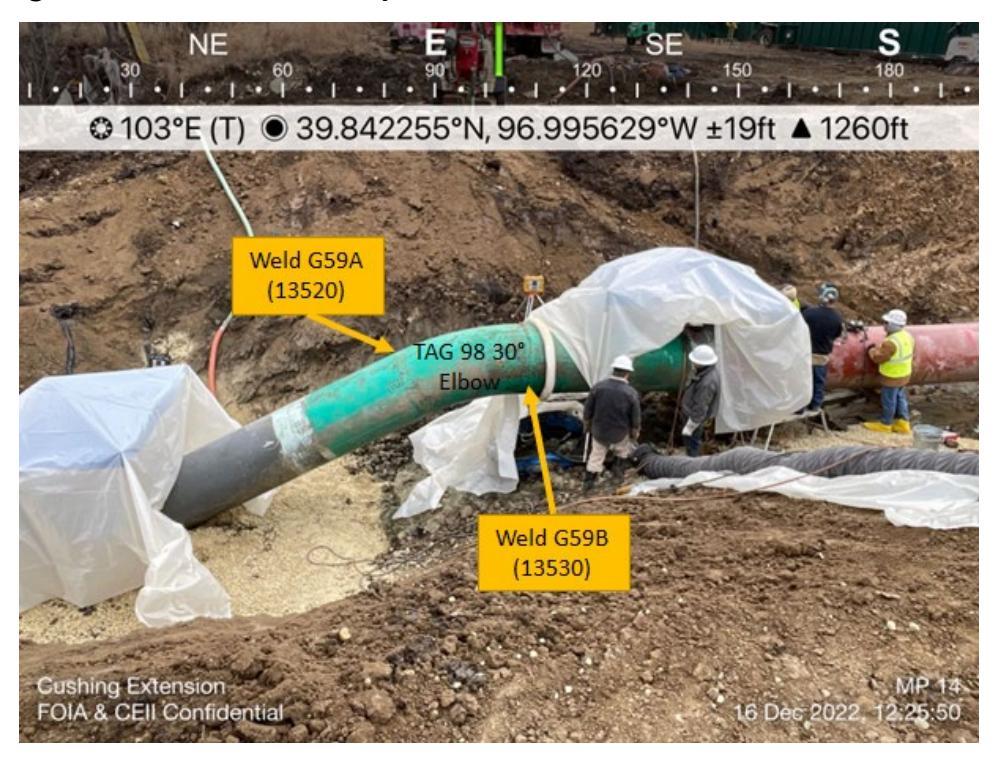
Figure 8. Excavated Bend Assembly – December 16, 2022

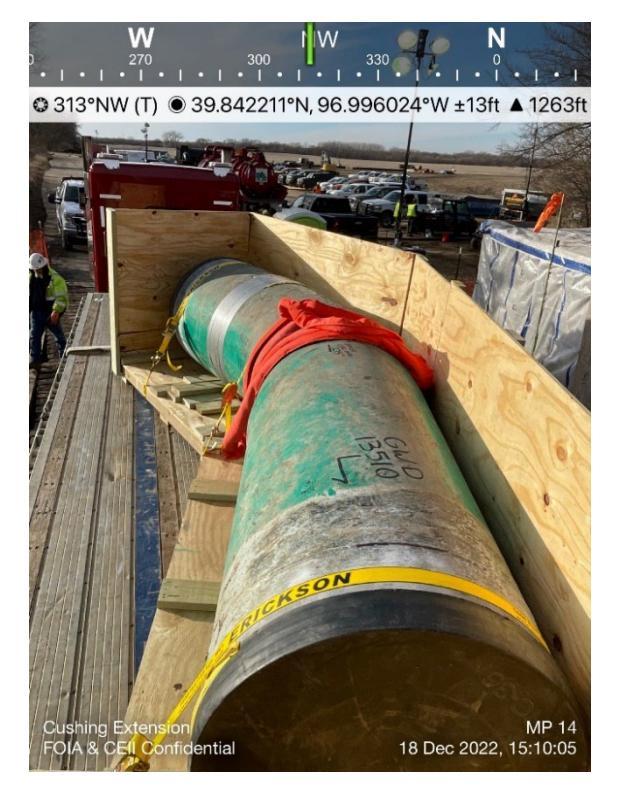
Figure 9. Pipe Segment Sent to Anderson for Metallurgical Evaluation (December 18, 2022)

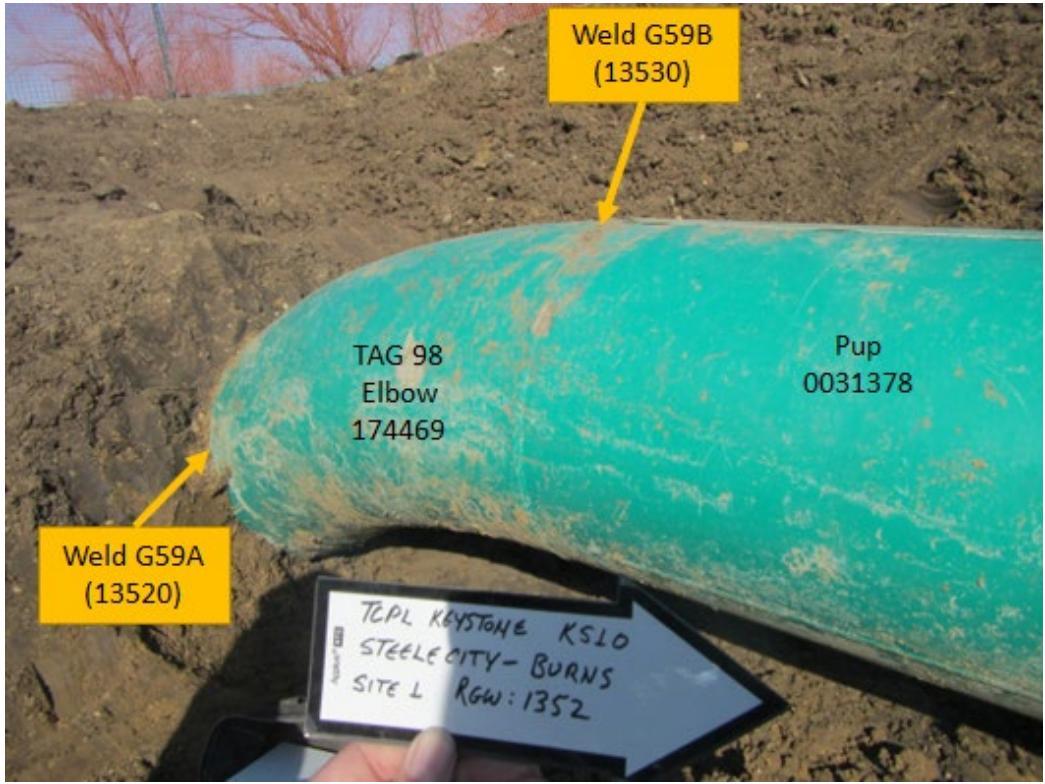
The 2012 BHI Profile ILI caliper tool identified a ID restriction (due to ovality) near the girth weld²⁷ that failed. According to the Pipe Integrity team, excavations for ovalities are only required if there are concerns that ILI tool passage could be impeded, which was the case for this ID restriction²⁸. An excavation was performed in March 2013 to evaluate the restriction (see Figure 11). The ovality was measured using calipers and ultrasonic wall thickness measurements were taken. The ovality was measured in the ditch at of the OD²⁹ as shown in Figure 12. The ovality³⁰ was determined not to be an integrity concern at the time as it pertained to future ILI runs and the bend assembly was backfilled without any further interventions.31

Figure 11. TAG 98 Bend Assembly (BND 350) During March 2013 Excavation to Investigate ILI-Called ID Restriction (March 1, 2013)

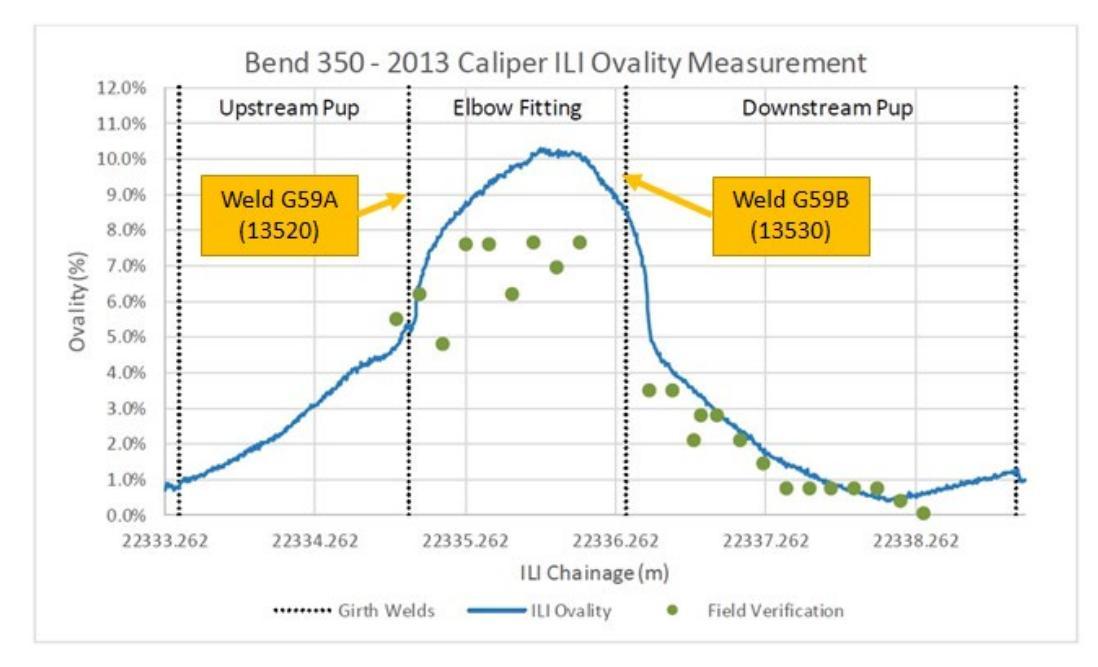
Figure 12. TAG 98 Bend Assembly (BND 350) ILI-Called Ovality and Actual Measurements³²

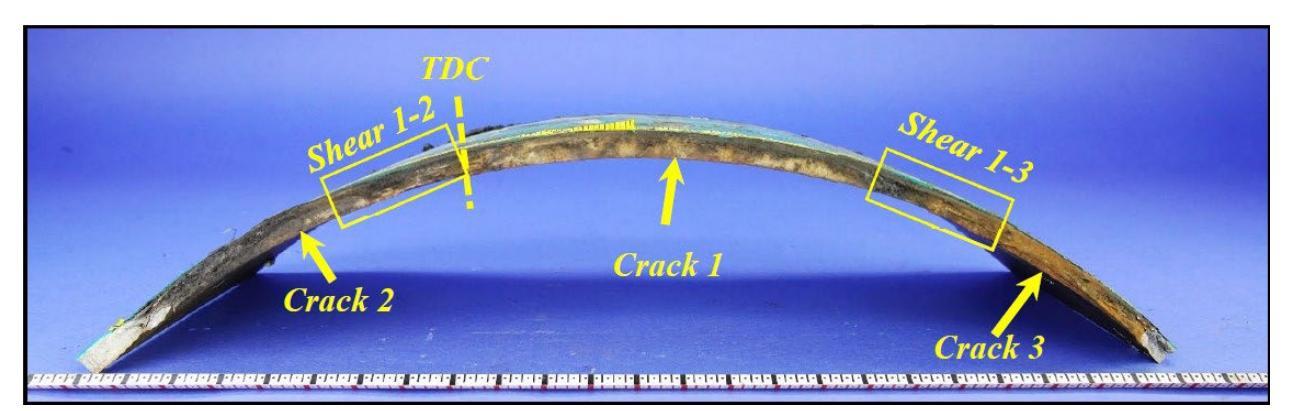
Figure 14 shows the exposed fracture surface on the pup side (downstream) of the failed girth weld (GWD 13530). Note the three distinct elliptical crack features. The top dead center (TDC) of the pipe is marked with the dashed yellow line.

Figure 14. View of Downstream (Pup Side) of the Exposed Fracture.

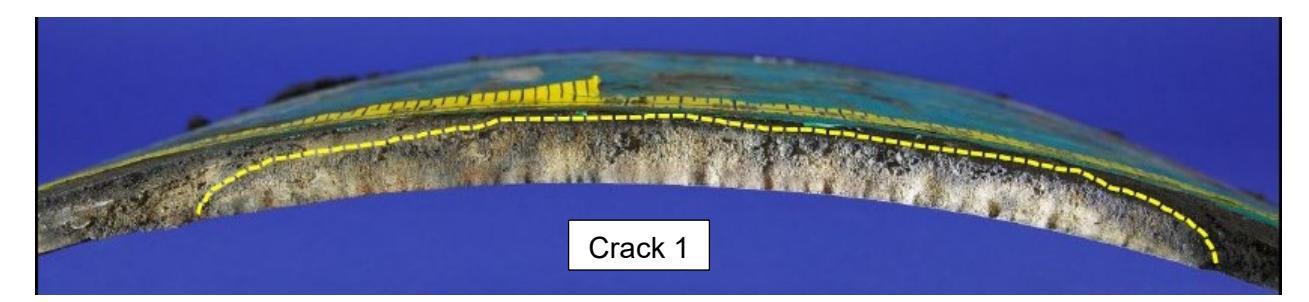
Figure 15, Figure 16, and Figure 17 show magnified views of the three elliptical crack features that were identified originating from the ID toe of girth weld GWD 13530 (G59B) on the thin wall side of the weld (pup side). The initiating features were coincident with LOF regions at the ID toe with a maximum depth of 0.008-inch (200 μ m) and circumferential lengths presumed to extend the full length of each crack feature. LOF defects and fatigue crack extension were observed on both GWD 13530 and GWD 13520. The flat region of each crack front(s) over time, characteristic of a progressive or fatigue cracking mechanism from the ID surface. As shown in Table 1, the maximum depth of Crack 1 was measured as 0.50-inch (97.1% of the NWT). The total length of the flat, thumbnail feature was approximately 8.7-inches. The wall thickness at the location of the failure was approximately 0.540-inch.

Crack	Depth [in]	Depth % of NWT	Length [in]	Location (deepest part of feature from TDC)
Crack 1	0.50	97.1%	8.70	14.3°
Crack 2	0.38	73.8%	4.25	346.5°
Crack 3	0.18	34.9%	4.00	41.4°

Figure 15. Magnified View of Crack 1 in GWD 13530 (G59B)

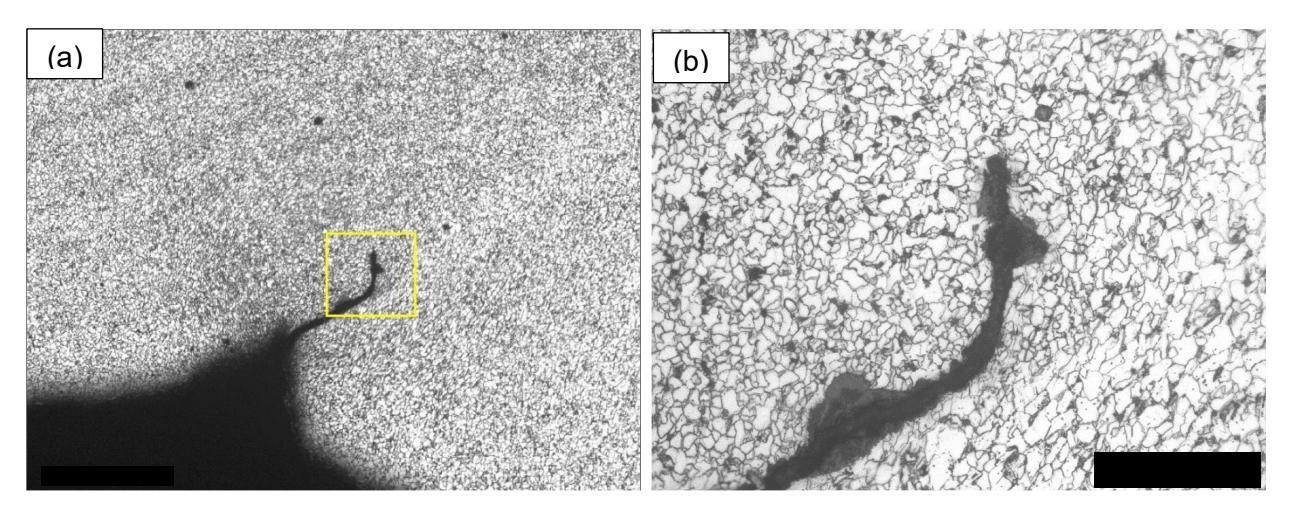
Figure 26 presents a metallographic section of an intact portion of GWD 13530 (G59B) at 139° from TDC which was coincident with a PAUT indicated feature. As shown in Figure 27(a), there was an indication consistent with a LOF defect identified at the toe of the girth weld on the pup side of GWD 13530. Figure 27(b), shows a magnified view at the upward curvature of the defect at the terminal end which may be due to the onset of fatigue cracking. The higher magnification micrograph shows dense, tightly adhered oxide scale lining the surfaces of the LOF which is consistent with formation at the time of welding. Similar LOF defects (which also showed evidence of fatigue) and repairs of the ID weld root pass were also noted in GWD 13520, which did not fail.

Figure 27. Optical Micrographs Showing a Scale-Filled, ~200 μm long LOF at the Pipe Side Weld Toe of GWD 13530 (a) 100x and (b) 500x

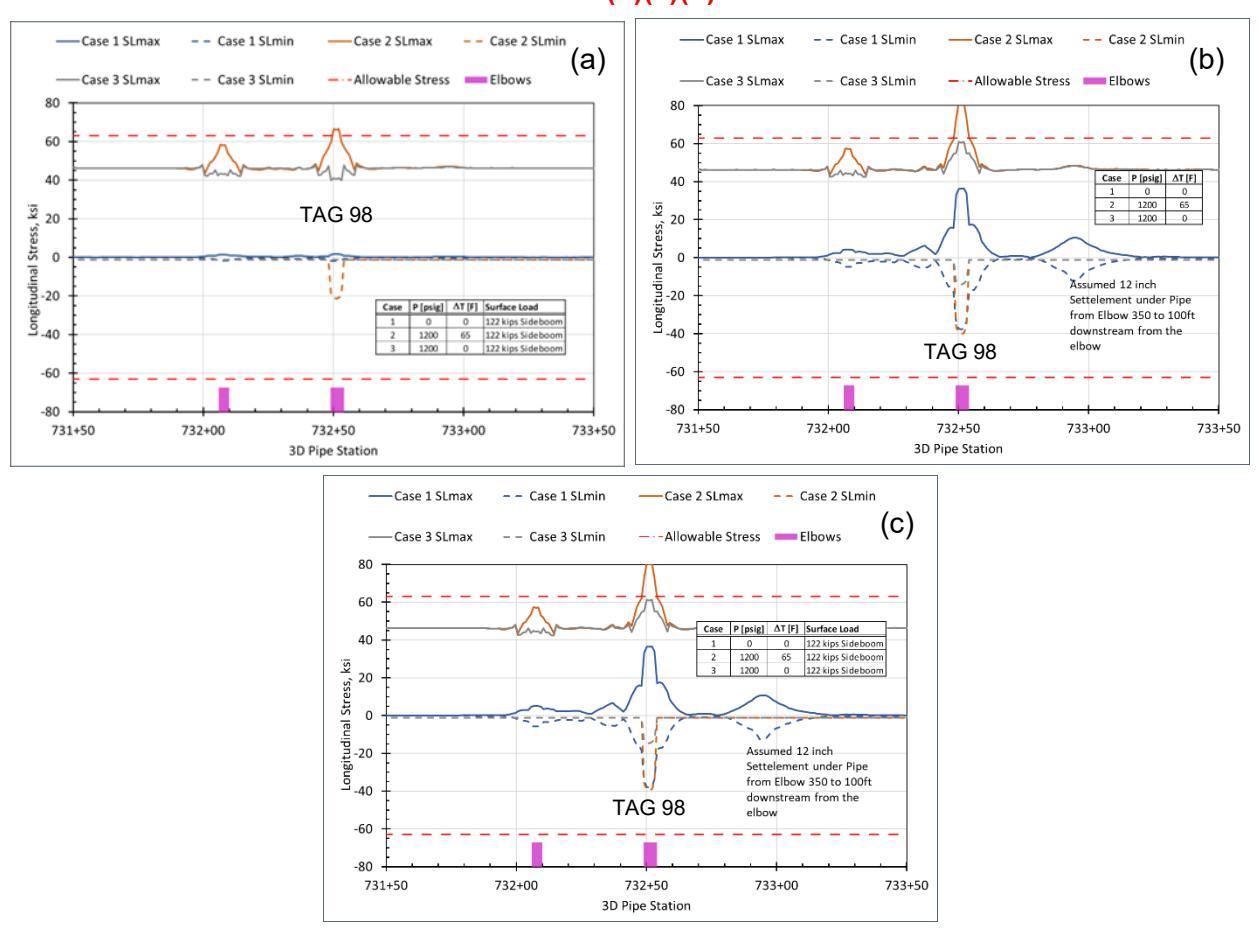
Three sets of analyses were performed to examine the effects of the side boom and settlement loads, namely (1) side boom surface loading with no settlement, (2) settlement with no side boom surface loading, and (3) settlement and side boom surface loading. Table 5 shows the three loading combinations that were analyzed for each analysis. The longitudinal stress results of the post-construction outside force FEA analyses are shown in Figure 31. The results show that surface loading from a side boom alone would not induce high enough stress levels to plastically deform the elbow. In contrast, post-construction soil settlement could have produced enough bending and axial stresses to cause yielding⁵⁰ in the elbow assembly.

The post-construction settlement or gap under the pipeline can explain the out-of-roundness of the elbow. However, this scenario does not explain the wrinkle as the amount of compressive stress at the elbow is not excessive. For ground settlement to cause a wrinkle, the amount of movement should be around 24-inches or more. It is also possible that the wrinkle was formed later due to thermal cycles or ground movement, but that would require two independent coincidences both affecting the same location of the pipeline at different times, which although is possible it decreases the overall likelihood of the scenario. In addition, the bending strain analysis from the IMU data and assessments by Geotech SMEs did not find evidence of ground movement near the TAG 98 elbow.

Figure 31. FEA Longitudinal Stresses with Elbow Elements and Lower-Bound Soil Properties (a) Side Boom Load Only, (b) Settlement Load Only, and (c) Side Boom and Settlement Loads

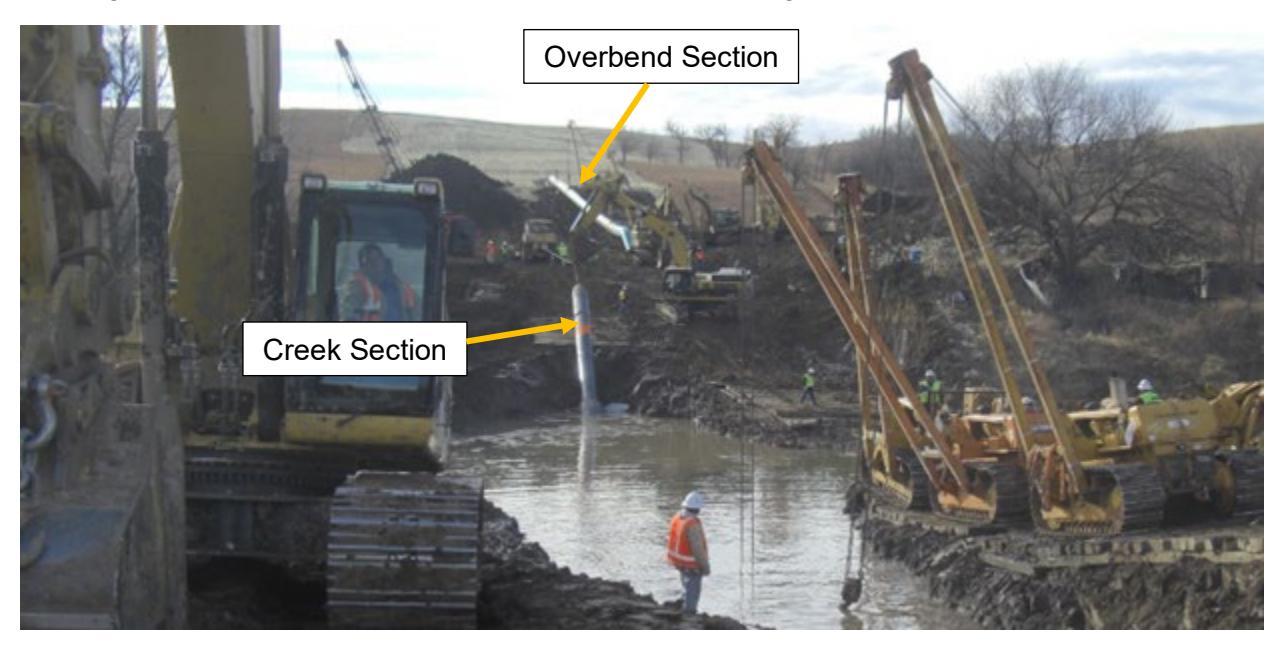
A review of photographs during the December 2010 replacement shows that two side booms were used to hold the overbend section above the ground over the south-slope (see Figure 32).

The creek portion was buried but the downstream overbend section was most likely exposed during the hydrostatic test and free to move because the final tie-in weld had not yet been made. A note in the daily inspection report from December 11, 2010, suggests that the side booms may have been demobilized prior to the hydrostatic test, however, these records are unclear as to how the pipeline was placed in the ditch and supported during the hydrostatic test. Discussions with the Field Engineer onsite during the hydrostatic test indicated that the side booms would have been removed and the pipe supported with cribbing or soil supports. The potential for inadequate support during the hydrostatic test or fit-up creating a cantilever beambending effect was studied to estimate the potential bending stresses.

Figure 32. Use of Sidebooms During Replacement of TAG 98 (December 10, 2010)

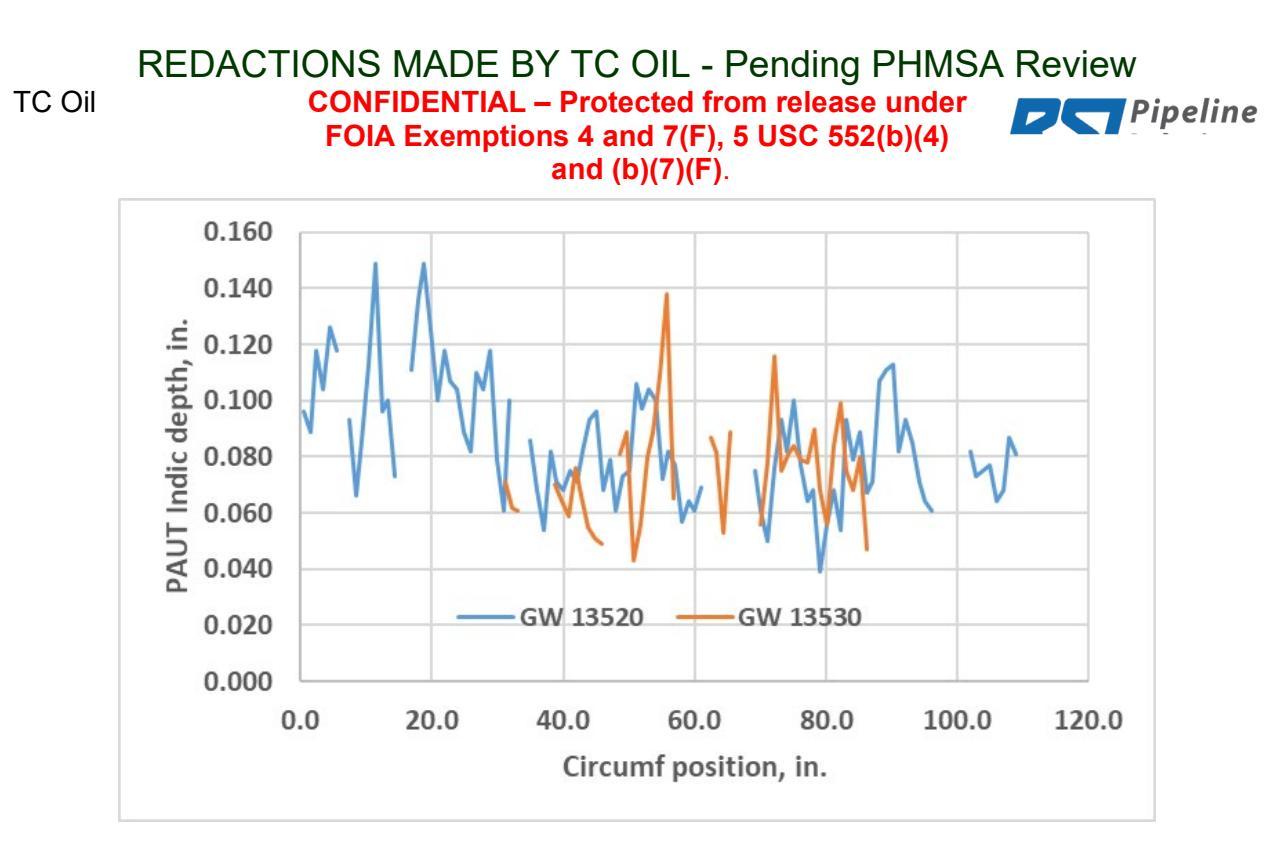
RSI also examined the indicated flaw depth data from the PAUT NDE performed at Anderson (see Figure 38 for GWD 13530 and GWD 13520). The magnitudes and pattern of indications are similar for both welds. Since the indications appear on the intrados of both welds, they are unlikely to represent initial tearing or overload from loads applied when TAG 98 was installed. They are also unlikely to have been caused by thermal fatigue because the intrados would have been in compression under these loads. The left-hand side of the x-axis represents the TDC of the pipe and the scan direction is clockwise. The flaw depth measurements tend to decrease at the intrados and increase at the extrados which may be evidence of some influence of bending from the installation or thermal loads.

Figure 38. PAUT Indicated Flaw Depths for GWD 13520 and GWD 13530

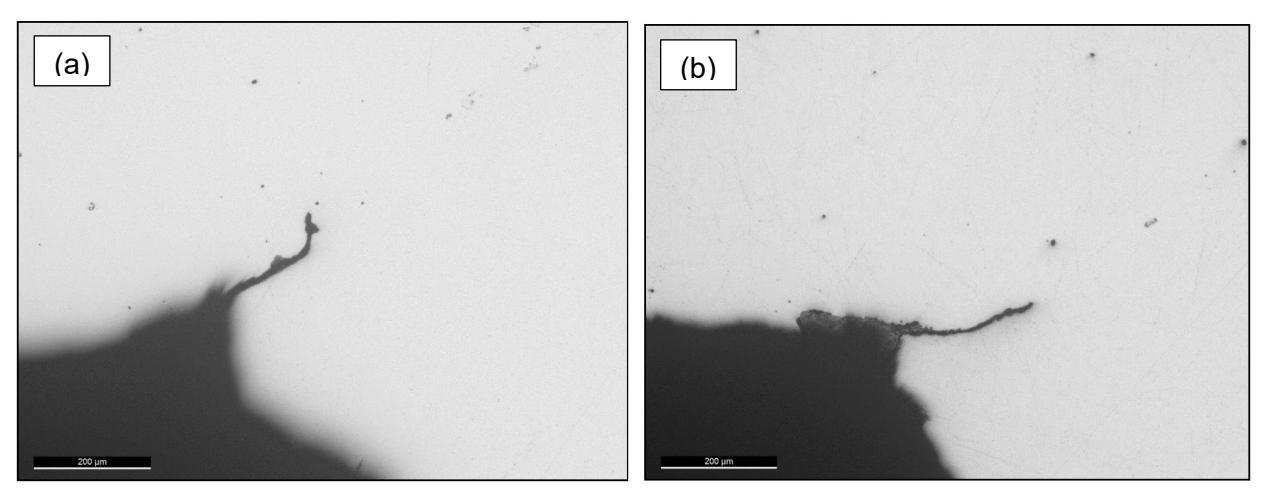
The fracture surfaces were not clear enough to discern if there was a region of initial tearing when the installation load that caused the ovality was applied, but it is plausible. Additionally, in comparison with actual cross-sections, the PAUT likely over-predicted depths by a factor of 2x to 10x. As shown in Figure 39, the depth of both flaws is approximately 0.008-inch (200 μ m) but the nearby PAUT indications are noted as (a) 0.055-inch and (b) 0.080-inch⁵². So, even where the PAUT indicates flaws that were much larger in GWD 13530 they in fact were similar in size to the LOF that initiated cracking and does not refute the fact that flaws were not reported by radiography at the fabrication shop.

Figure 39. Comparison of Cross-Sections for GWD 13530 with PAUT Findings (a) 139° from TDC and (b) 270° from TDC

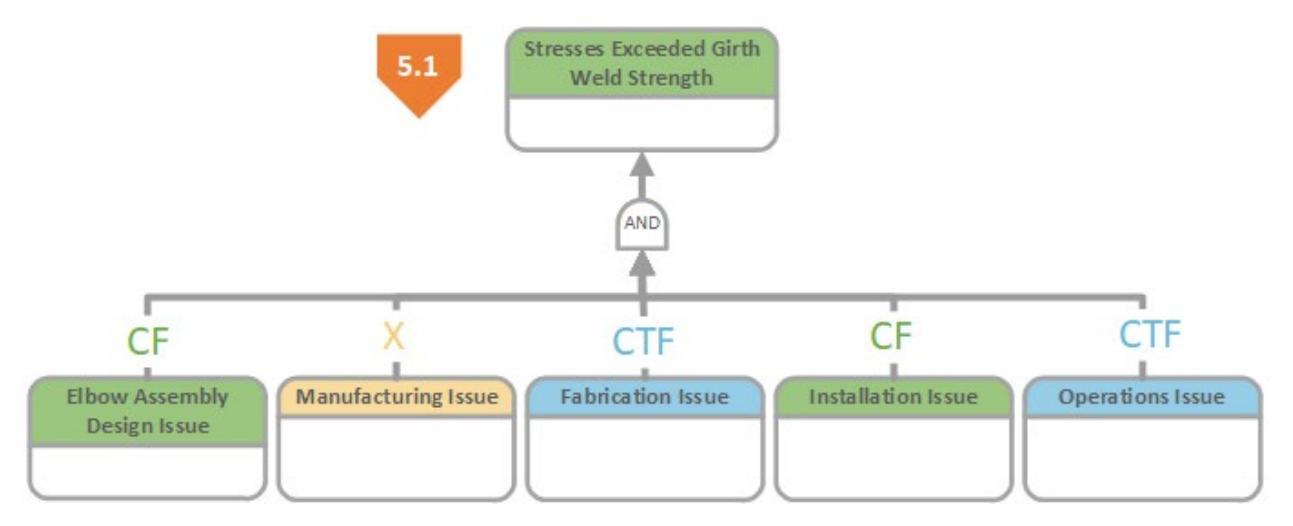
Figure 50. Simplified Cause and Effect – Stresses Exceeded Girth Weld Strength

Anderson determined that the direct cause of the GWD 13530 (G59B) failure was fatigue (progressive) cracking. The fatigue cracks initiated from a LOF region at the ID toe of the girth weld on the pup side. The circumferential orientation of the cracks suggested a bending stress as the driving mechanism. The fatigue cracks then propagated linearly through the pup side of the weld until the remaining ligament could no longer support the applied load. These findings suggest several possible areas of investigation including the design of the elbow assembly, manufacturing of its components, its fabrication and welding, its installation in the field, and the

operational conditions to which it was exposed. Each of these lines of inquiry shown in Figure 50 (detailed Cause and Effect Trees are provided in Appendix B) are discussed in detail below.

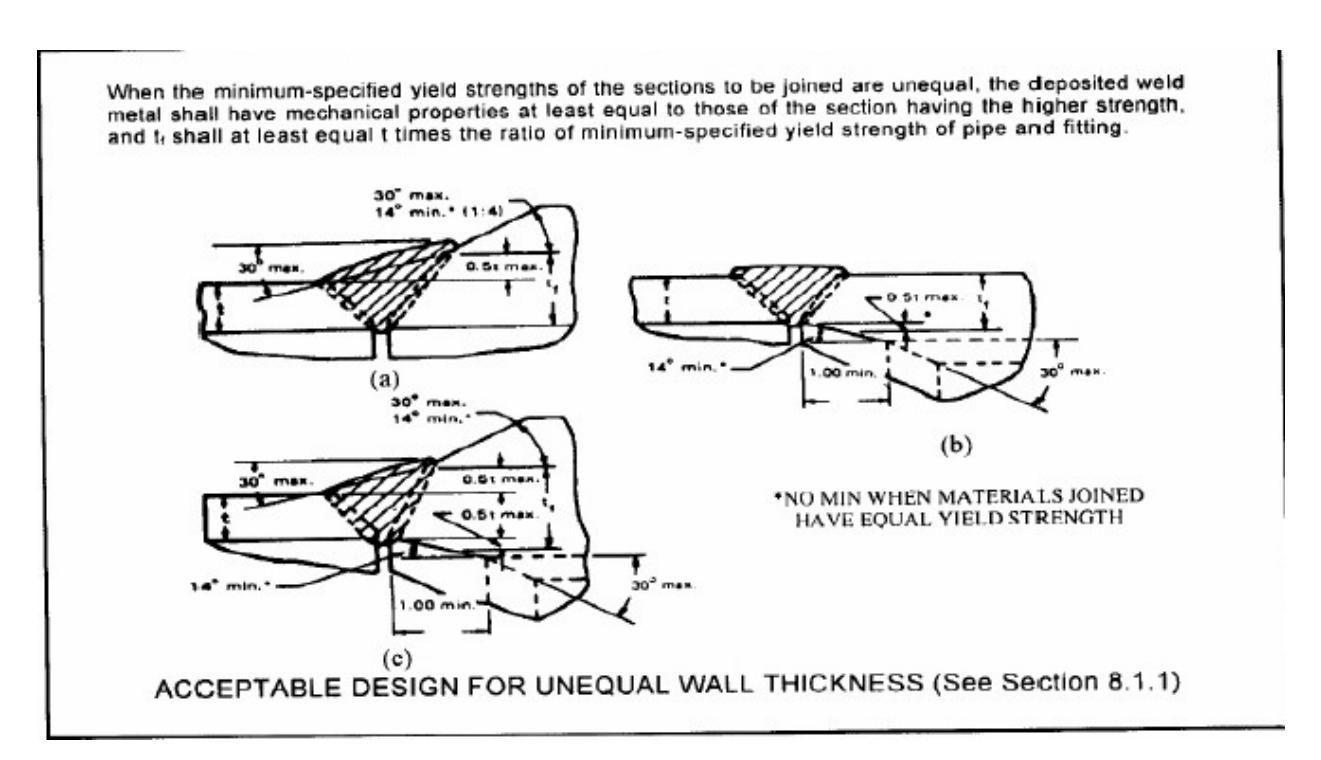
Figure 52. Acceptable Design for Unequal Wall Thickness (MSS SP-75, Figure 3)

. Figure 53 shows the as-built bevel details for the TAG 98 elbow. The transition joint design followed US industry standards, including ASME B31.4, ASME B31.3, ASME B16.25, and MSS SP-75 as well as Company specifications and recommendations from the JIP on Guidance for Field Segmentation and Welding of Induction Bends and Elbows⁷¹. It appears, however, that the taper transition length of approximately 0.78-inch in the metallographic section prepared through GWD 13530 at Crack 2 (see Figure 54) is less than the minimum requirement of 1.00-inch from Figure 3 of MSS SP-75-2008 (see Figure 52). The shorter transition length can increase stress concentrations in the girth weld.

Effect	Contributing Factors
Taper Transition Length	CTF1: The taper transition length on the TAG 98 (BND 350) elbow was less than the 1.00-inch minimum requirement in Figure 3 of MSS SP-75-2008 which can enhance stress concentration in the girth weld.

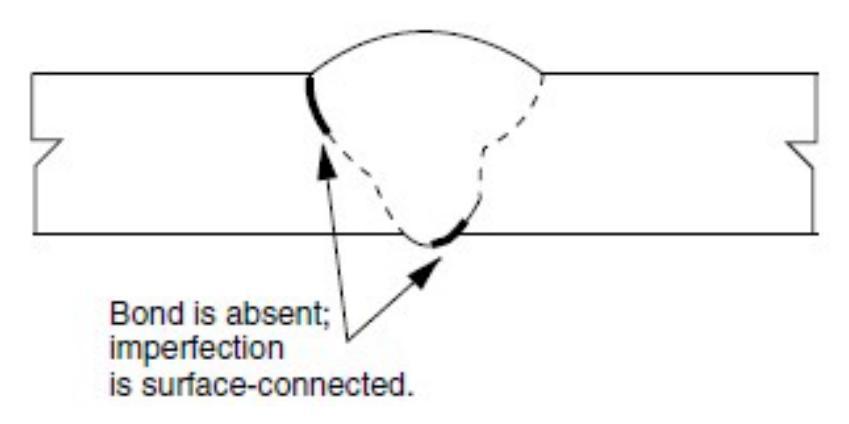
Figure 59. Incomplete Fusion at Root of Bead of Top of Joint (IF)⁹⁰

As noted by Anderson, "the initiating features appeared consistent with lack-of-fusion at the ID toe approximately 200 µm in length. Lack-of-fusion and cracking extending from the LOF was observed on both GWD 13530 and 13520." Per Section 9.3.4 of API 1104, "Incomplete fusion (IF) is defined as a surface imperfection between the weld metal and the base material that is open to the surface." This condition is shown schematically in Figure 59. According to API 1104, "IF shall be considered a defect should any of the following conditions exist: (a) The length of an individual indication of IF exceeds 1-inch (25 mm); (b) The aggregate length of indications of IF in any continuous 12-inch (300 mm) length of weld exceeds 1-inch (25 mm); or (c) The aggregate length of indications of IF exceeds 8% of the weld length in any weld less than 12-inch (300 mm) in length."

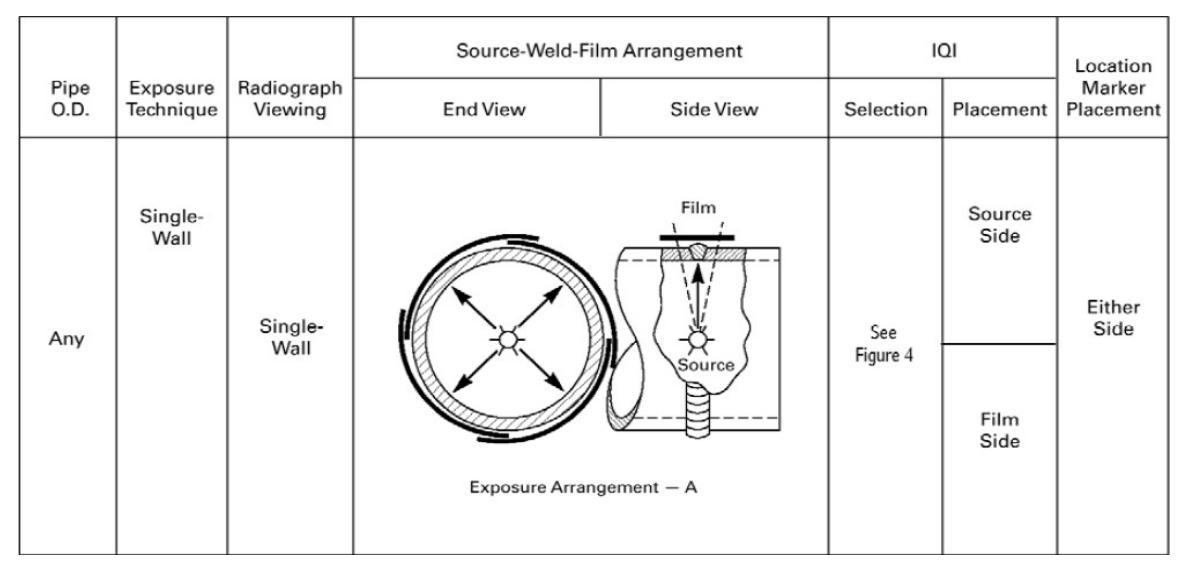
Figure 62.Schematic of SWE/SWV Radiography Technique Used on GWD 13530⁹⁶

Radiography is a common and accepted industry practice for girth weld inspections. Radiography was performed on GWD 13530 (G59B) and GWD 13520 (G59A) by a certified Level II Technician on November 19, 2010, using the single wall exposure/single wall viewing (SWE/SWV) technique (see Figure 62). An image quality indicator (IQI) is placed between the pipe and film to verify the sensitivity of the inspection. For weld thicknesses ranging between

Radiography works best for blunt flaws and for assessing weld workmanship but has some difficulty detecting sharp flaws like cracks or LOF.⁹⁵ Note that the radiograph need only to have enough sensitivity to detect and image a specified wire diameter in a standard IQI. For TAG 98, that essential wire diameter is 0.016-inch, therefore, flaws shallower than 0.016-inch might not be detectable using conventional RT techniques defined in codes and standards such as API 1104. In addition, for welds joining pipe with a sizeable difference in wall thickness, the radiographic film exposure time can also be difficult to optimize for both wall thicknesses. TES-WELD-AS-US, Rev 1 requires NDE for both wall thicknesses when the pipe wall thickness difference is greater than **Exercise**, as was the case for TAG 98 (BND 350).

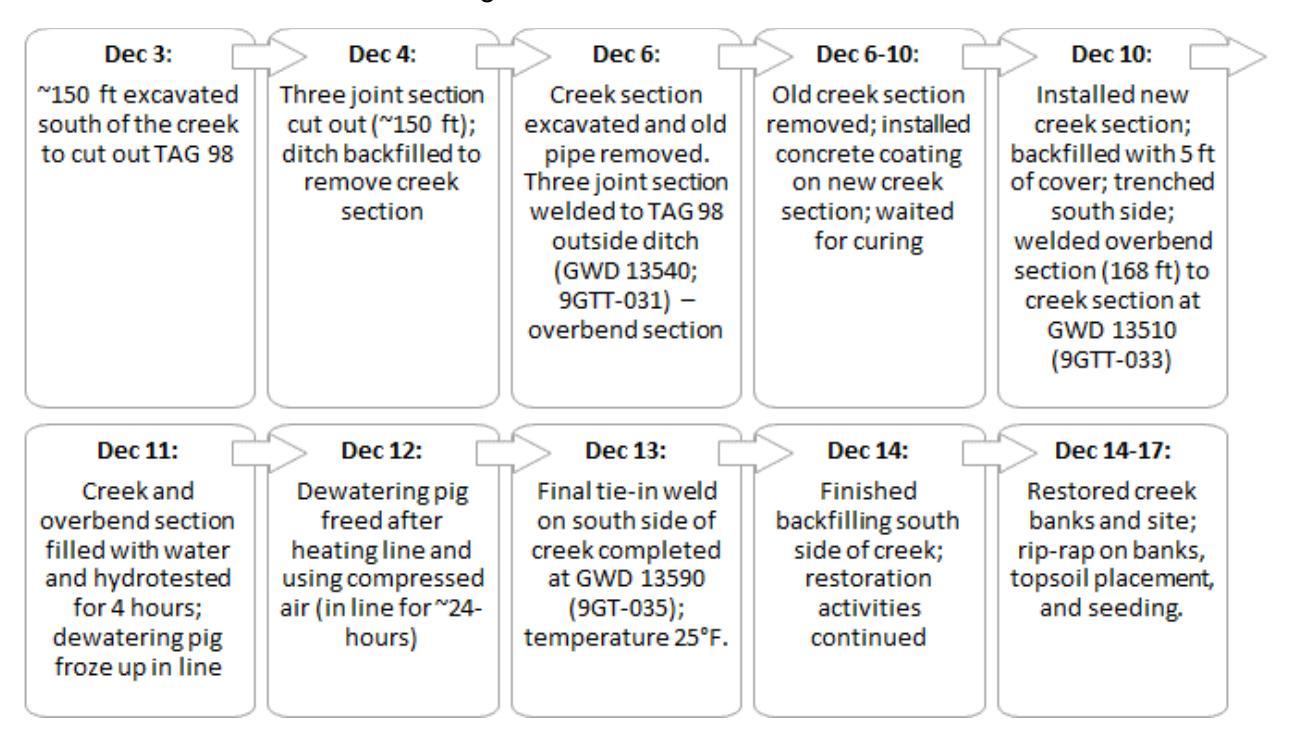
Figure 66. Summary of TAG 98 Installation Timeline (December 3-17, 2010)

Construction along the Cushing Extension had been largely completed by the end of October 2010 and was a month ahead of schedule. TC Oil was preparing for dry commissioning when the low yield fitting problem was discovered. TC Oil made the decision to replace fittings along construction spreads 9C, 10C, and 11C. TC Oil worked with formation to manufacture the replacements and to find fabricators that could manufacture the assemblies within a tight schedule yet still maintain the quality standards that were expected. As discussed previously, the TAG 98 (BND 350) elbow assembly was cut-out and replaced in December 2010 by the construction contractor formation. The following narrative was compiled from Daily Inspection Check List, Welding Inspector's Daily Report, and Daily Inspection Report records. These events are summarized in Figure 66.

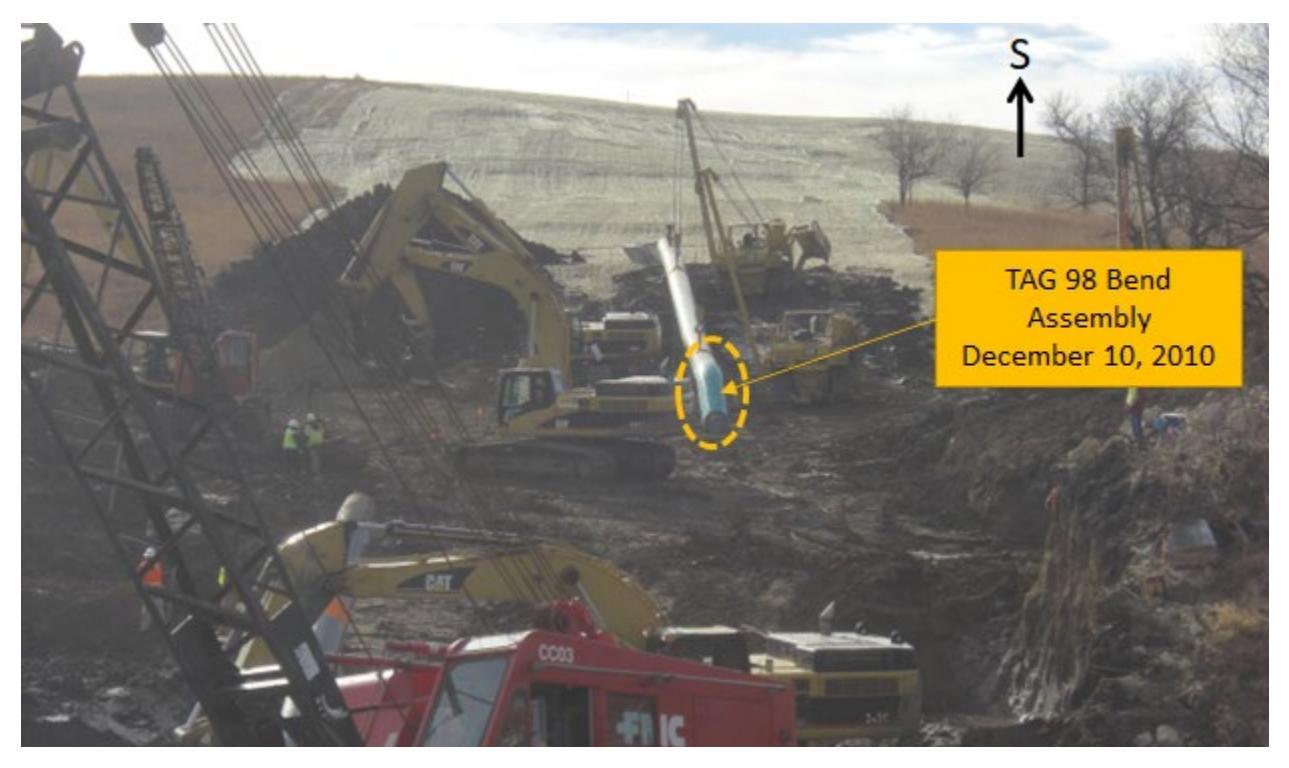
Figure 67. Installation of TAG 98 (December 10, 2010)

Around November 23, 2010, construction activities began in the Mill Creek area to remove the old creek section and associated elbows and prepare the site for the replacement fittings. Initial activities included installing truck mats on the ROW and removing topsoil to prepare the site. Fabrication of the new section to be installed beneath the creek was started on November 30. 2010, outside of the ditch. Open cut excavation on the north side of Mill Creek began on December 1, 2010, along with topsoil and rip-rap¹⁰² removal on the south side of Mill Creek. On December 3, 2010, approximately 150-ft of the ROW was excavated on the south side to expose the pipe and cut-out the old overbend fitting (presumed to be TAG 98). On December 4, 2010, a three joint section (approximately 150-ft in length) was cut out on the south side. After its removal, the ditch was backfilled, and mats were placed to begin excavating the creek. On December 6, 2010, the creek section was excavated, and the old pipe and fittings were removed. The three joint section removed on December 4, 2010 was also welded to the downstream side of the TAG 98 bend assembly (GWD 13540; 9GTT-031). In addition, a 6-ft pup was attached downstream of the three joint section (GWD 13580; 9GT-030) presumably to facilitate fit-up at the final tie-in weld. The total length of this section, referred to as the 'overbend section', was approximately 168-ft in length, including the TAG 98 elbow assembly. The 'overbend section' held up by two side booms is shown in Figure 67 prior to it being welded to the creek section.

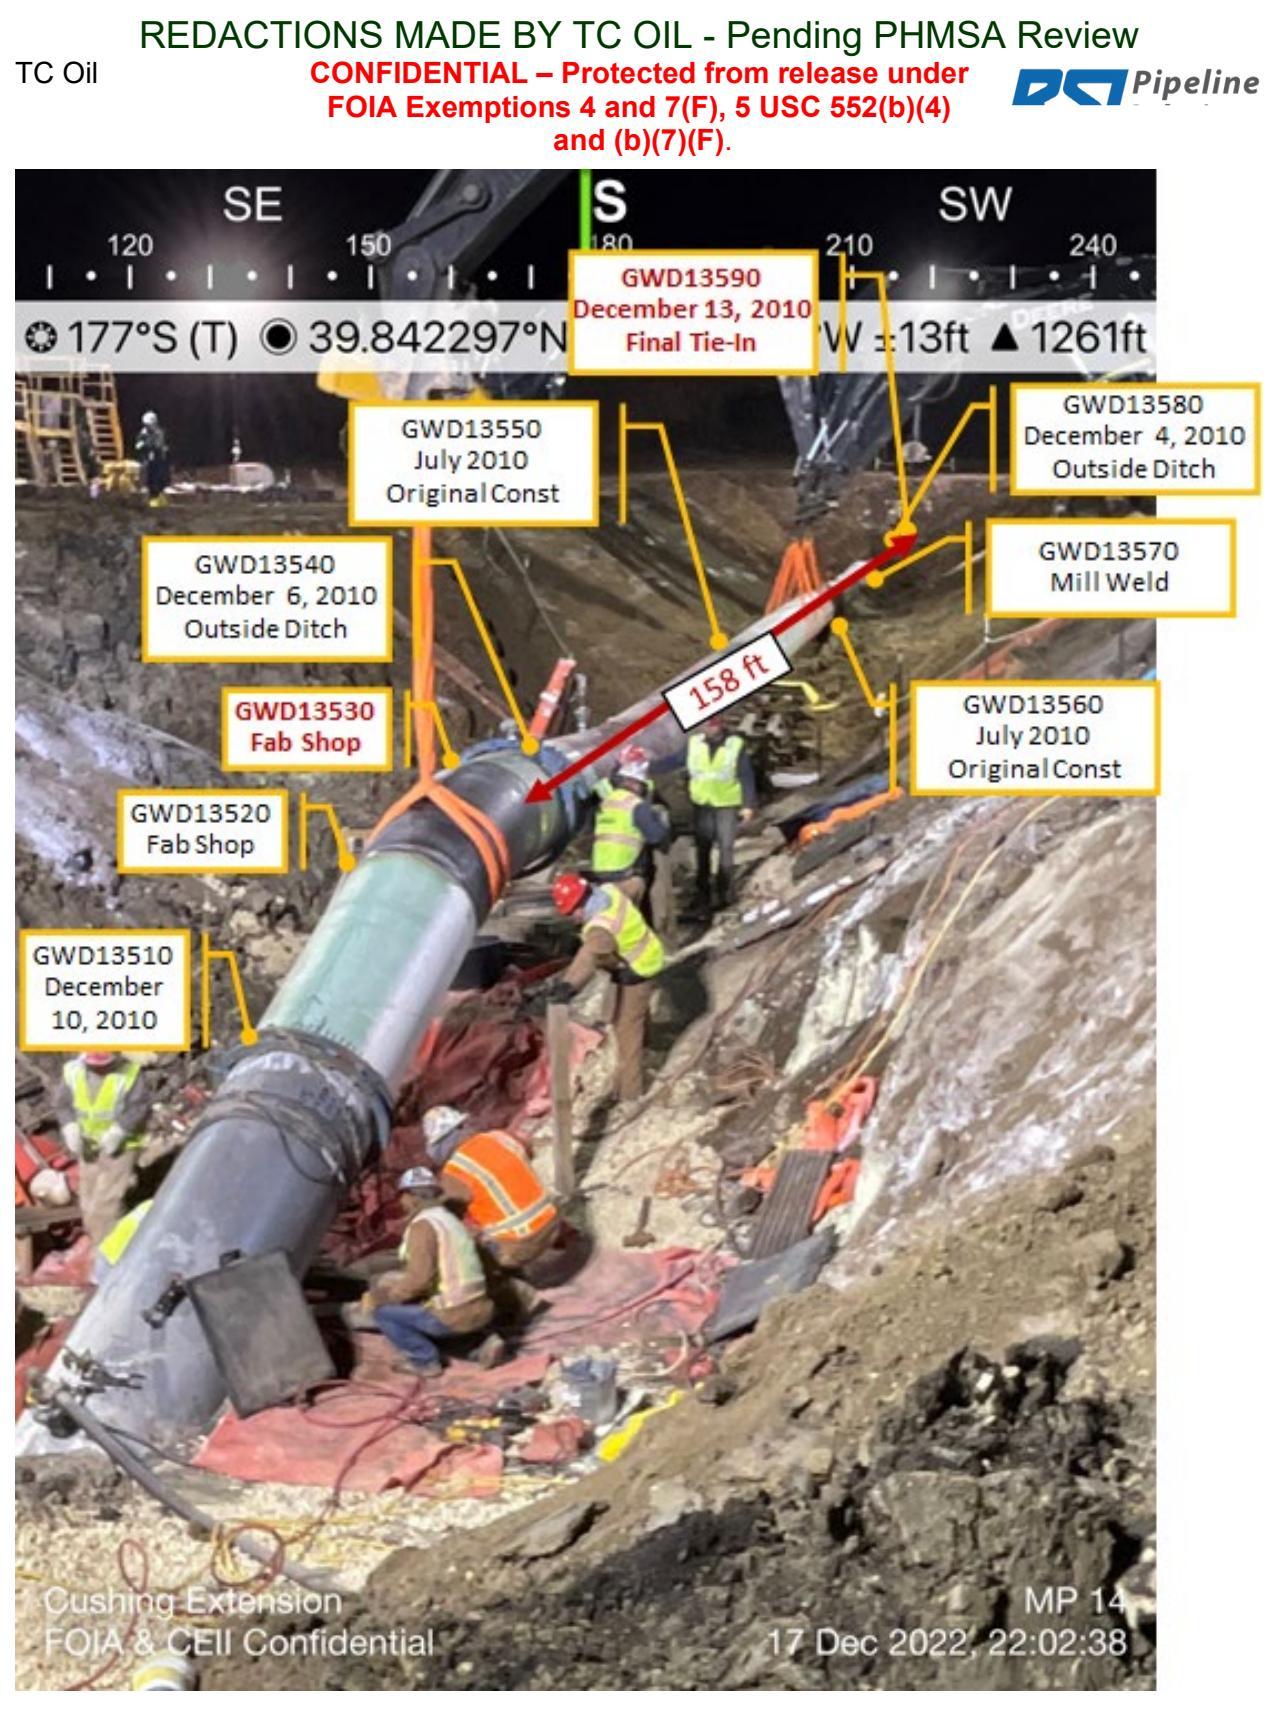
Figure 68. Key Girth Weld Installation Dates – Approximately 158 ft Between GWD 13530 and Final Tie-In Weld GWD 13590 (photo for illustrative purposes only, it is not from the time of construction)

As shown in Figure 68, the final tie-in (GWD 13590; 9GT-035) on the south side of Mill Creek was completed on December 13, 2010, after the hydrostatic test. Approximately 150-ft to 200-ft had been trenched on December 10, 2010, to replace the overbend section as described in the daily inspection records. Though daily inspection reports state that the fit-up was good and no issues were noted (see Figure 74), there is the potential that additional stress was applied to

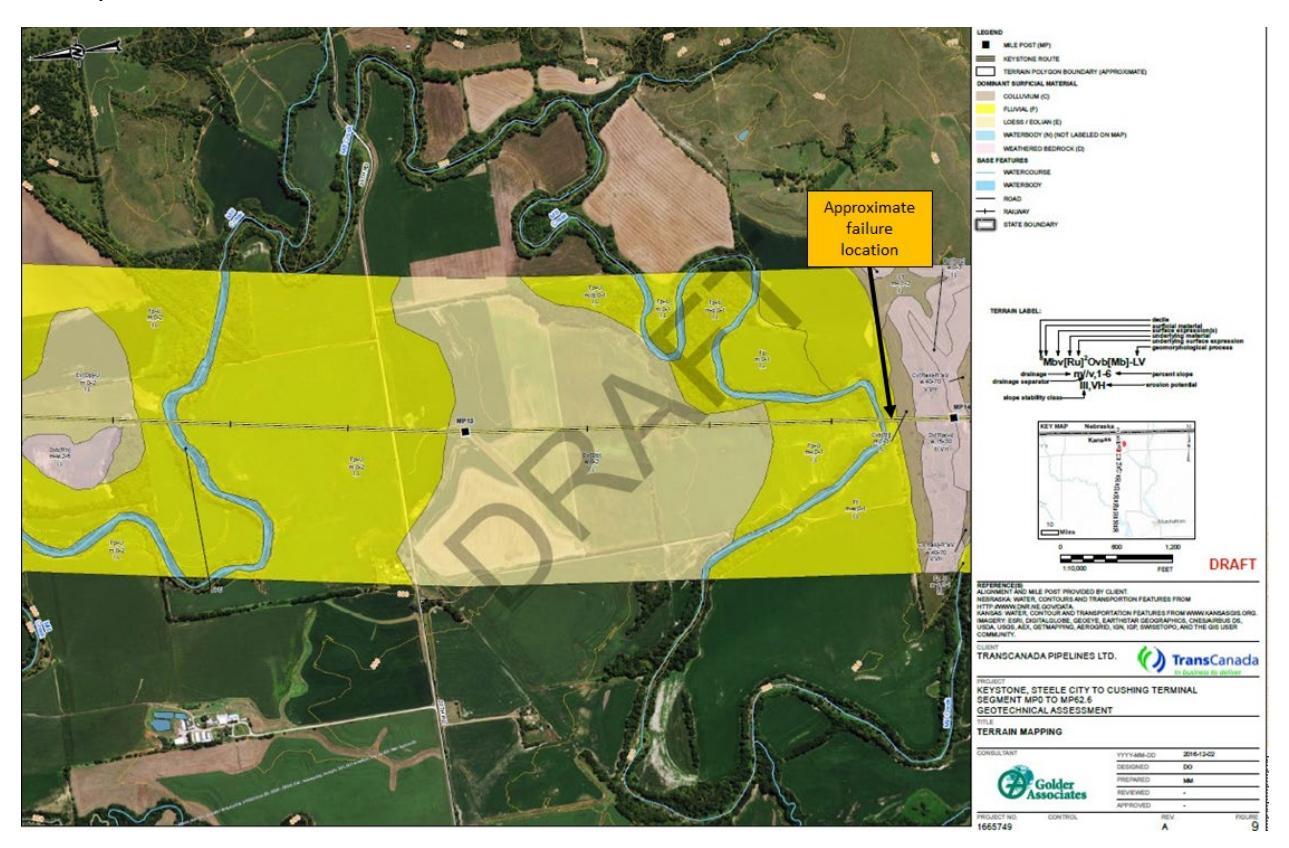
Figure 70. Geotechnical Assessment Near MP 14¹⁰⁷

As shown in Figure 70, the dominant soil types are fluvial/colluvium deposits in the area south of Mill Creek. This was confirmed by the Geotechnical SMEs onsite where they found claycolluvium soils throughout. The US Department of Agriculture, Natural Resources Conservation Service (USDA NRCS) publishes a web soil survey¹⁰⁶ providing information on local soil data to make land use and management decisions. One of many soil data categories that is reported is soil susceptibility to compaction. The area south of Mill Creek is rated as 'medium' for soil compaction which indicates that the potential for compaction is significant and after compaction the soil can support standard equipment with only minimum increases in soil density. The area also has a moderate rating for frost action which is "the likelihood of upward or lateral expansion of the soil caused by the formation of segregated ice lenses (frost heave) and the subsequent

collapse of the soil and loss of strength on thawing...silty and highly structured, clayey soils that have a high water table in winter are the most susceptible to frost action." The evidence supports that the soil in the area is appropriate for pipeline support but also may have been susceptible to frost action.
