RCFA for the Keystone Milepost 14 Release

Stephanie Flamberg, Bill Amend, Peter Martin, Michael Rosenfeld, Adam Steiner, and Benjamin Zand

April 21, 2023

Final Report

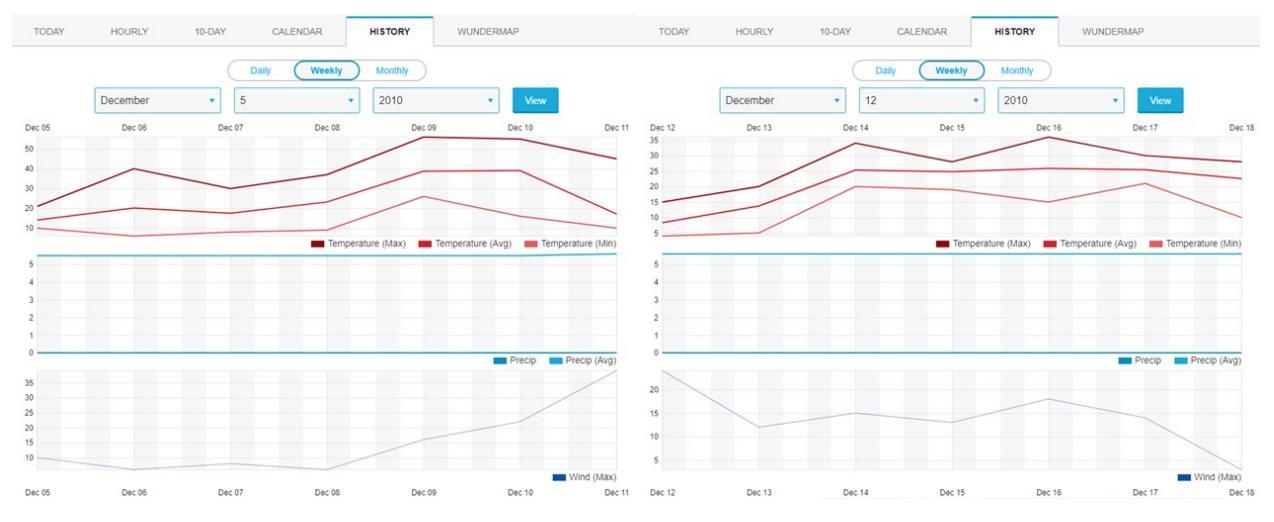
Figure 71. Historical Weather Conditions in Steele City, Nebraska (December 5-18, 2010)¹⁰⁹

As shown in Figure 71, the average temperature in nearby Steele City, Nebraska did not exceed 25°F (-4°C) between December 10, 2010, and December 14, 2010. The trench on the south side of Mill Creek was excavated December 10th and backfilled December 14th giving four to five days for the excavated soil to potentially freeze. Between those dates the newly installed overbend and creek sections were hydrostatically tested in the ditch with temperature maximums below 20°F (-7°C). No precipitation was noted, so crews were likely not dealing with snow or ice, but there was the potential for the ditch and the soil used as padding/backfill to freeze. The creek section had been backfilled prior to the hydrostatic test but the investigation team believes that the overbend section remained unburied so that any potential leaks at tie-in welds could be visually identified.

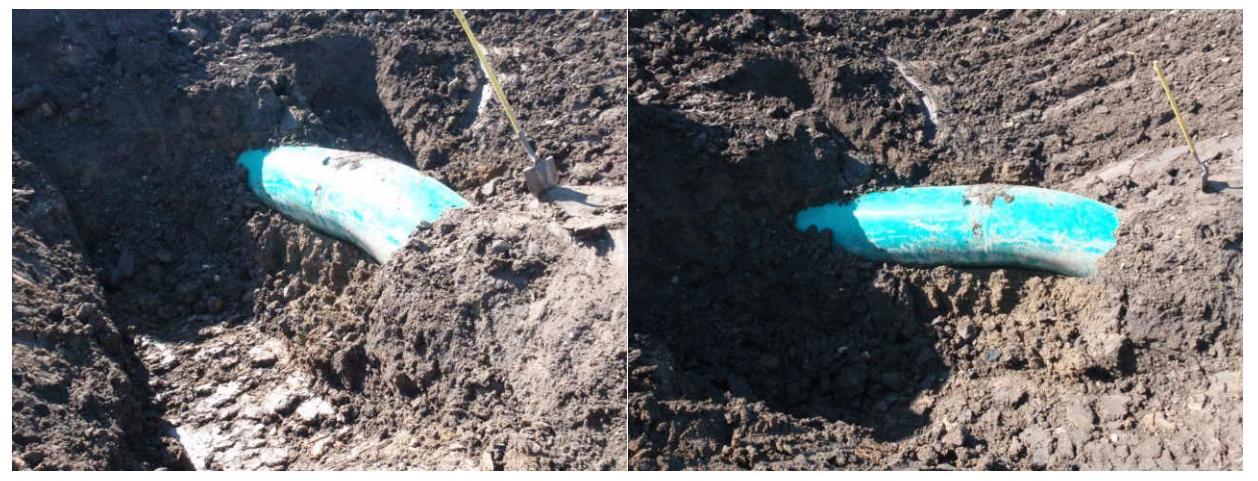
Figure 72. Photos Showing Soil Support Beneath TAG 98 (March 1, 2013)

Daily inspection reports indicate that a trench was excavated for placement of the new overbend section on the south side of Mill Creek. No further information was received describing the depth of the trench, the need for foundational material, the type of support beneath the pipeline, or the level of compaction achieved prior to backfill. However, because the trench south of Mill Creek was excavated four days prior to backfilling and the temperatures were below freezing for those four days, it is plausible that the in-situ foundational and backfill materials were partially frozen at the time of placement leaving them susceptible to thawing and loss of strength once operations began. There is no clear evidence to support or refute this possibility, except for photos from the March 1, 2013 integrity dig that do not appear to show any significant gaps or voids between the soil support and the elbow (see Figure 72). The FEA analysis in Section 4.2.1.2 showed that with settlement up to 1-ft beneath the pipe, the bending load could result in ovalization of the elbow but may not be sufficient to explain the wrinkle. Though inconclusive, lack of foundational support in the ditch is a potential causal factor.

procedural requirements. A specific Tech Memo was not found for this dig but photographic documentation (see Figure 11 and Figure 72) shows that the excavation extents were relatively small, and support appeared to be good. The excavation and subsequent backfill/compaction activities in 2013 likely did not contribute to this incident.

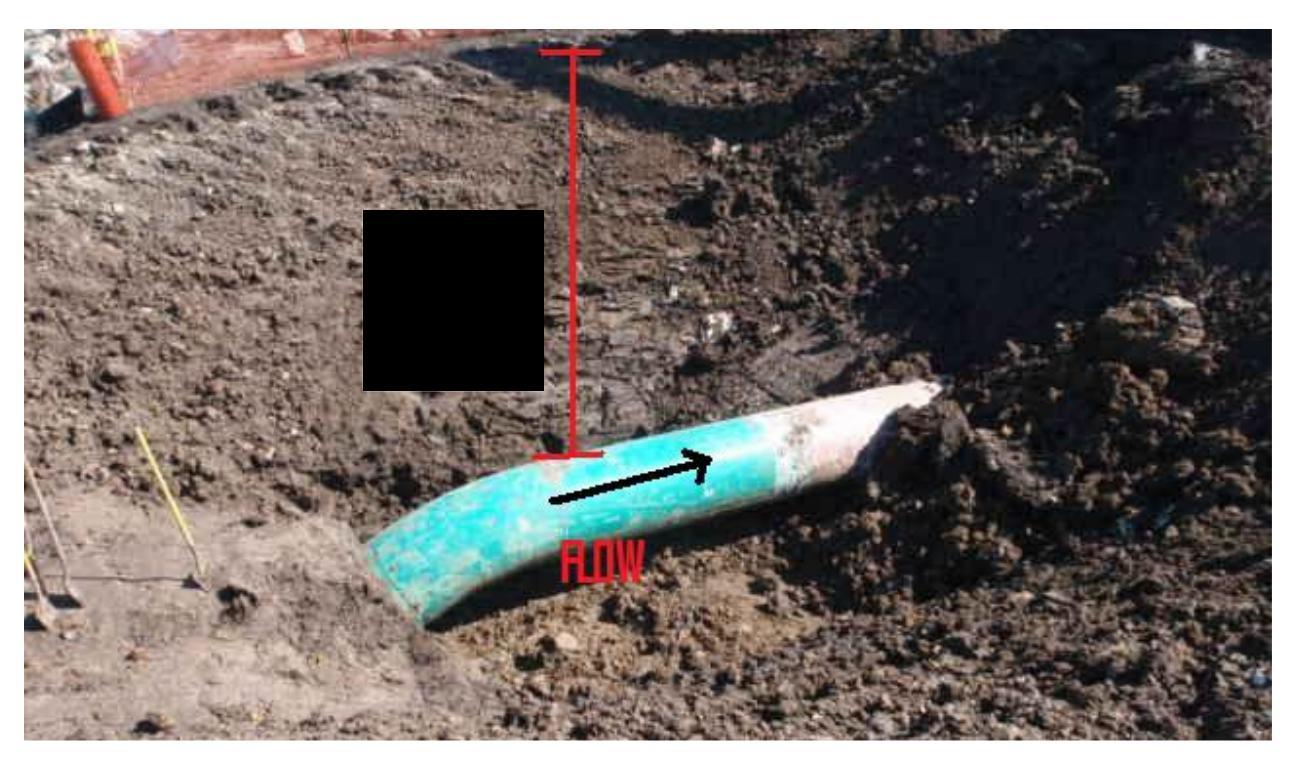
Figure 75. Photo of TAG 98 (BND 350) During March 2013 Integrity Dig Showing a Depth of Cover of

The depth of cover near the release location was approximately as recorded during the 2013 integrity dig (see Figure 75) and again in 2017 when a depth of cover survey was performed in the Mill Creek area (see Figure 76). The FEA showed that once the pipe was tiedin and backfilled, the overburden loads with **f** of settlement below the pipe were large enough to cause ovalization of the TAG 98 bend assembly.

A bending strain analysis was performed post-incident and reported a vertical bending downstream of GWD 13530 (see Appendix C). This amount of strain is less strain about of an unsupported long span of than the buckling strain -inch wall thickness pipe - which was confirmed by the lack of a midspan buckle in the caliper data. This amount of strain corresponds to a bending stress of which is well within the elastic range. The bending moment at the ends of such a span would be of similar magnitude. This magnitude of bending and the inches of upspring in the pipe upon excavation points to some post-installation soil settlement but not enough to completely explain the deformations seen at the heavy wall elbow and pup. As with the other potential loading scenarios during installation of the replacement fitting, RSI could not conclusively determine if soil settlement was causal to the plastic deformation experienced by the TAG 98 (BND 350) bend assembly.

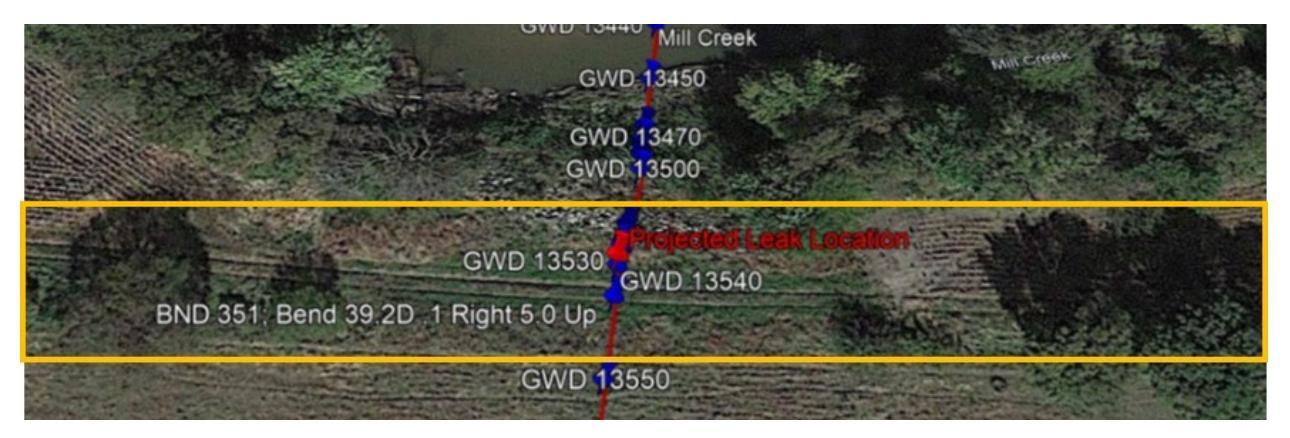
Figure 77. Aerial View of Site Highlighting the Two-Track Road Near the MP 14 Incident

As shown in Figure 77, a two-track road running east-west crosses the pipeline approximately 9-ft downstream of the release location. The road is "closed" and is not maintained by the township but heavy farm-type equipment (tandem axle semi-truck, tandem axle grain trailer, and John Deere S670 combine; ~36,000-lb loads) crosses the uncased pipeline at a frequency of approximately 12 times per year each¹²³. The cyclic loads from vehicular traffic were considered to determine their potential impact. With a lateral distance 9-ft away and a depth of cover at the TAG 98 bend assembly of **1000**, the cyclic loads from vehicular traffic were likely minimal. Therefore, vehicle loads were determined not to be a causal or contributing factor to the MP 14 Incident.

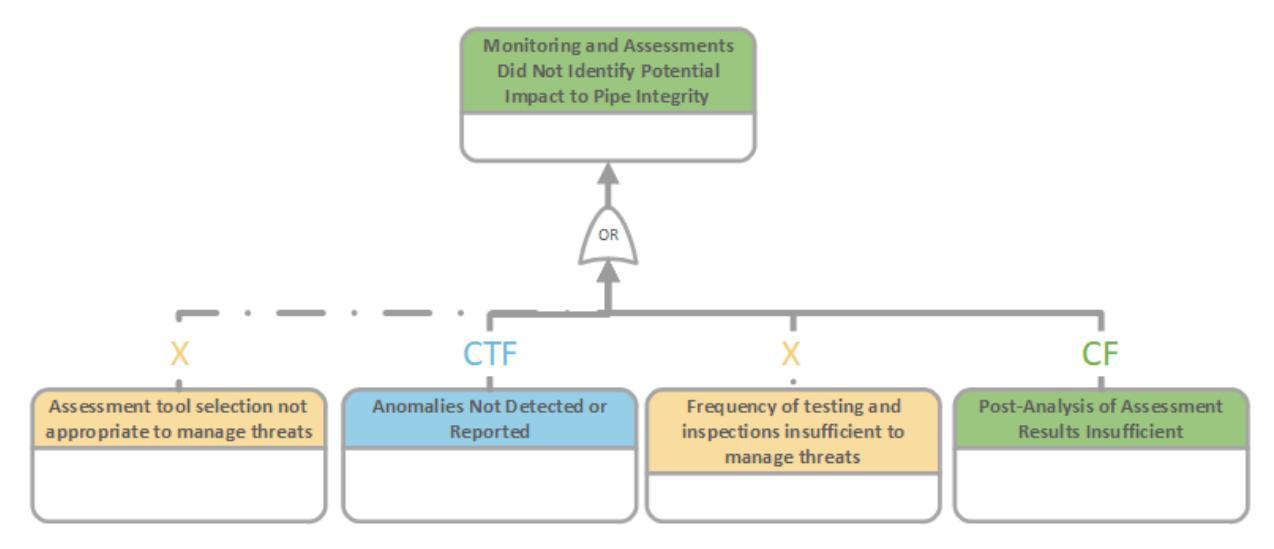
Figure 81. Simplified Cause and Effect – Monitoring and Assessments

Although multiple ILIs of the affected segment were completed between 2010 and 2022, including a metal loss ILI in 2018 that had capabilities to detect some anomalous girth weld conditions, the LOF and fatigue crack in GWD 13530 was not discovered prior to the rupture. The 2012 profile and 2013 caliper surveys did report the ID restriction (due to ovality) and an investigation was performed in March 2013; however, the severity of the threat was underestimated in terms of its potential effect on girth weld integrity. Several possible sequences of events were postulated as shown in Figure 81 (detailed Cause and Effect Trees are provided in Appendix B). Causal factors were identified related to post-analysis of

assessment results. The limitations of ILI technologies in detecting girth weld cracks in a 3D bend was a contributing factor to the cracks not being identified. The selected assessment tools and the frequency of inspections were adequate for the identified threats and therefore determined not to be causal.

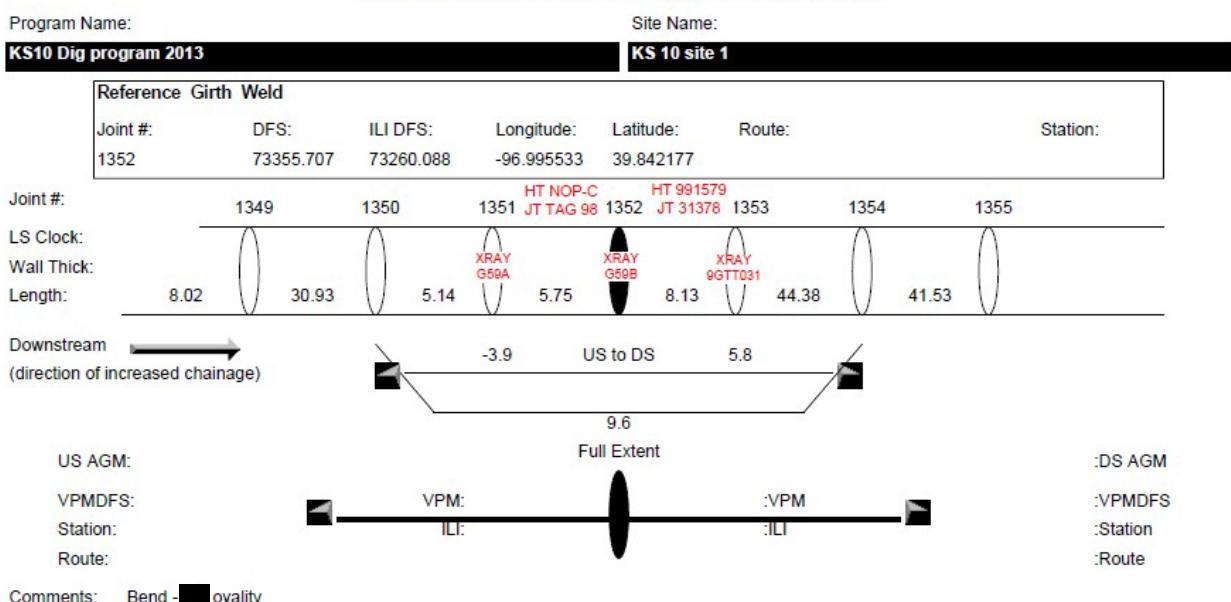
Figure 82. Dig Sheet for ID Restriction Found at TAG 98

The 2012 inspection identified a 9% ID restriction (due to ovality) near the girth weld¹³⁵ that failed (see Figure 82) – the ID restriction had damaged the cleaner and gauge tools¹³⁶ sent through the line prior to the caliper inspection. As discussed previously, excavations for ovalities

are only required if there are concerns that ILI tool passage could be impeded, which was the case for this ID restriction. Therefore, the ID restriction was excavated in March 2013 to evaluate it (see Figure 83). The ovality was confirmed and measured at **1000** of the OD¹³⁷ in the ditch and was determined not to be an integrity concern at the time. The bend assembly was backfilled without any further intervention.

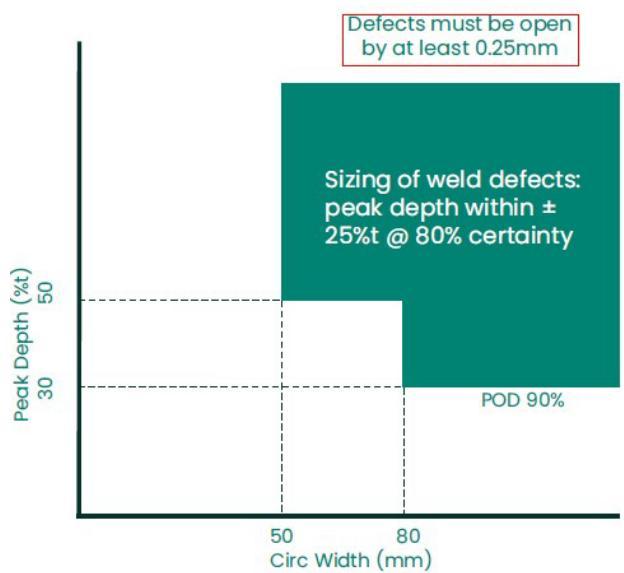
Figure 85. MFL4 Detection and Sizing Capabilities for Girth Weld Anomalies

The MFL4 tool is a standard MFL tool that also has a specification for detection of girth weld anomalies. The tool has two specifications for girth welds as shown in Figure 85, (1) a POD of 90% for flaws with a peak depth of 50% and circumferential width of 2-inch (50 mm); and (2) a POD of 90% for flaws with a peak depth of 30% and width of 3.1-inch (80 mm), with the caveat that the defects must be open by at least 0.01-inch (0.25 mm). In addition, the POI is estimated at 50% for cracks and only very deep and sharp signals are classified as a crack; otherwise, an anomalous weld signal is classified as a weld anomaly. Girth weld defects that have an opening of less than 0.01-inch (0.25 mm) are included in the assessment, but the POD, POI, and sizing specifications do not apply¹⁴².

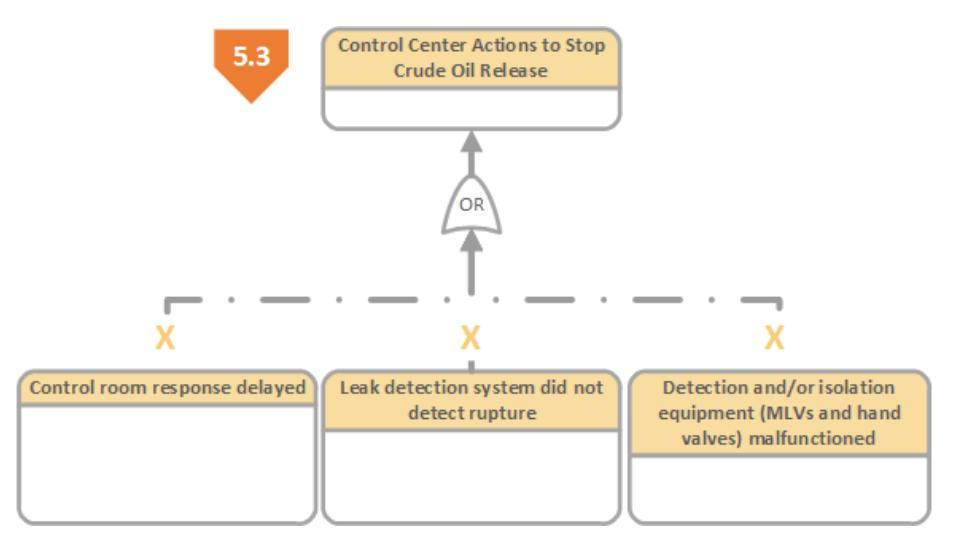
Figure 88. Control Room Response Event–Sequence - Cause and Effect Tree

Images showing a ductile overload region on the metallographic section substantiate that the cracks in GWD 13530 had not leaked prior to the pipeline rupture. Therefore, the size of the release was dictated by the response of the control room in shutting down and isolating the pipeline. The control room response event sequence is shown in Figure 88. The investigation team determined that the control room response was appropriate and therefore not causal to the release volume.

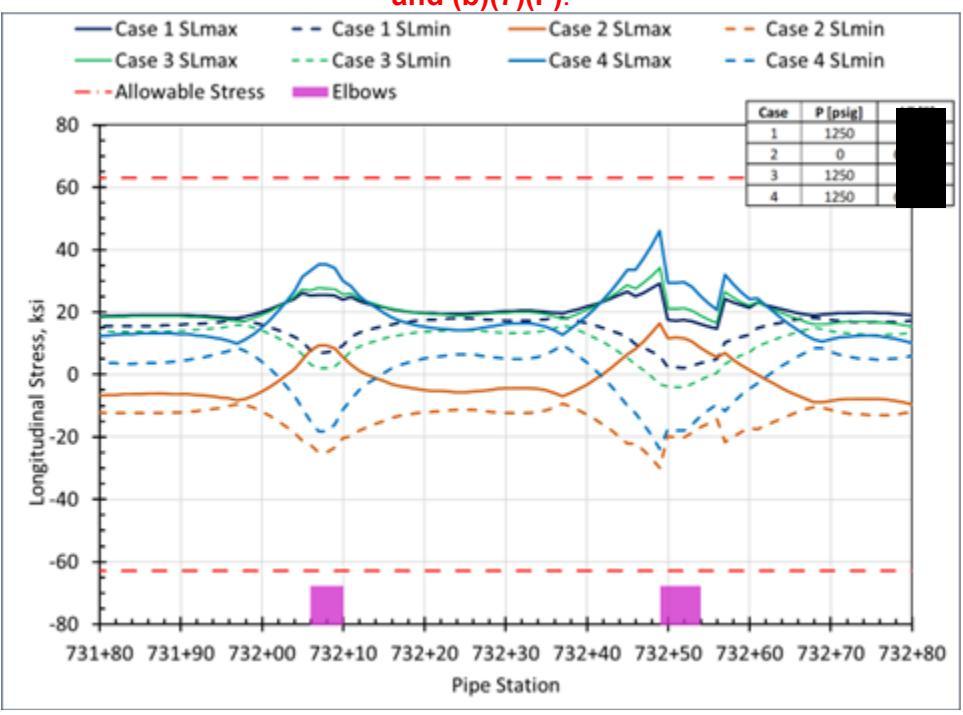
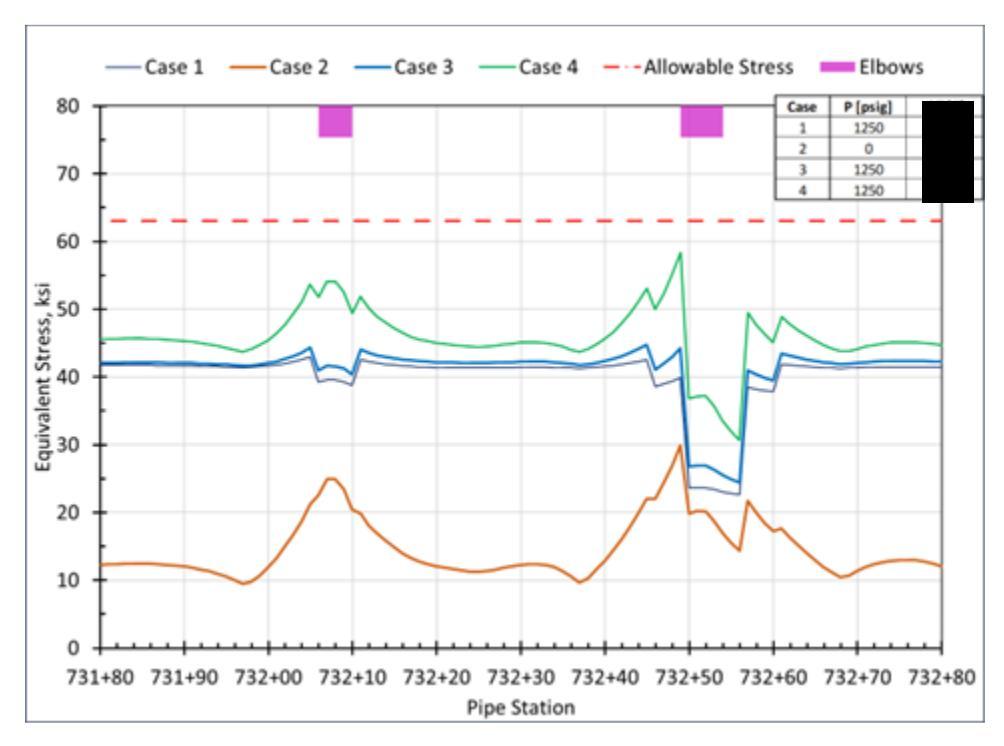
Figure D.11. FEA Longitudinal Stresses with Three-Node Pipe Elements and Upper-Bound Soil Properties

The FEA results for the upper-bound soil properties (see Table D.3) with PIPE289 elements are shown in Figure D.11 and Figure D.12. The overall stresses are lower than those calculated with the lower-bound soil properties (see Table D.2) because a stiffer soil provides stronger support and a lower anchor length for the pipeline along bends and elbows. The normal pipe elements that were used in these analyses did not account for pipe cross-sectional warping and ovalization at the elbow. The following analyses address these effects by replacing the pipe elements with elbow elements.

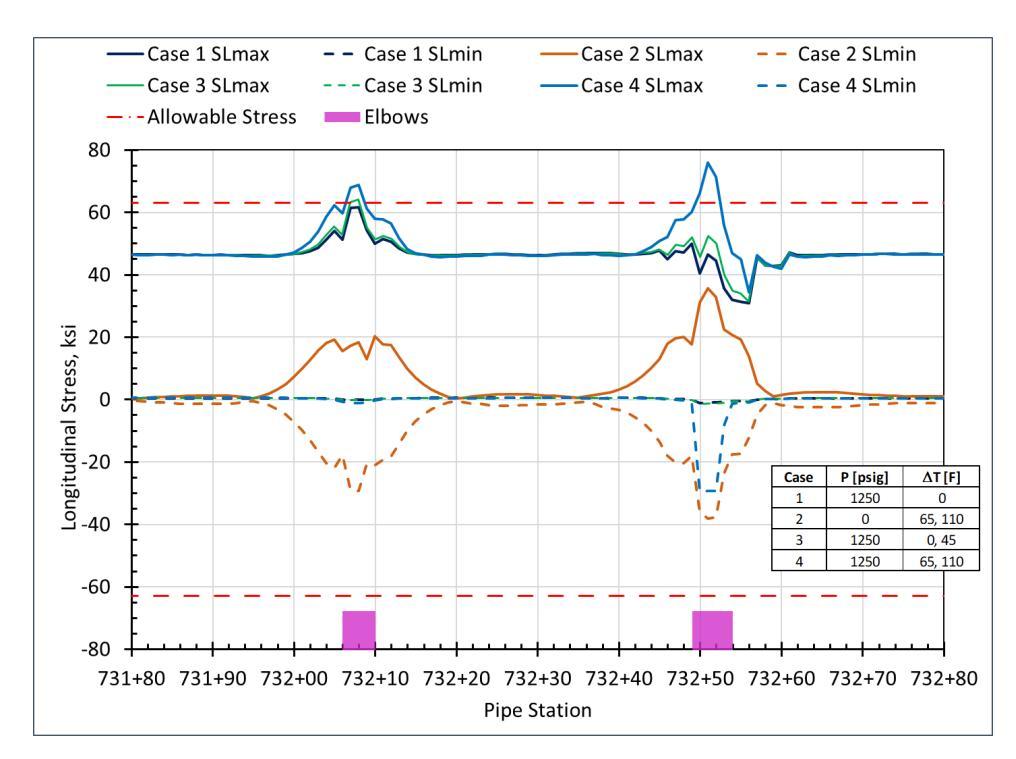
Figure D.13. FEA Longitudinal Stresses with Elbow Elements and Lower-Bound Soil Properties

In the above equations, *D* is pipe outer diameter (inch), *P* is the pipe operating pressure (psig), *S* is the yield strength (psi), and *t* is pipe wall thickness (inch). The above equations result in allowable compressive strains ranging from 0.4% to 0.6%. The calculated compressive strains in the longitudinal direction of the elbow and the pups were all less than 0.14%. The maximum equivalent stress from the ELBOW290 analysis (see Figure D.14) was 69.6 ksi (99.4% SMYS). Figure D.15 and Figure D.16 show the results for upper-bound soil properties. The stresses are lower compared to those associated with the lower-bound soil properties.

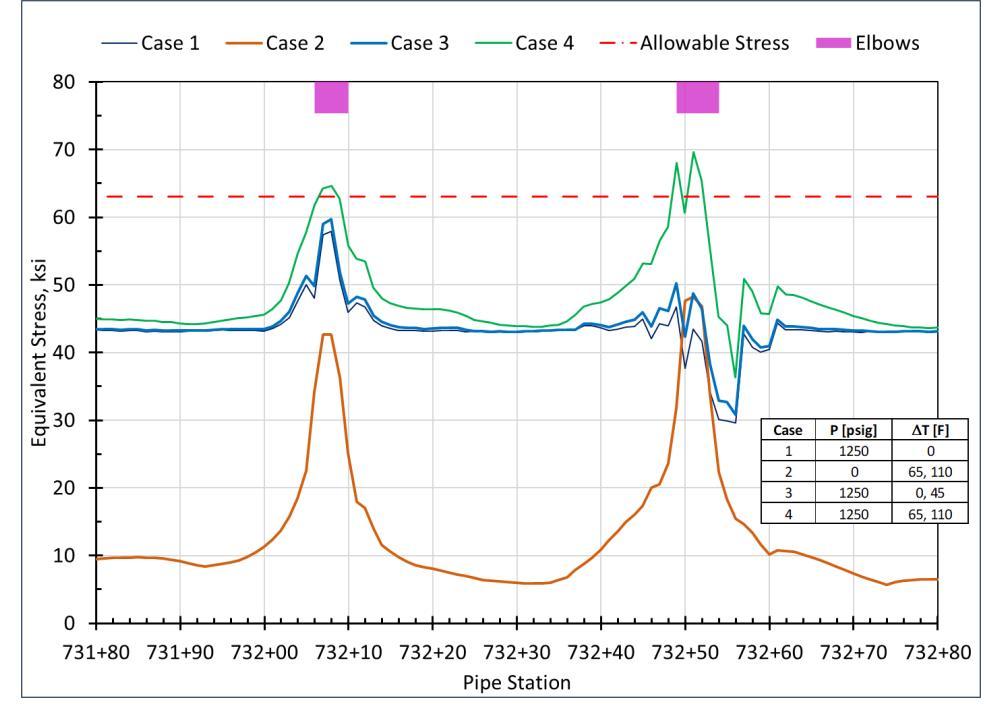
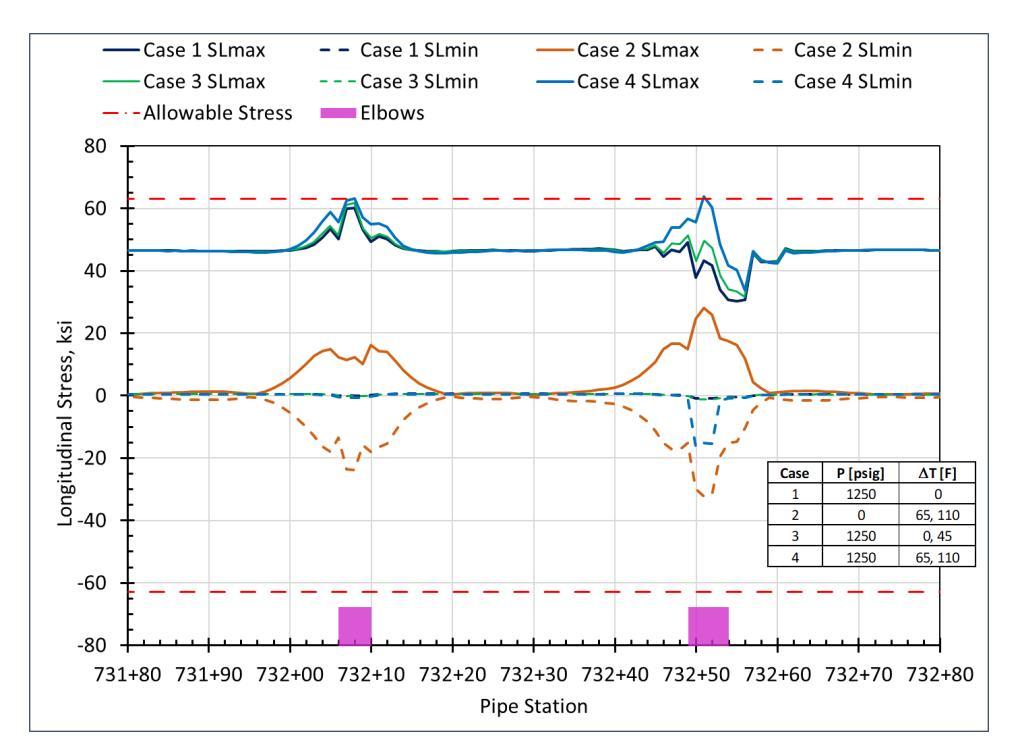
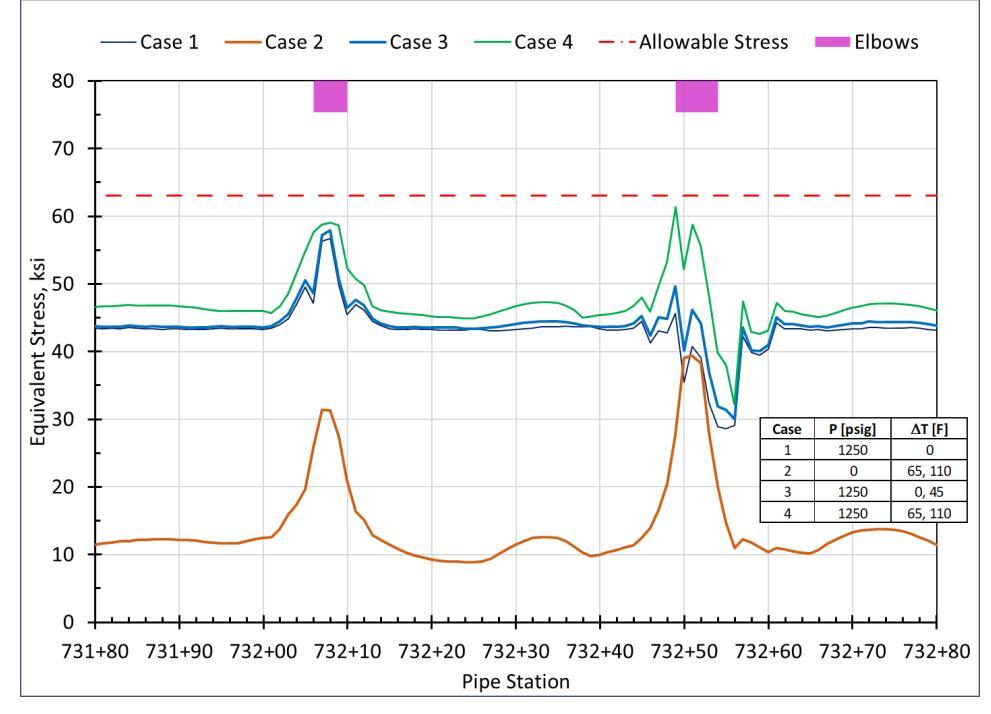
Figure D.14. FEA von Mises Stresses with Elbow Elements and Lower-Bound Soil Properties

Figure D.15. FEA Longitudinal Stresses with Elbow Elements and Upper-Bound Soil Properties

Figure D.16. FEA von Mises Stresses with Elbow Elements and Upper-Bound Soil Properties

The above results (i.e., the stress graphs in Figure D.9 through Figure D.16 and the compressive strain limit from Equations 9 and 10) shows that although the equivalent stress exceeds the allowable stress of the pipe material, it is insufficient to cause pipe ovality or a wrinkle. Based on the FEA results, RSI concluded that the TAG 98 wrinkle and ovality most likely did not occur because of pipeline operational loads.

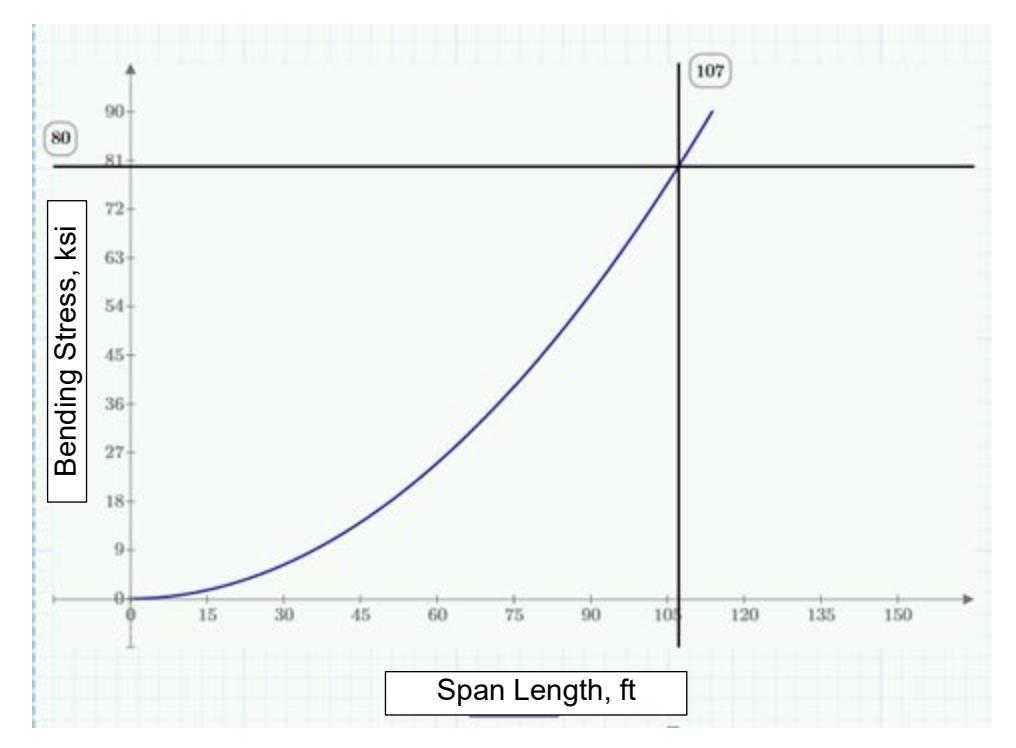
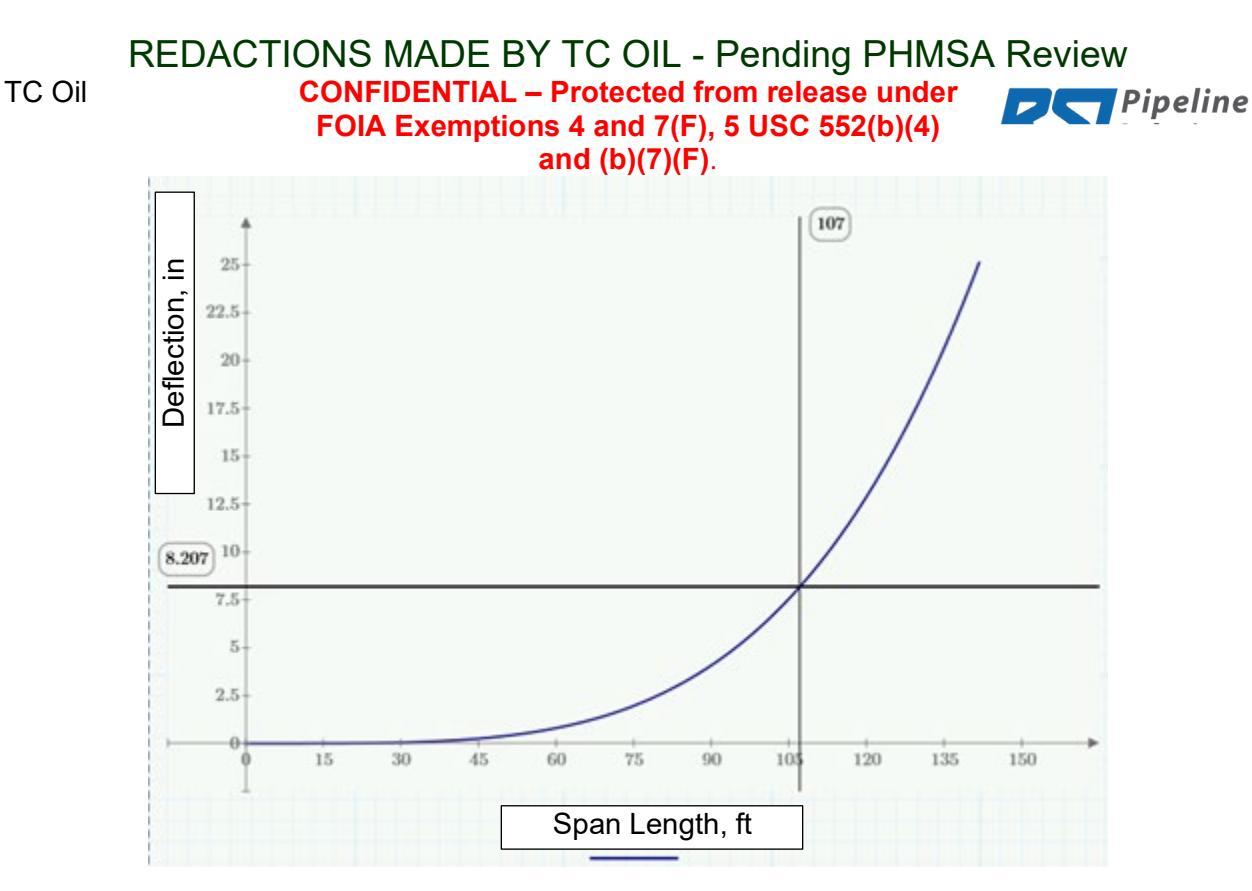
inches as a function of the span length (not the length value along the beam). The results show that it is possible to have high levels of bending stress that exceed the material yield strength. However, in order to generate bending stresses high enough to cause significant plastic deformation, the span length must be around 100-ft or longer, and beam deflections must be several inches. Although, in theory this scenario is possible, in practice it is very unlikely that such a long and wide gap under the pipeline would have gone unnoticed before placement of the overburden soil.

Figure D.17. Beam Bending Stress with both Ends Fixed as a Function of Span Length

Figure D.18. Beam Deflection with Both Ends Fixed as a Function of Span Length

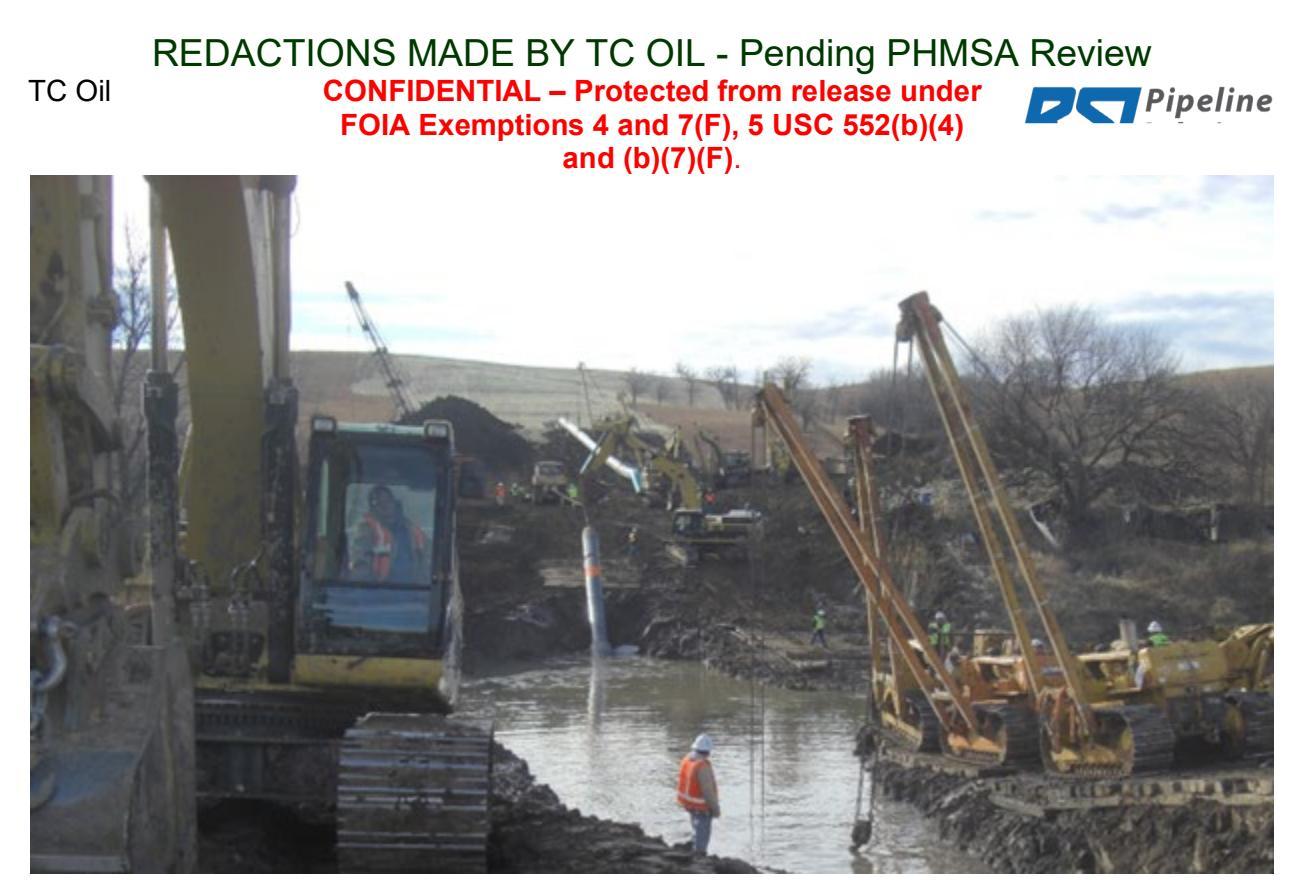
The second scenario considered is cantilever bending of the replacement segment after the upstream tie-in weld was complete but before the final tie-in weld was made downstream. A review of photographs during the December 2010 replacement of TAG 98 show that two side booms were used to hold the pipe segment above the ground over the south-slope (Figure D.19). It is also known that the creek portion of the replacement segment was buried with 5-ft of soil but the downstream overbend section was likely exposed during the hydrostatic test on December 11, 2010. Furthermore, the downstream tie-in weld (GWD 13590; 9GT-035) was completed after the hydrostatic test on December 13, 2010. A note in the daily inspection report from December 11th suggests that the side booms may have been demobilized (prior to the hydrostatic test), however, these records are unclear as to how the pipeline was placed in the ditch or how it was supported during the hydrostatic test. Improper operation of side booms can sometimes create high levels of bending stress. To assess this hypothesis, RSI first performed several analytical cantilever beam-bending analyses. Figure D.20 shows a schematic of the assumed model. The cantilever assessment model included (1) an accidental load at some distance from the fixed end and (2) the weight of the pipeline and hydrostatic test water. It was assumed that the free end of the beam will, after some amount of deflection, touch the ground generating an end reaction force. The model was set-up in Mathcad Prime, allowing us to define the point load, weight per unit length of the pipe, and the end reaction as variables. The span length in all the cantilever analyses were set to 170-ft.

Figure D.19. Use of Sidebooms During Replacement of TAG 98 (December 10, 2010)

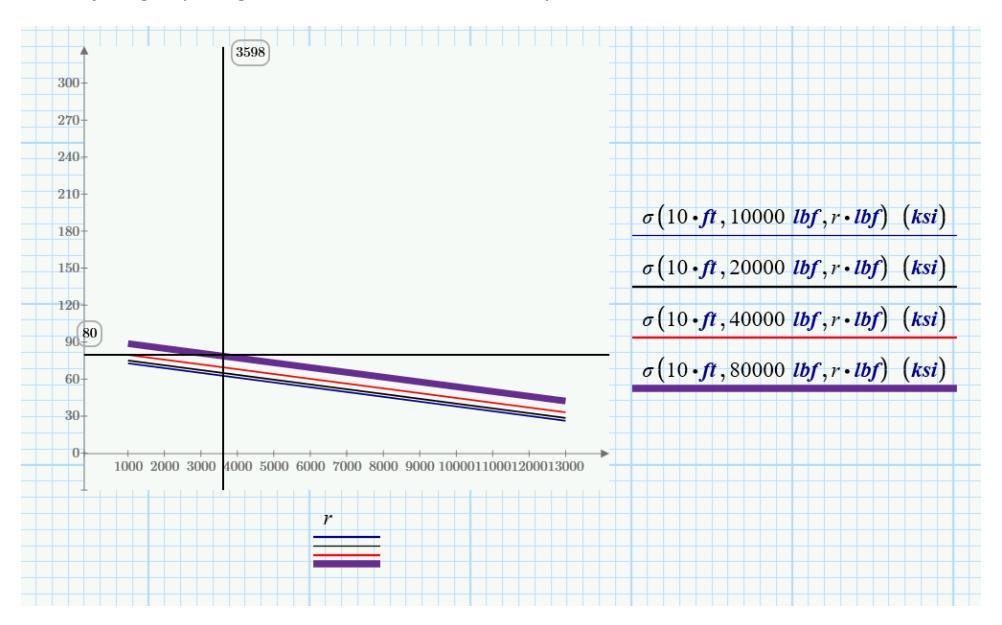
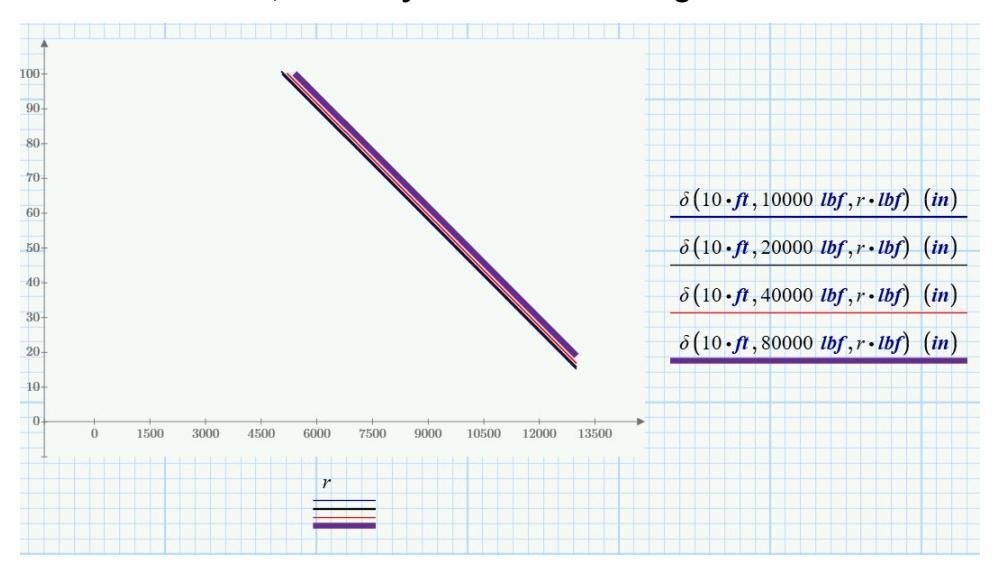
zero reaction represents a beam with a completely free end. A reaction force of about 14,500 lbf represents a beam with one fixed end and one pinned end (i.e. this is equivalent to the south end of the pipe segment sitting on the ground). The results suggest that high accidental loads can cause sufficient bending stress such that it exceeds the yield strength of the material. However, as seen in Figure D.23 the amount of deflection associated with high bending stress levels is relatively high (i.e. greater than 100-inches).

Figure D.22. Cantilever Beam Bending Stress for Empty Pipe with Various Concentrated Loads at a Distance of 10-ft from the Fixed End. The x-axis in this figure is end reaction force in lbf, and the y-axis is the bending stress in ksi.

Figure D.23. Cantilever Beam Bending Deflections (inch) for Empty Pipe with Various Concentrated Loads at a Distance of 10-ft from the Fixed End. The x-axis in this figure is the end reaction force in lbf, and the y-axis is the end deflecting in inch.

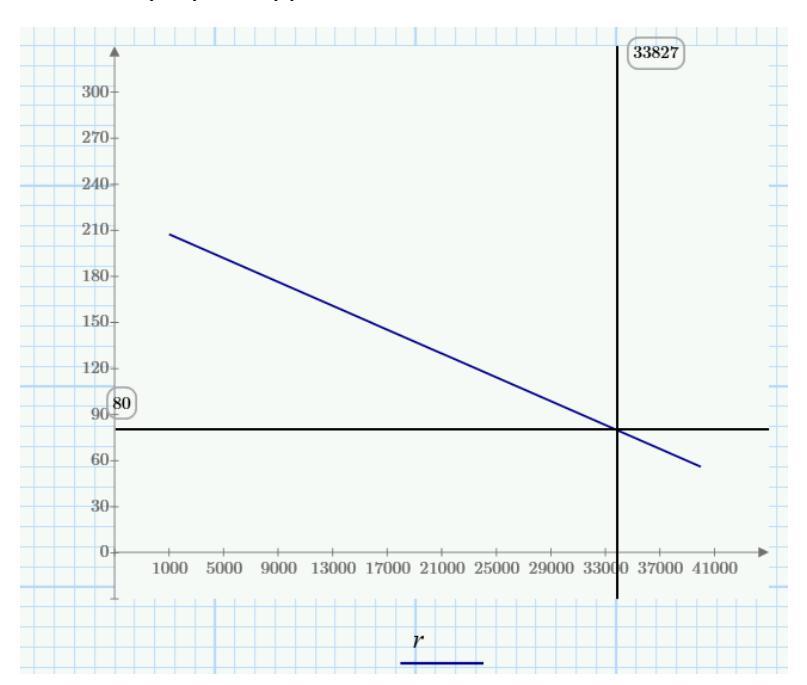
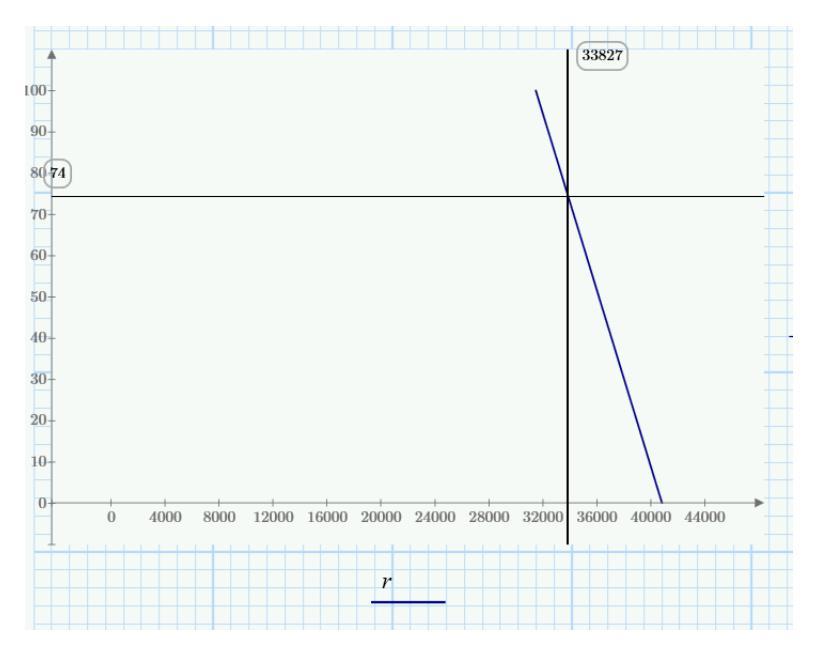
Another potential scenario is the excessive bending stress during the hydrostatic test. The results of this scenario are shown in Figure D.24 and Figure D.25. The results indicate that high bending stresses (e.g. 80 ksi) would be possible when the pipe segment was filled with hydrostatic water if it lacked proper support.

Figure D.24. Cantilever Beam Bending Stress for Pipe Filled with Hydrostatic Test Water. The x-axis in this figure is end reaction force in lbf, and the y-axis is the bending stress in ksi.

Figure D.25. Cantilever Beam Deflection for Pipe Filled with Hydrostatic Test Water. The x-axis in this figure is end reaction force in lbf, and the y-axis is the bending Deflection in inch.
