RCFA for the Keystone Milepost 14 Release

Stephanie Flamberg, Bill Amend, Peter Martin, Michael Rosenfeld, Adam Steiner, and Benjamin Zand

April 21, 2023

Final Report

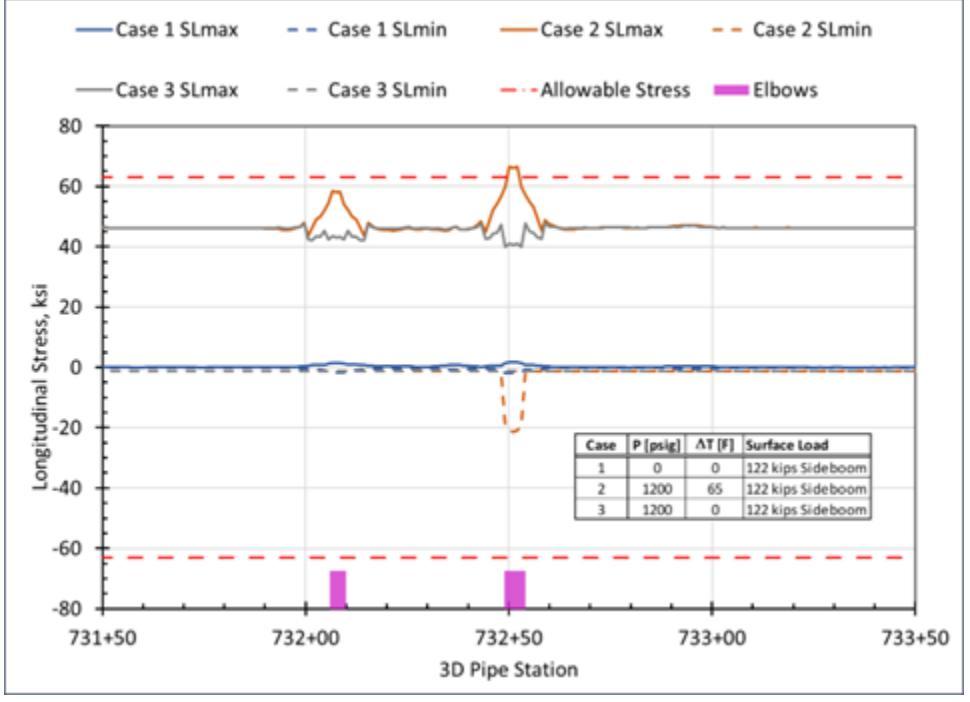
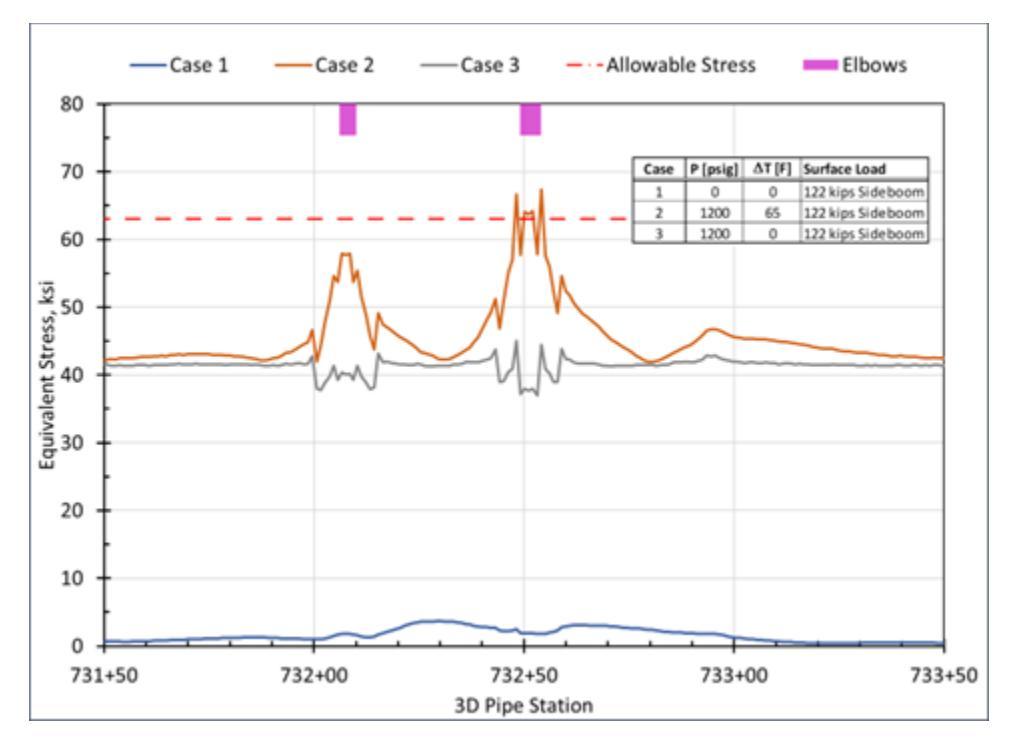
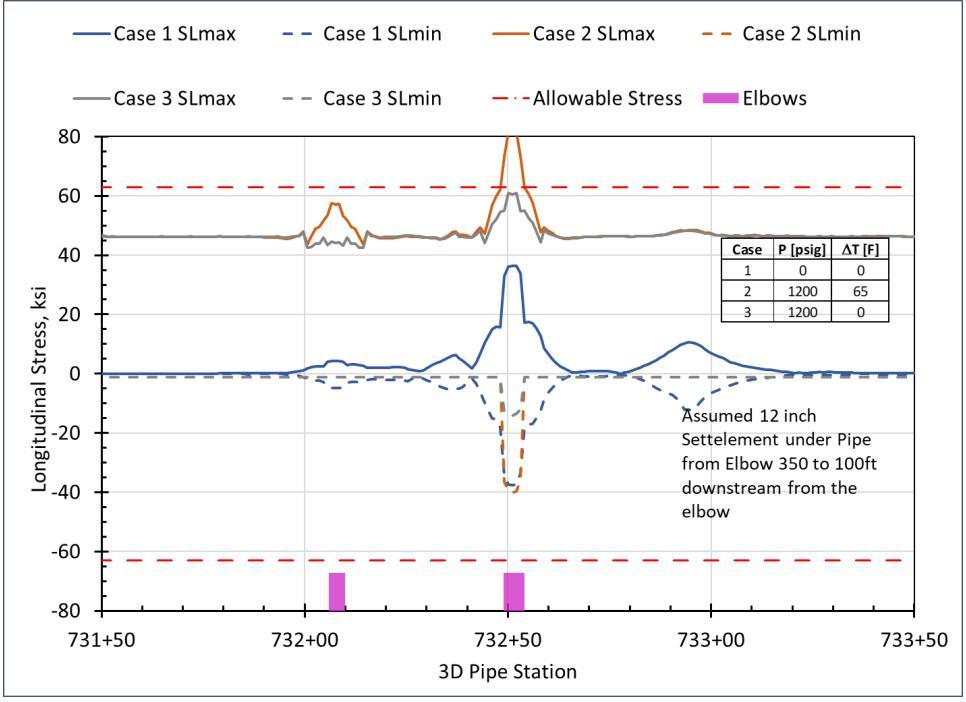
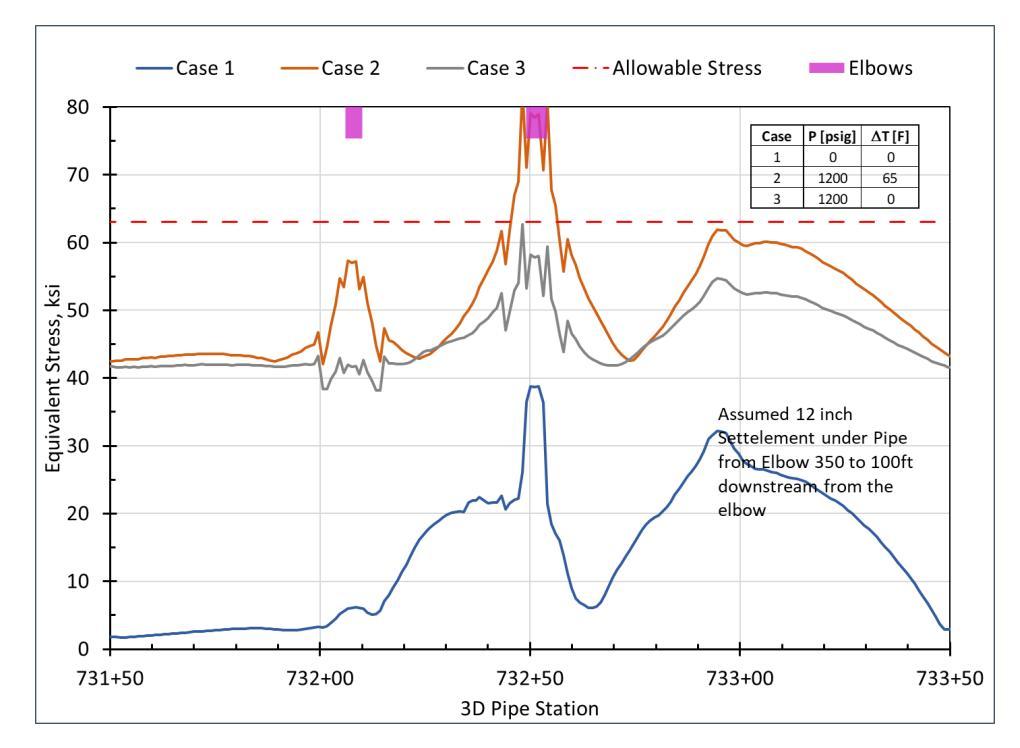
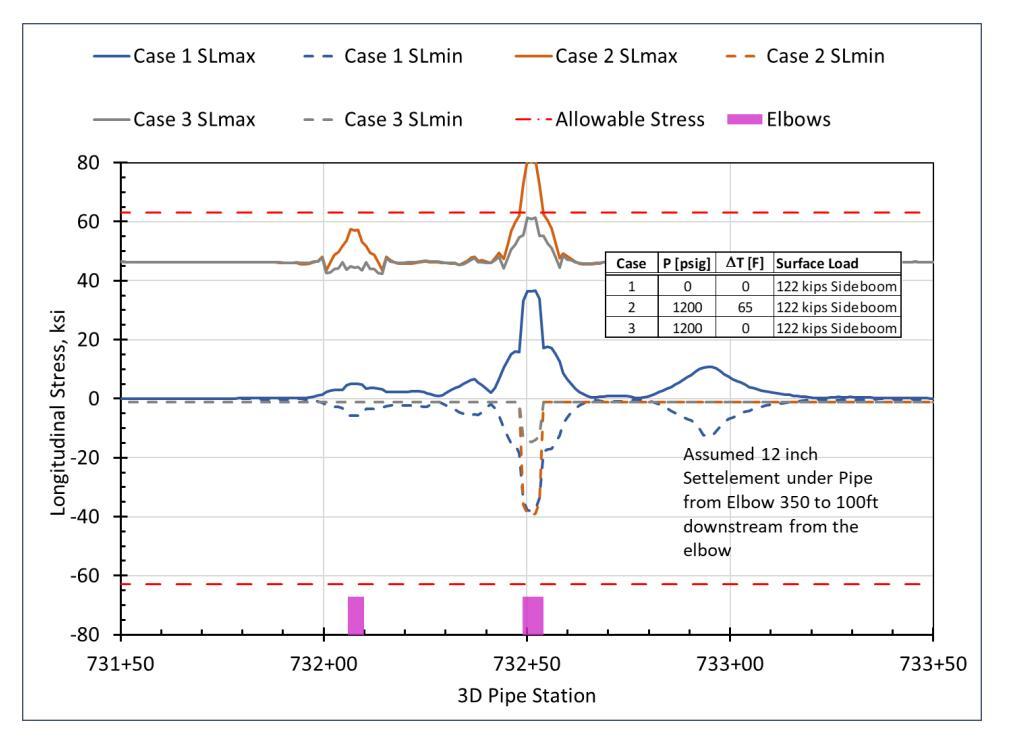
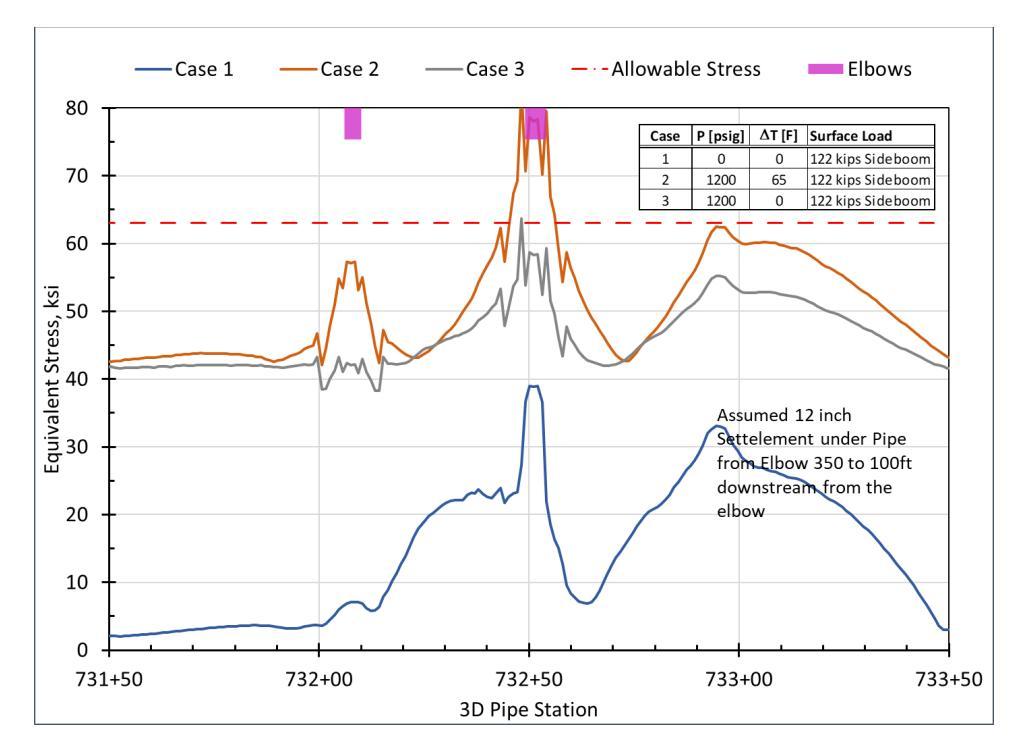
Figure D.28. FEA Longitudinal Stresses for Post-Construction Analysis with Side Boom Load Only

Figure D.29. FEA von Mises Stresses for Post-Construction Analysis with Side Boom Load Only

Figure D.30. FEA Longitudinal Stresses for Post Construction Analysis with Ground Settlement Only

Figure D.31. FEA von Mises Stresses for Post Construction Analysis with Ground Settlement Only

Figure D.32. FEA Longitudinal Stresses for Post Construction Analysis with Ground Settlement and Side Boom Load

Figure D.33. FEA von Mises Stresses for Post Construction Analysis with Ground Settlement and Side Boom Load

The post-construction settlement or gap under the pipeline can explain the out-of-roundness of the elbow. However, this scenario does not explain the wrinkle as the amount of compressive stress at the elbow is not excessive (Figure D28, Figure D.30 and Figure D.32). In order for ground settlement to cause a wrinkle, the amount of movement should be around 24-inches or more. It is also possible that the wrinkle was formed at a later time due to thermal cycles or ground movement, but that would require two independent coincidences both affecting the same location of the pipeline at different times, which although is possible it decreases the overall likelihood of the scenario. In addition, the bending strain analysis from the IMU data and assessments by Geotech SMEs did not find evidence of significant ground movement near the TAG 98 elbow.

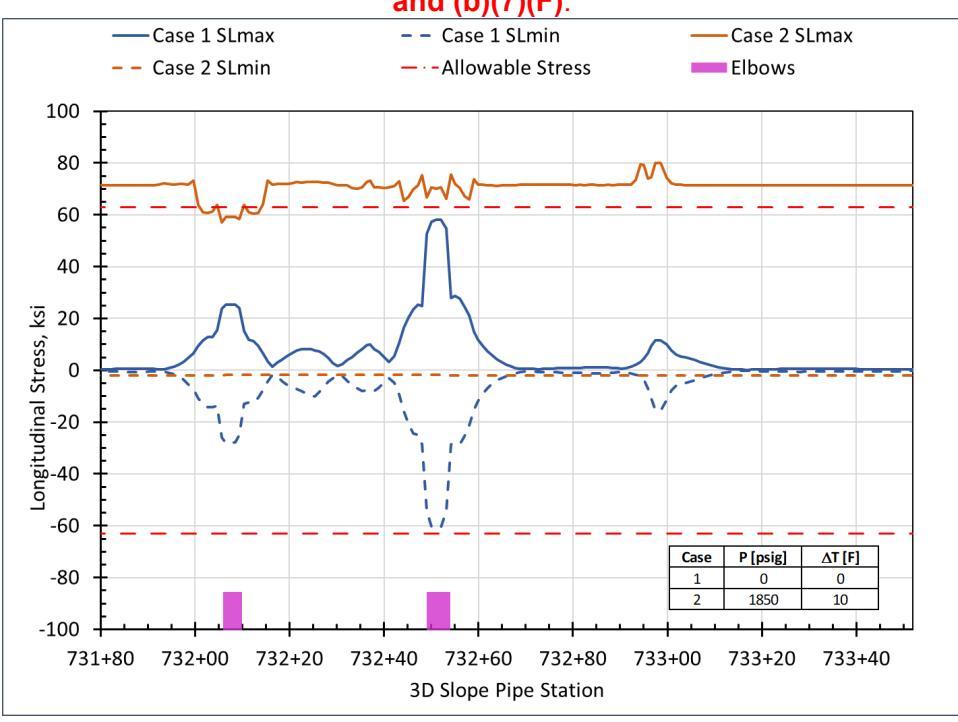
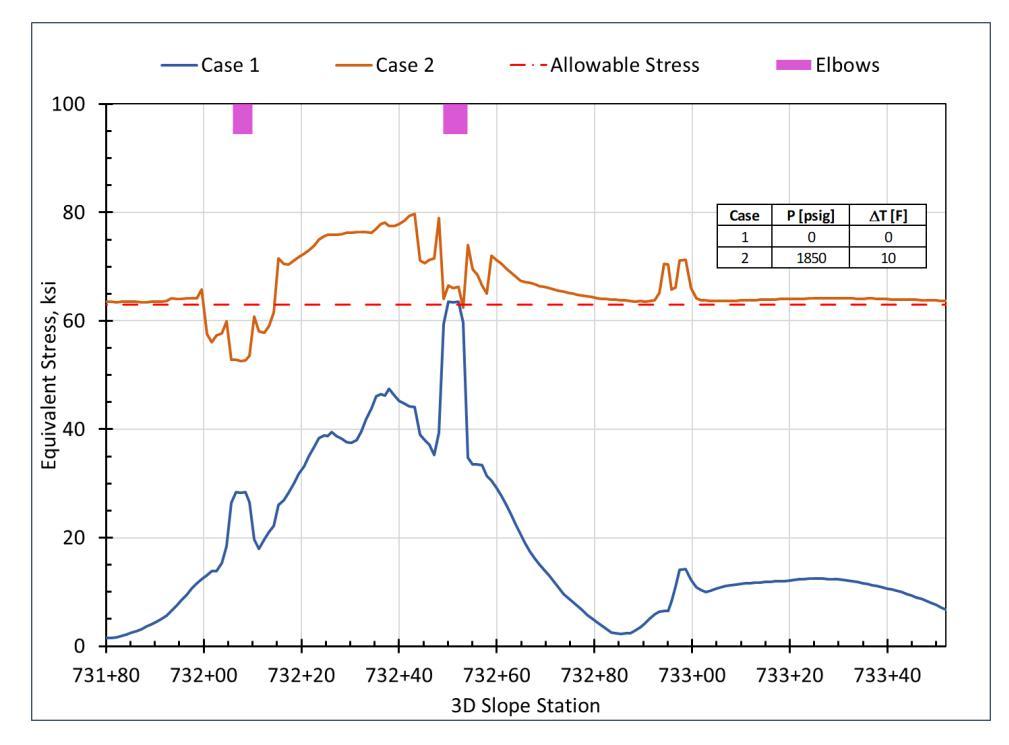
Figure D.36 for the equivalent stresses. The results show that cantilever action could have overstressed the TAG 98 (BND 350) elbow if the end deflection was at least 6-ft. This amount of end deflection is excessive and could only happen if the pipe length on the south slope was supported above ground before the hydrostatic test and then lost the support after it was filled with water. This type of movement would have been noticeable by construction crews and most likely would have resulted in a safety standdown (which there is no evidence of in the daily inspection reports).

Figure D.35. FEA Longitudinal Stresses with 6-ft End Deflection

Figure D.36. FEA von Mises Stresses with 6-ft End Deflection
TC Oil REDACTIONS MADE BY TC OIL - Pending PHMSA Review CONFIDENTIAL – Protected from release under FOIA Exemptions 4 and 7(F), 5 USC 552(b)(4) and (b)(7)(F).

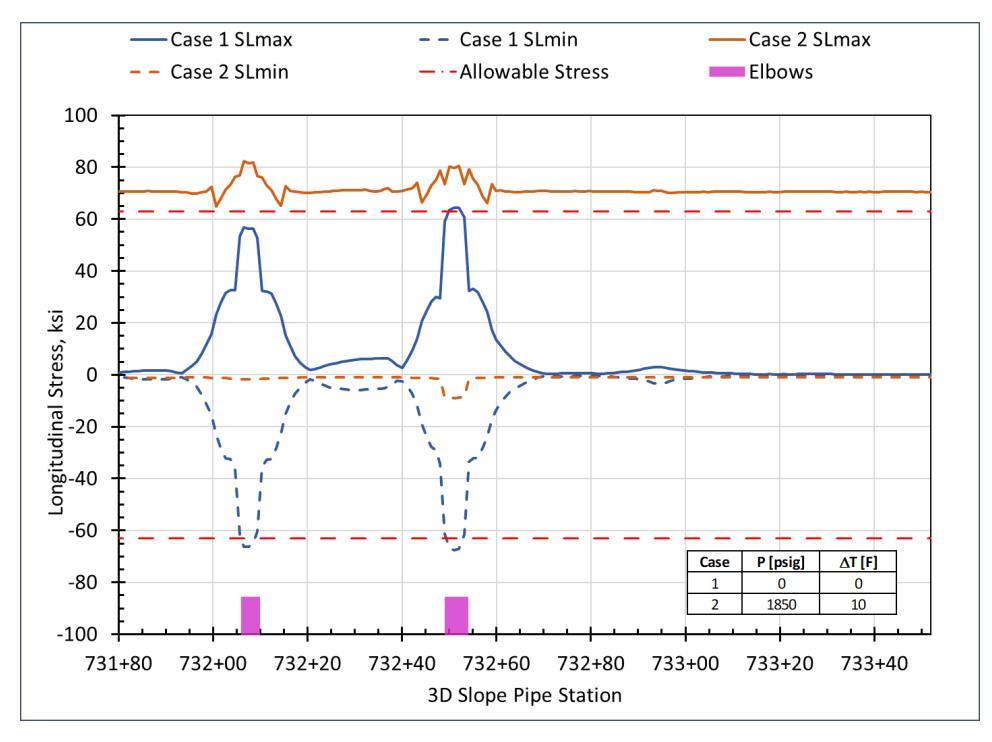
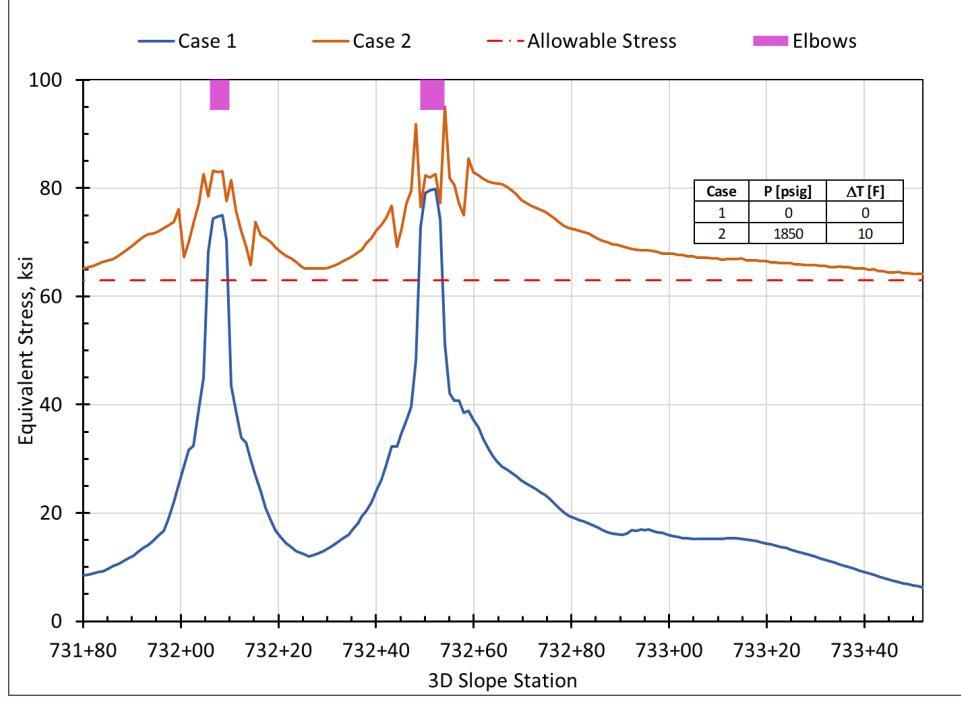
A sliding displacement of 6-inches in the downhill direction was applied to the end of the cantilever length and the model was run to calculate stresses. The results of this analysis are shown in Figure D.38 and Figure D.39. The results show that sliding of the pipeline down the slope can also create excessive bending stress at the elbow, however, the weight of the pipe filled with hydrostatic water is insufficient to cause the sliding. In other words, some outside loading had to act on the pipeline to force it to slide.

Figure D.38. FEA Longitudinal Stresses with 6-inches of Sliding

Figure D.39. FEA von Mises Stresses with 6-inches of Sliding

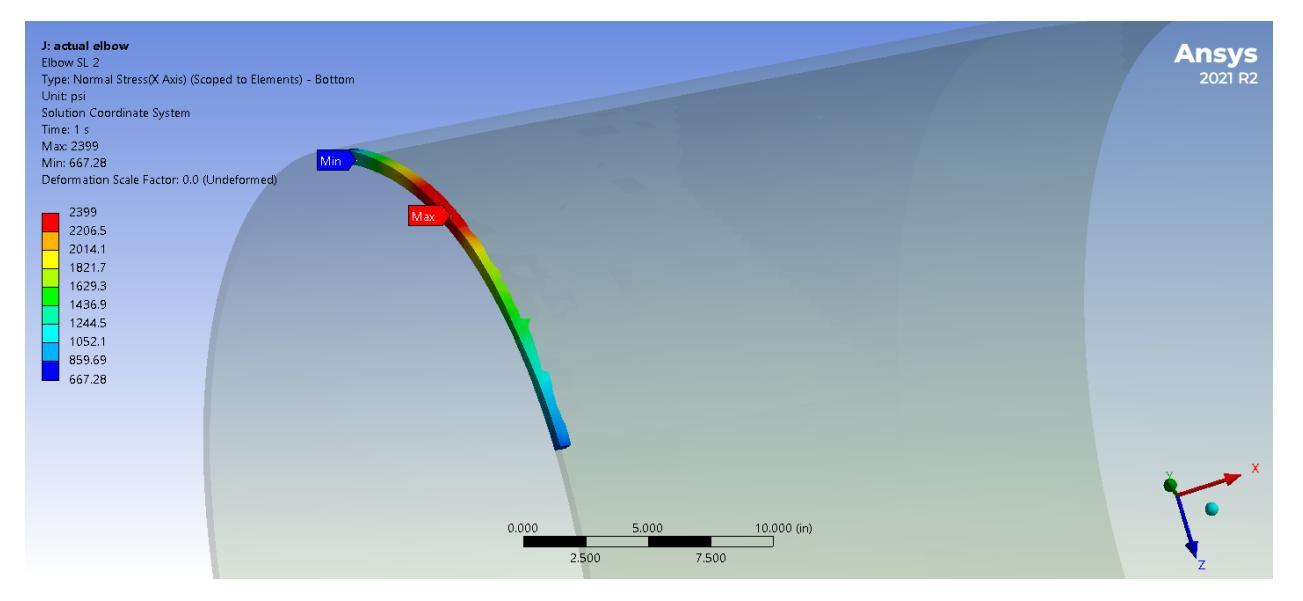
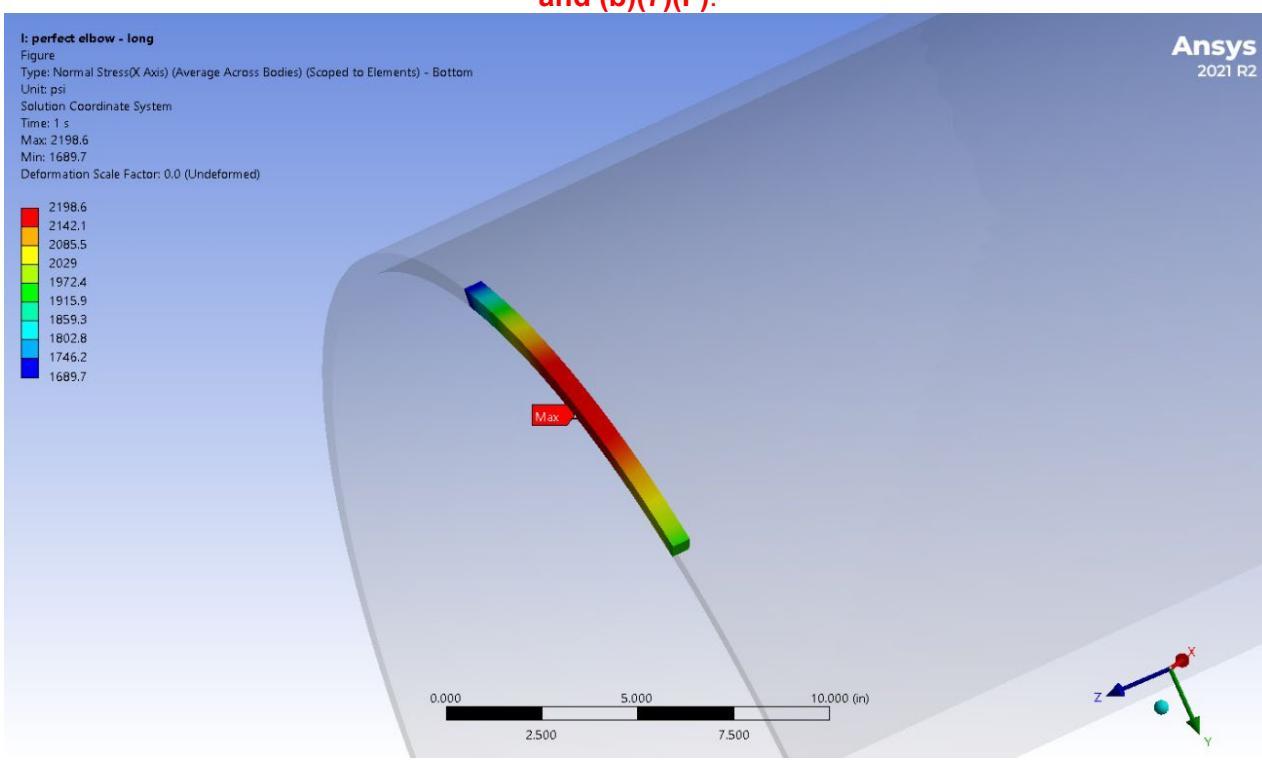
The wall thickness transition and geometrical features of the subject elbow, including the wrinkle and ovality, are expected to have caused stress concentration at the girth-weld, intensifying the stress ranges calculated in the previous section. Three sources for the SCF were identified after reviewing Anderson's metallurgical report, the laser scanner STL files, and other information including elbow out-of-roundness, wall thickness transition, and weld hi-lo. The three-dimensional (3D) shell model described under Section D.3 'Shell Model' was used to calculate the SCF associated with elbow out-of-roundness. This was achieved by applying a uniform bending moment to the end of the model (the end closer to the subject girth-weld), fixing the other end, and solving the model to calculate longitudinal stresses around the girth-weld. The highest tensile stress from this analysis was calculated as 2,399 psi (Figure D.44)¹⁵⁷. Then another shell model was built with similar dimensions and wall thickness values to the actual elbow model but with ideal geometry (i.e., a perfectly circular cross-section). The ideal elbow model was analyzed under the same boundary conditions to calculate the longitudinal stresses at the girth weld. The highest tensile stress from this analysis from this model was calculated as 2,199 psi (Figure D.45). The ratio of these two stresses is the SCF due to out-or-roundness¹⁵⁸:

Figure D.44. FEA Longitudinal Stresses at the Hot-Spot of the Subject Girth-Weld Under a Uniform Bending Moment of 1x10⁶ ft-lb – Actual Elbow with Out-of-Roundness

Figure D.45. FEA Longitudinal Stresses at the Hot-Spot of the Subject Girth-Weld Under a Uniform Bending Moment of 1x10⁶ ft-lb – Idealized Elbow Geometry

The SCF value calculated from the above analysis accounts for the residual ovality (ovality after the elbow is detached from the rest of the pipe) and wrinkle. The bending moment that was used in the analysis was relatively small, generating a bending stress of about 2,199 psi. Consequently, elastic ovality caused by the application of the bending moment was negligible. The difference between the measured ILI and laser scanner ovality measurements suggests that the elbow was under a residual bending moment. In other words, the amount of ovality was greater when the elbow was buried and connected to the rest of the pipeline, which would have generated a higher SCF. To explore the SCF value under a potentially high residual bending moment, RSI ran a second analysis in which an initial bending moment was applied to the elbow to increase the ovality to 10% (the highest measured ovality from the 2013 caliper ILI). The bending moment required to create this amount of ovality was 1.8x10⁷ ft.lbf. Then an additional bending moment of 2x10⁶ ft.lbf was applied to the elbow to calculate the increment in the longitudinal stress. A similar analysis was performed on the idealized elbow. The increment in the stress from the actual elbow was calculated as 8,869 psi, and that from the idealized elbow was calculated as 4,642 psi. These results show that the SCF value for an elbow with 10% ovality could be as high as 1.91.

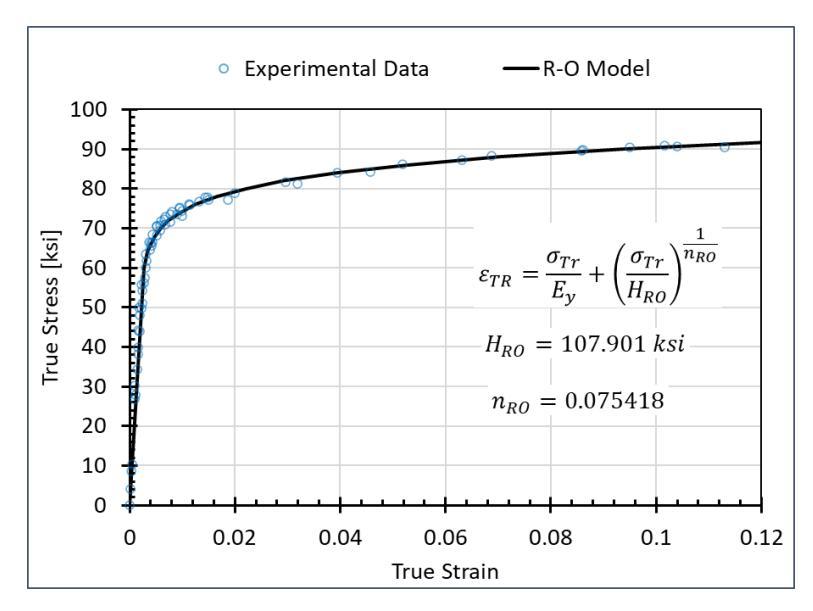
Figure D.48. Ramberg-Osgood Stress-Strain Curve Fitting Through Tensile Test Data from Longitudinal Base Metal Specimens

The R-O parameters on each figure were determined by the Least Square method. These stress-strain curves are shown in Figure D.48 and Figure D.49. Figure D.50 shows the shell model used for this analysis and the annotations on the figure show the boundary conditions. A vertical concentrated load of 100,000 lbf was applied to the pipeline right next to the elbow in

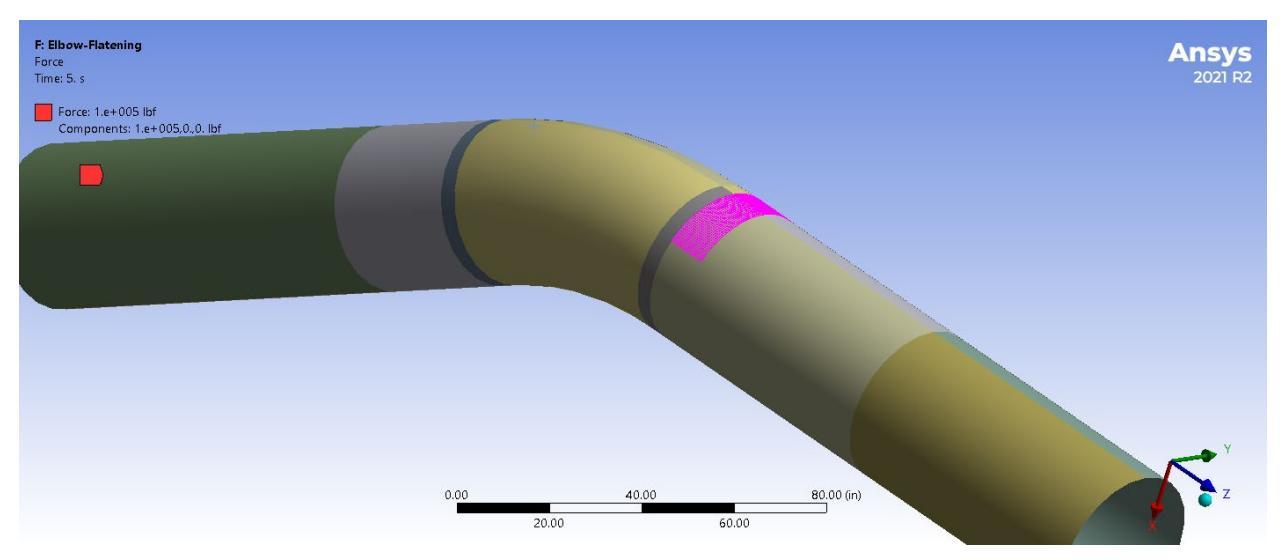
Figure D.51 The Pipe Area Where the Concentrated Load was Applied

five-time steps. The concentrated load was applied to a 10-inch by 20-inch area of the pipe surface (Figure D.51).

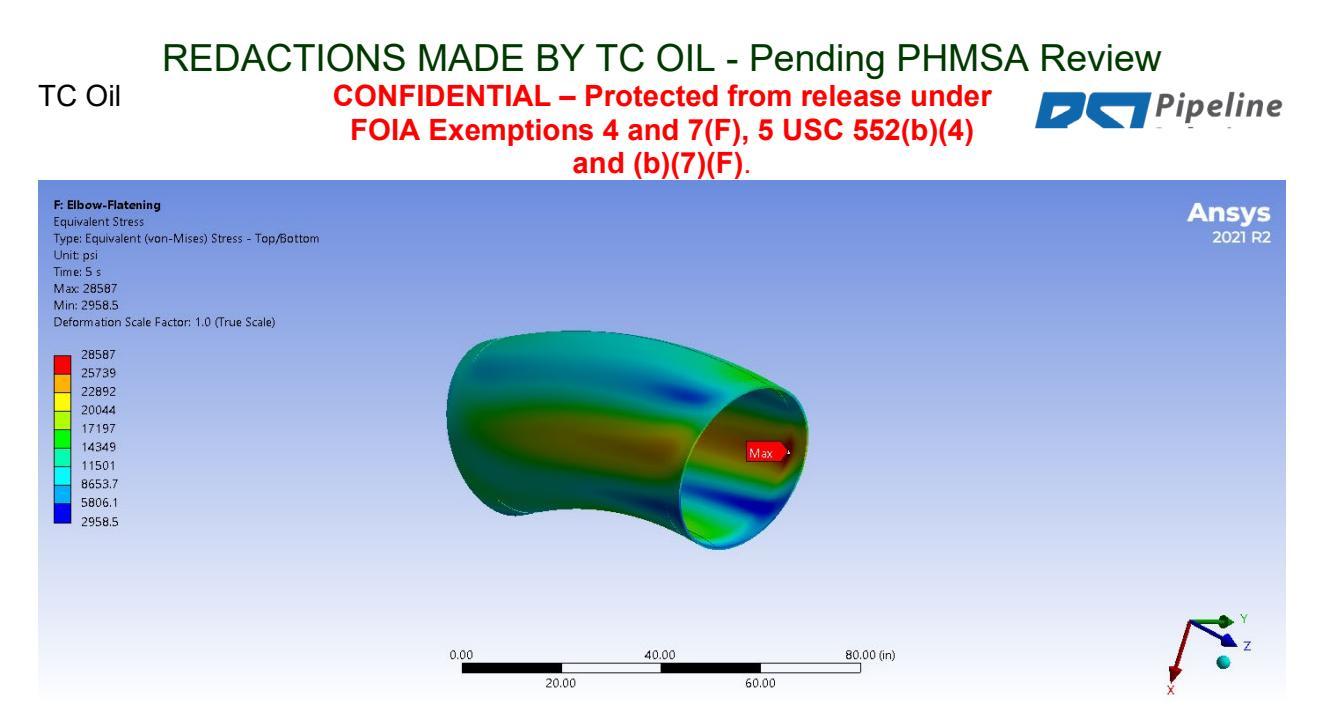
Figure D.52. Calculated vin Mises Stress in the Elbow under a Concentrated Load of 100,000 lbf.

The results show a maximum von Mises stress of 28.6 ksi in the elbow (Figure D.52), which is insufficient to cause plastic deformations. In conclusion, typical construction equipment would not be able to exert pressures and forces high enough to cause permanent deformation of the elbow.
