U.S. Chemical Safety and Hazard Investigation Board

# Organic Peroxide Decomposition, Release, and Fire at Arkema Crosby Following Hurricane Harvey Flooding

Crosby, Texas

Incident Date: August 31, 2017

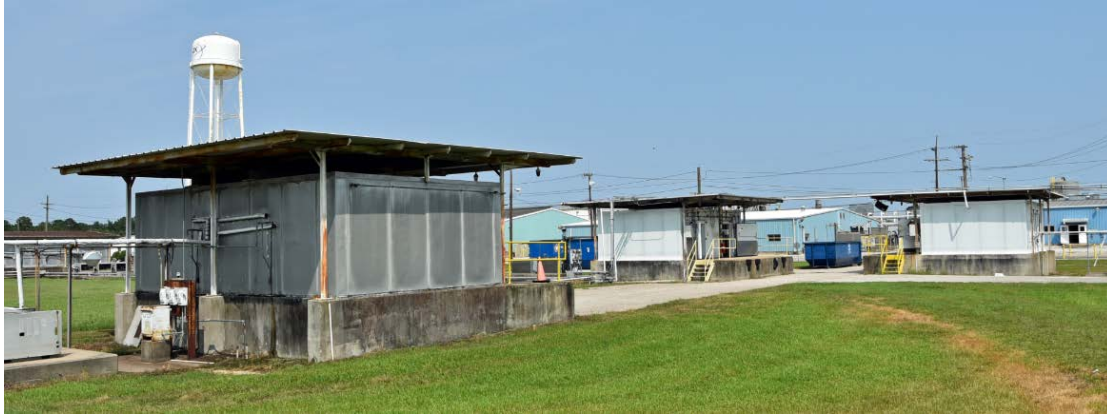
Figure 3. Crosby Low Temperature Warehouses. Three of the seven Low Temperature Warehouses at the Arkema Crosby facility are shown in this photograph. (Source: CSB Photo)

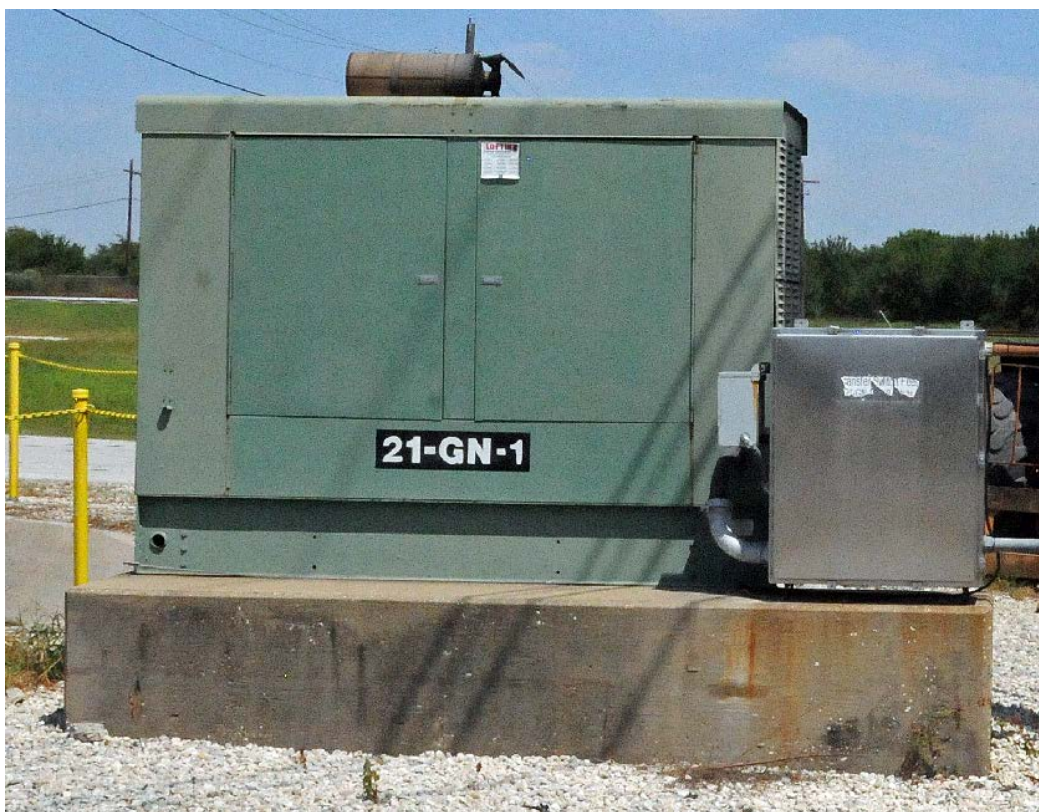
Figure 5. One of Seven Emergency Generators at the Arkema Crosby Facility. Generator 21-GN-1 is one of the two generators providing emergency electrical power to Arkema's seven Low Temperature Warehouses. The bottom of the generator (top of the concrete foundation) is about two feet above the ground. (Source: CSB Photo)

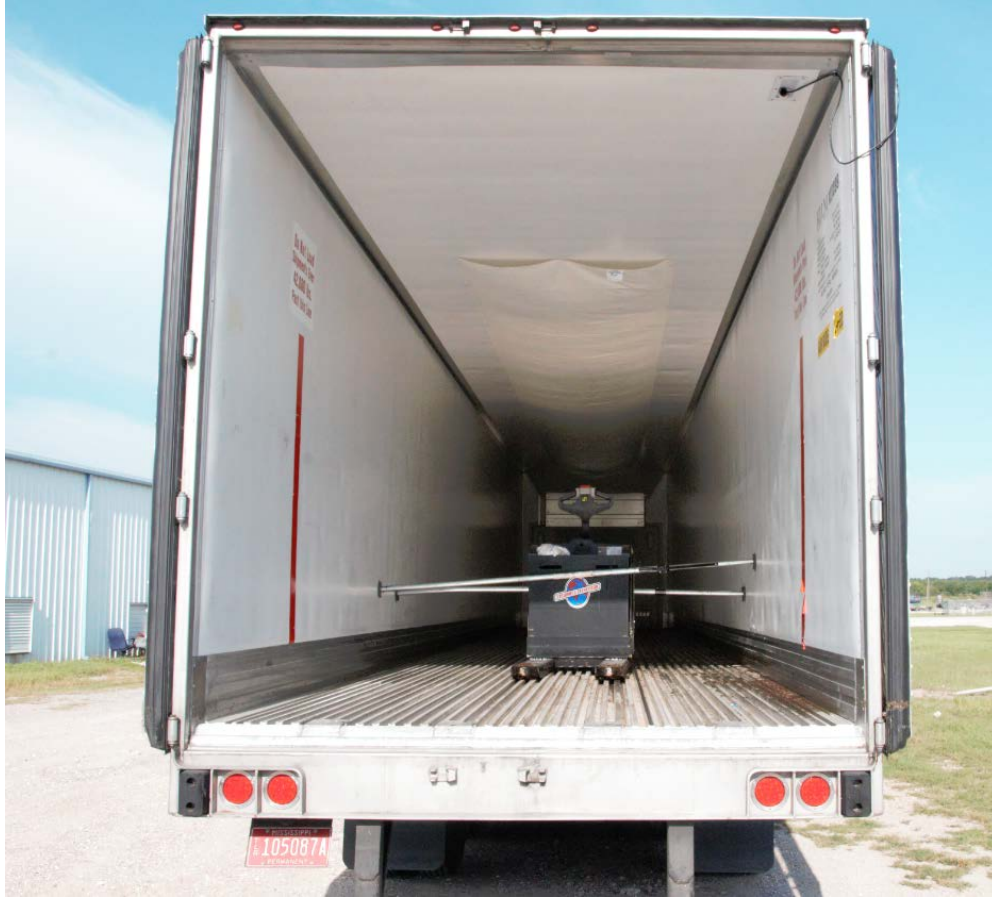
Figure 7. Refrigerated Truck Trailer. Arkema used about a dozen refrigerated truck trailers like this one used to ship organic peroxide products to customers and to provide a temporary storage location if the refrigeration at one or more of the Low Temperature Warehouses could not be maintained. (Source: CSB Photo)

55. As a final backup for scenarios causing elevated temperature in one of the Low Temperature Warehouses, organic peroxide products can be relocated to one or more portable refrigerated truck trailers (Figure 7). Arkema uses these refrigerated trailers primarily for shipping organic peroxide products to customers; however, Arkema procedures allow the use of these trailers in emergency situations or while making repairs to Low Temperature Warehouse refrigeration systems. The fuel tank for these refrigerated trailers is located under the container that powers the refrigeration unit. With a full tank, the refrigerated trailers can normally maintain appropriate cold conditions for more than a week.

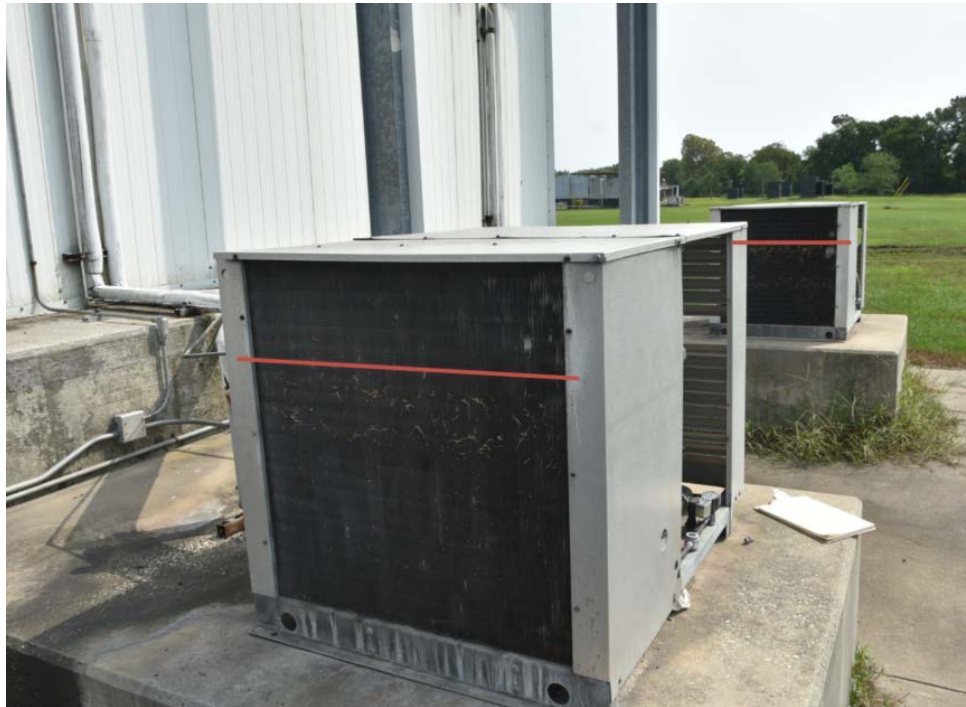
Figure 17. Air Conditioning Units Behind One of the Low Temperature Warehouses. The final floodwater level is approximated by the red lines on the air conditioning equipment at the Arkema Crosby facility. (Source: CSB Photo)

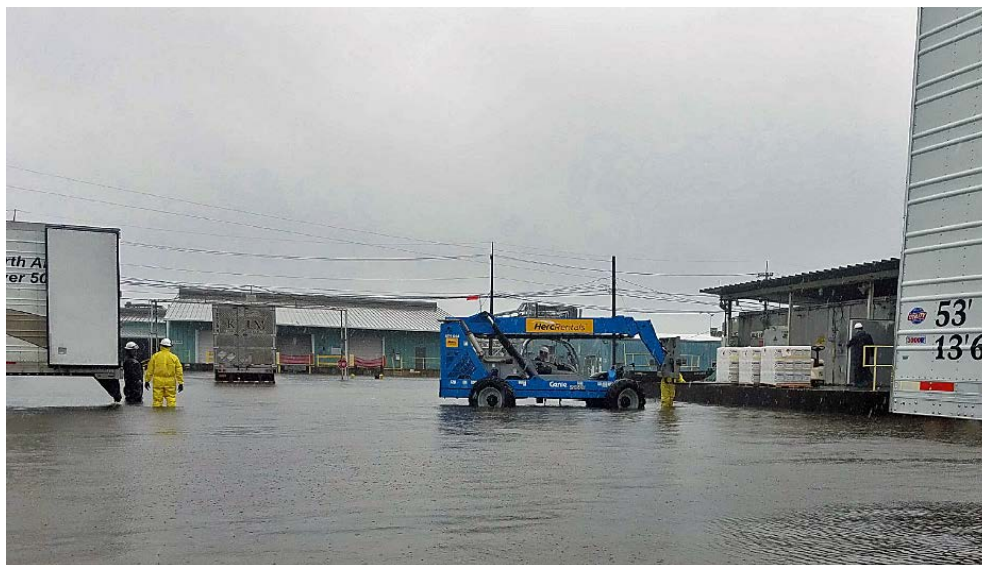
Figure 18. Forklift Used by the Ride-out Crew. Ride-out crew members used the forklift shown in this image to move organic peroxide pallets from the storage buildings after they turned off power to the buildings because of the rising floodwater. (Source: Arkema Photo)

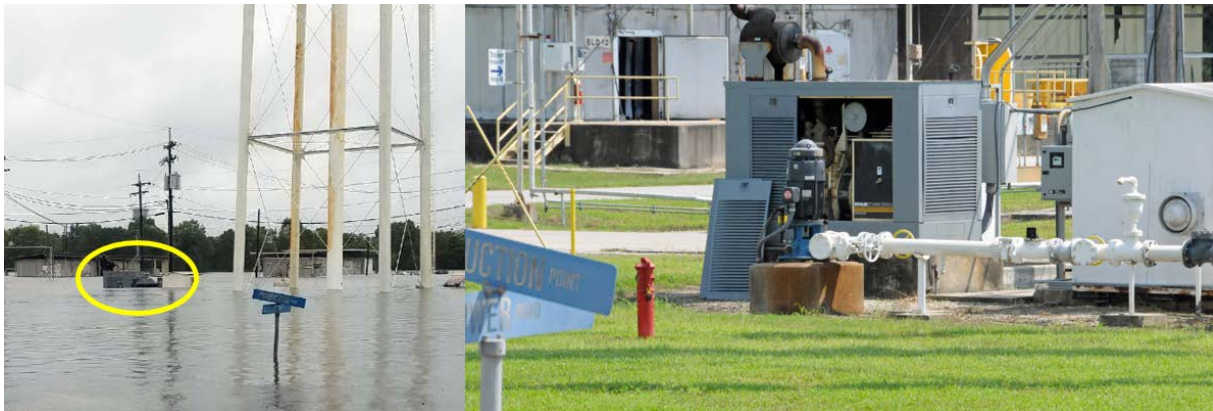
Figure 19. One of the Emergency Generators Providing Backup Electricity to the Low Temperature Warehouses. The photo on the left shows floodwater covering the bottom half of the generator (yellow oval) on Tuesday August 29, 2017. The post-incident photo on the right shows the same generator. (Source: Arkema Photo (left) Modified by CSB, CSB Photo (right))

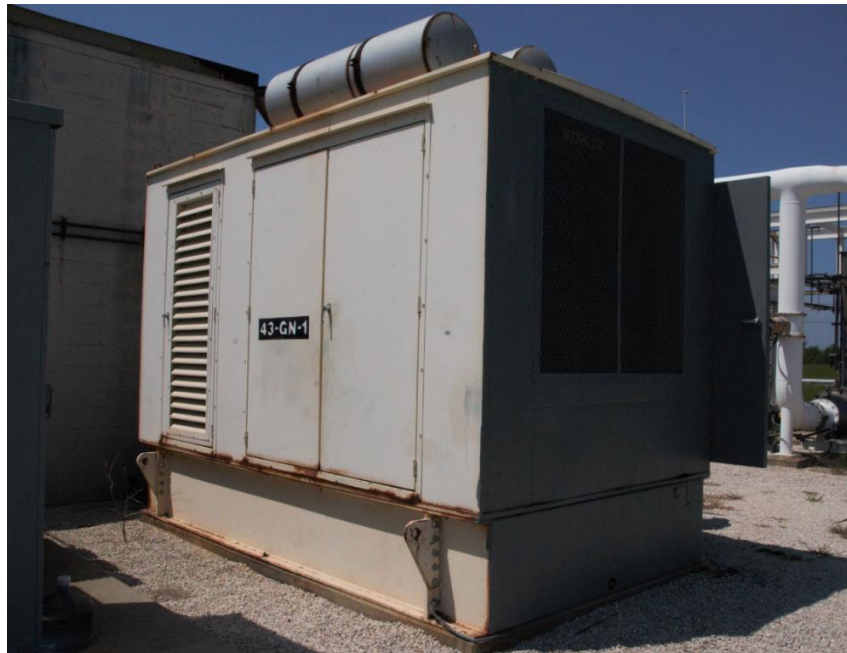
Figure 25. Emergency Generator. This is one of the emergency generators that automatically turned on when the power failed at the Arkema Crosby facility. (Source: CSB Photo)

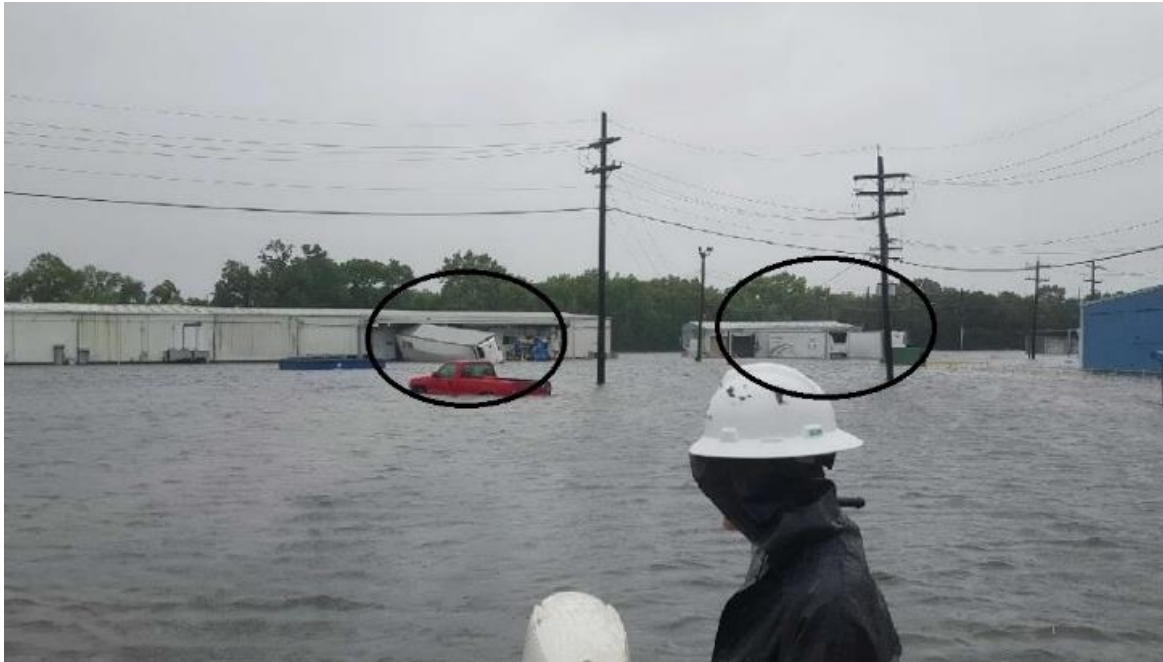
Figure 31. Condition of the Crosby Facility on the Morning of Tuesday, August 29, 2017. The ride-out crew sent this photograph to the corporate crisis team showing the trailer on the left had tilted. (Source: Arkema Photo Modified by CSB)

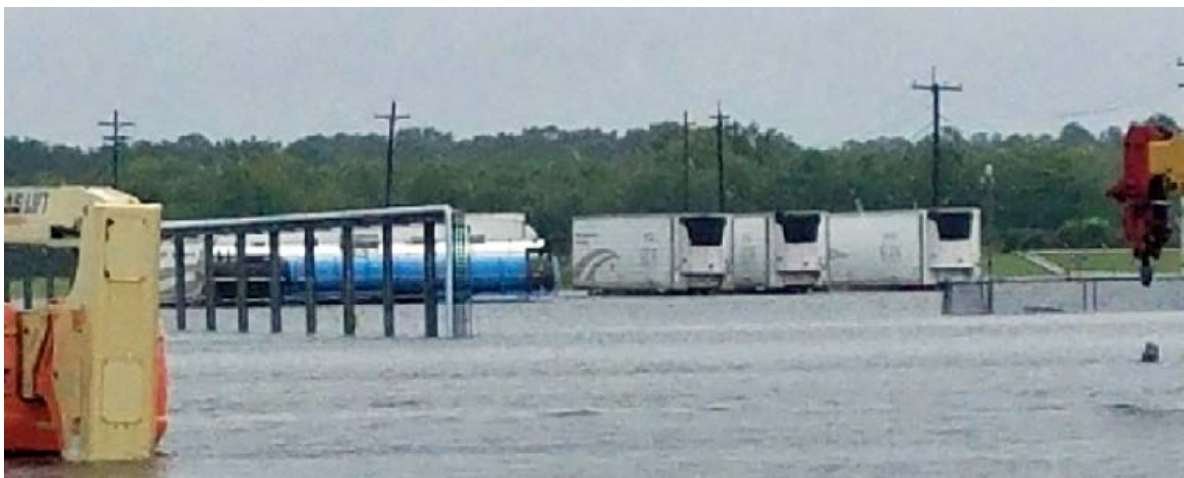
Figure 32. Refrigerated Organic Peroxide Trailers Located on High Ground. The refrigerated trailers containing organic peroxide products and resting on high ground are pictured here, located on the north side of the Arkema Crosby facility during high floodwater conditions on Tuesday August 29, 2017. All six trailers at this location were incinerated during a controlled burn on September 3, 2017. (Source: Arkema Photo)

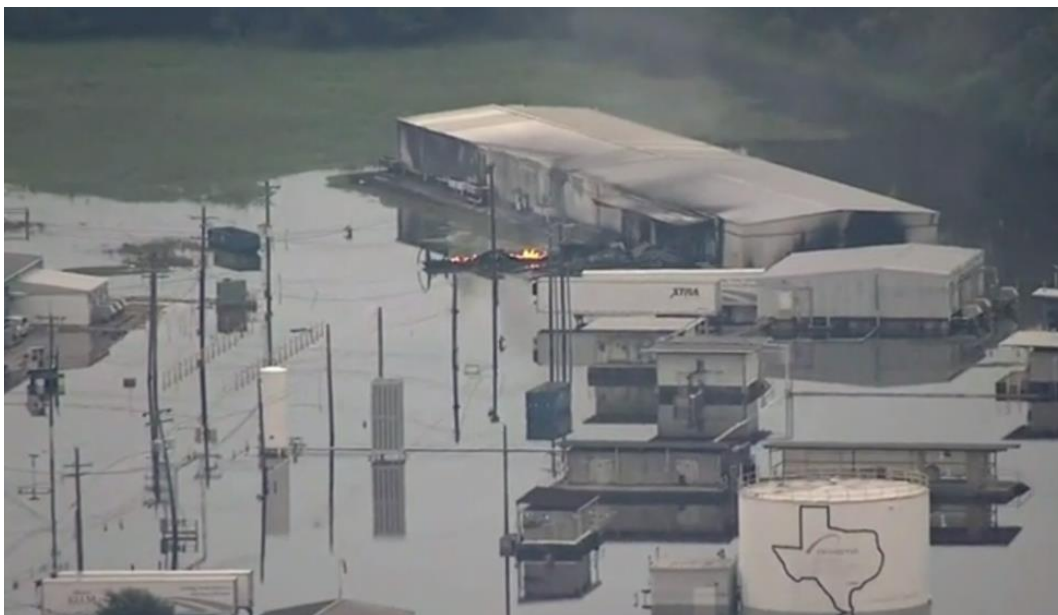
Figure 39. First Refrigerated Trailer to Burn at the Arkema Crosby Facility. The first refrigerated trailer to burn is shown smoldering outside of Building 21 [37].

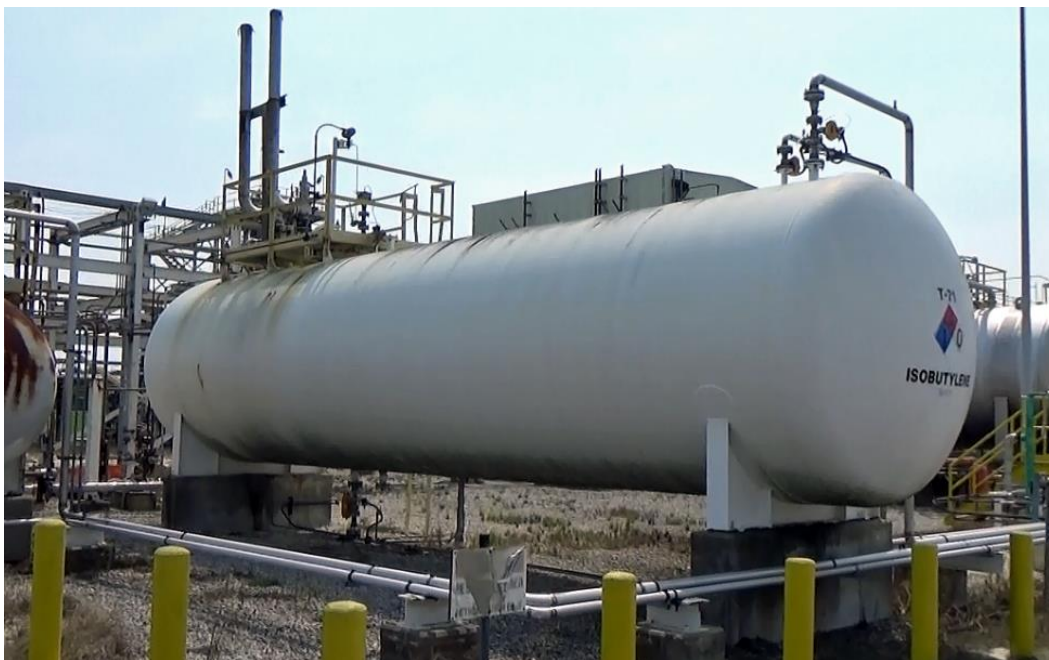
Figure 43. Isobutylene Storage Tank at the Arkema Crosby Facility. The isobutylene tank posed a concern because the controlled burn of the six refrigerated trailers in the laydown area would occur within about 40 yards of this storage tank. (Source: CSB Photo)

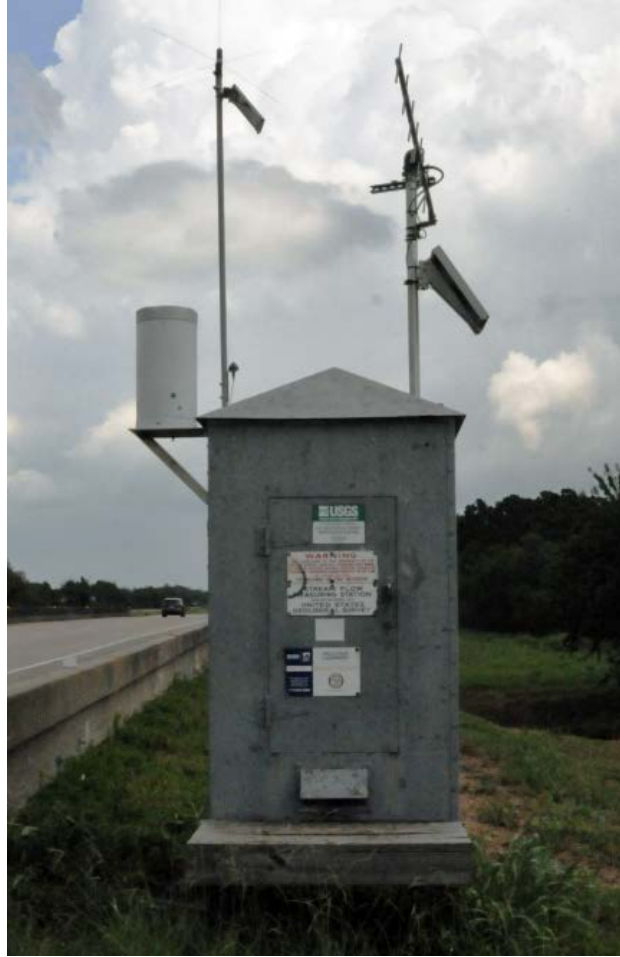
Figure 47. Gauge Station 1740. This gauge station uses a bubbler system to measure the Cedar Bayou water elevation at Highway 90, about three miles northeast of the Arkema Crosby facility.<sup>a</sup> (Source: CSB Photo)
